AIR ACCIDENT INVESTIGATION

Factual Accident Report to
Cessna 152
Registration 5Y-BYQ
at Malindi Airport Kilifi
on 7th April 2016

CIVIL AIRCRAFT FINAL ACCIDENT REPORT
5Y-BYQ

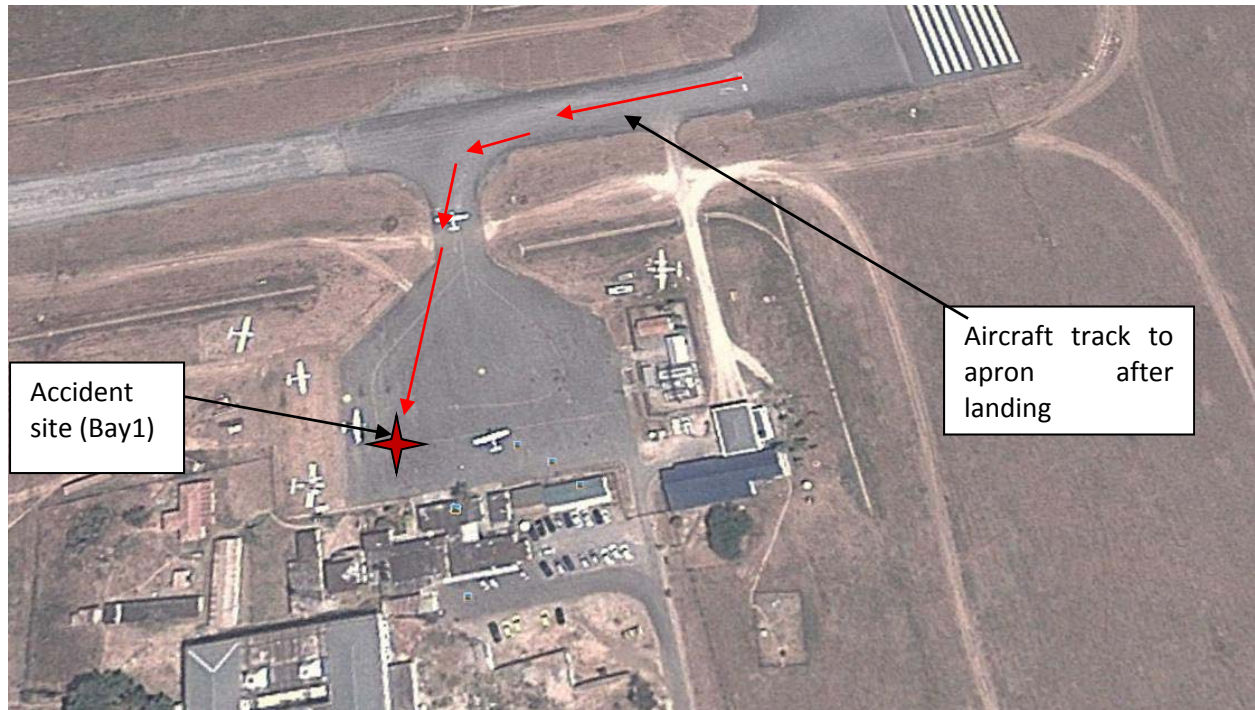
Figure 2: A section of Malindi airport map showing the aircraft track and the accident site

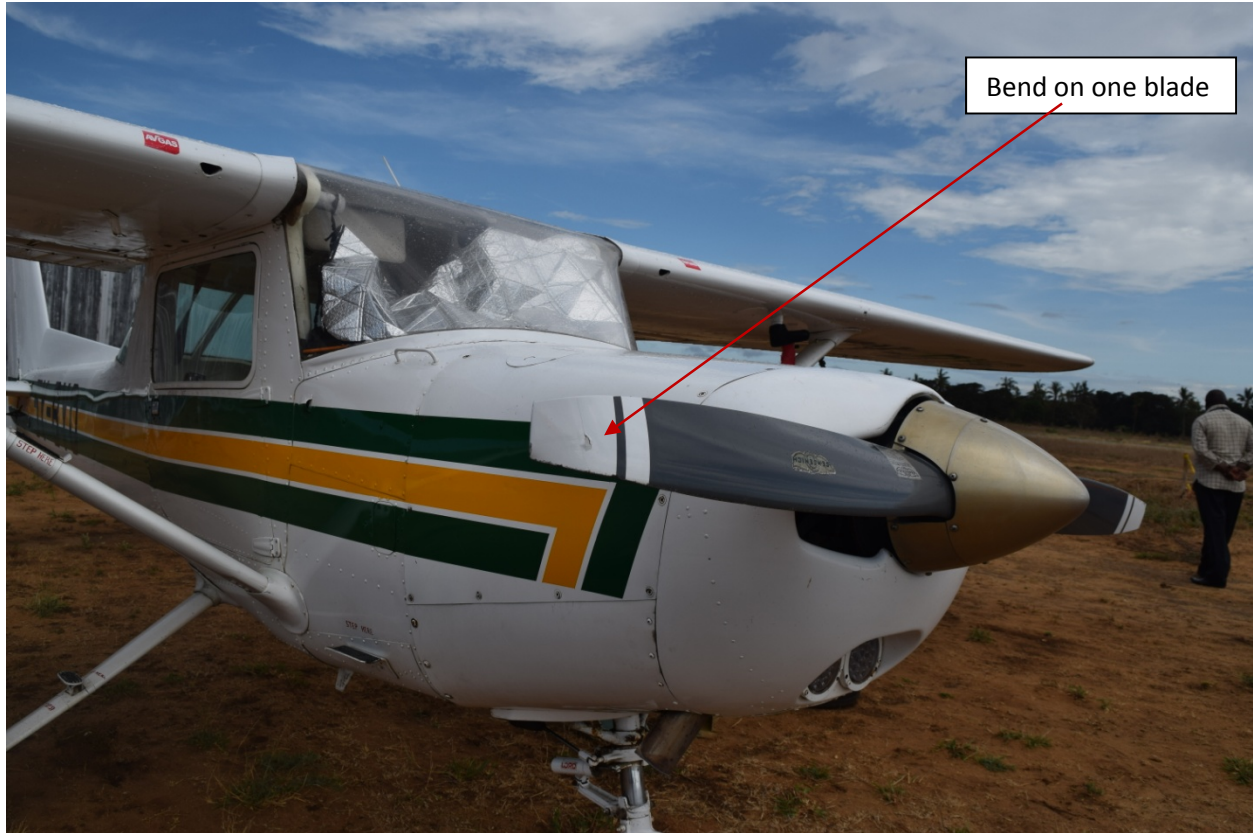
Slightly damaged in which there was a bend on the propeller.

Figure 3: A photograph showing the accident aircraft and the bent propeller blade

By the time of the accident the aircraft had a valid airworthiness certificate. It was also equipped and maintained in accordance with KCAA regulations. There was no substantial damage on the aircraft except a small bent on one of the propeller blade.

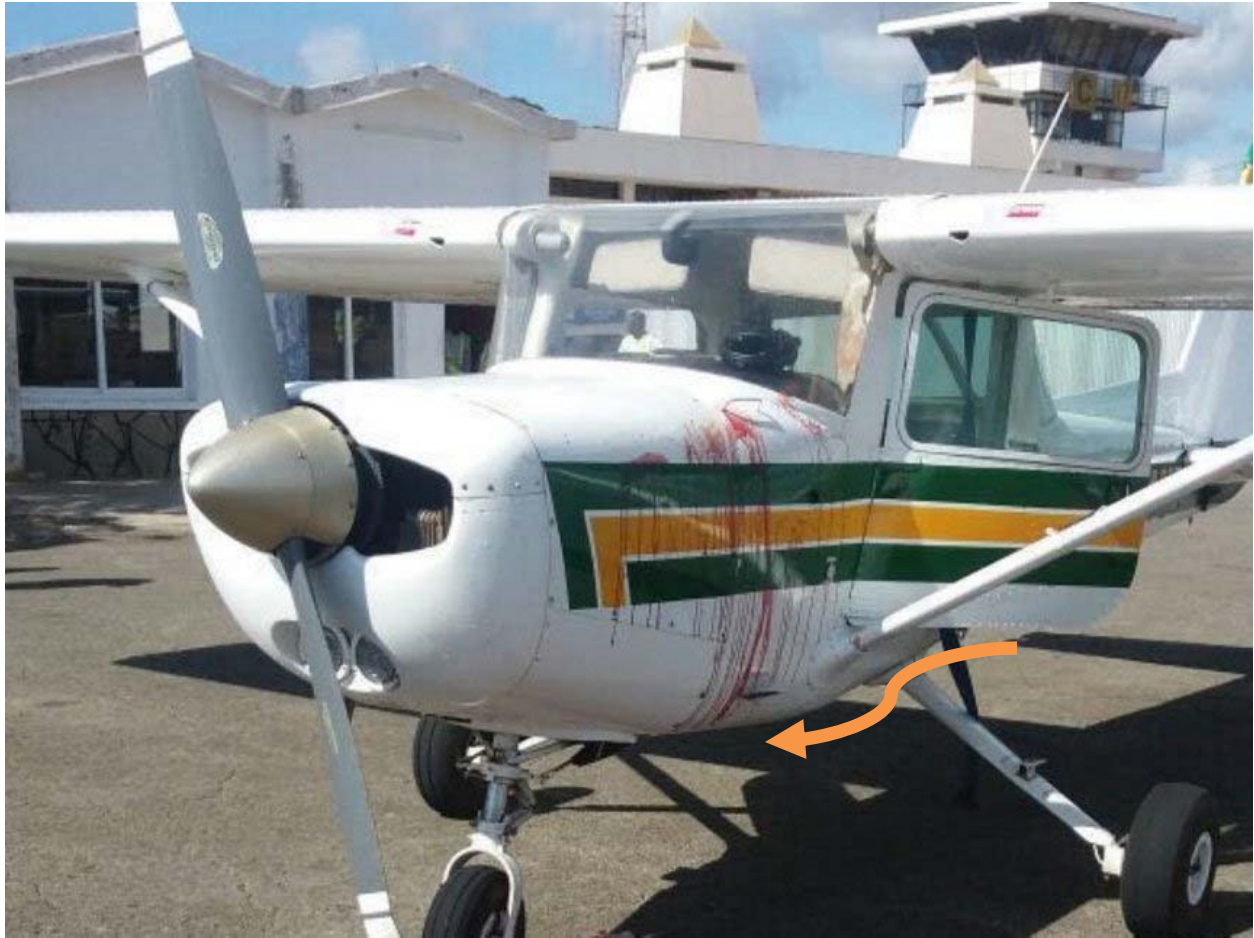
Figure 4: A photograph showing the scene of the accident site.

Post-accident inspection of the aircraft revealed that the right wing tip chipped off as it collided with the aircraft hangar, the nose wheel broke and separated, the aircraft dome broke off, the aircraft empennage got distorted and the wings got several dents.
