AIR ACCIDENT INVESTIGATION

FINAL ACCIDENT REPORT

5Y-KNJ

INCIDENT REPORT

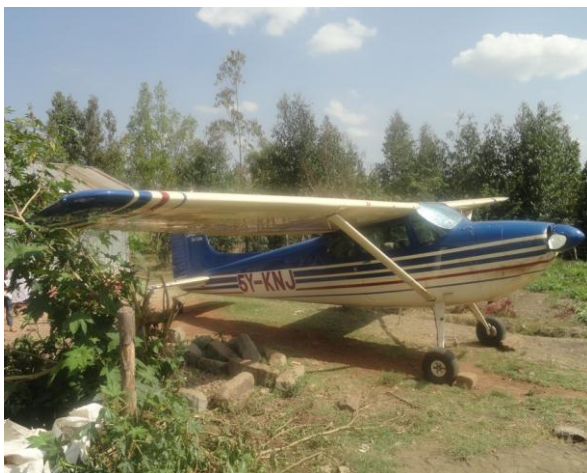
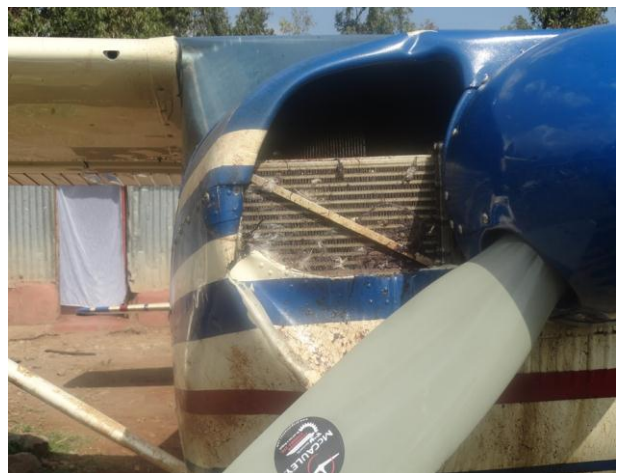
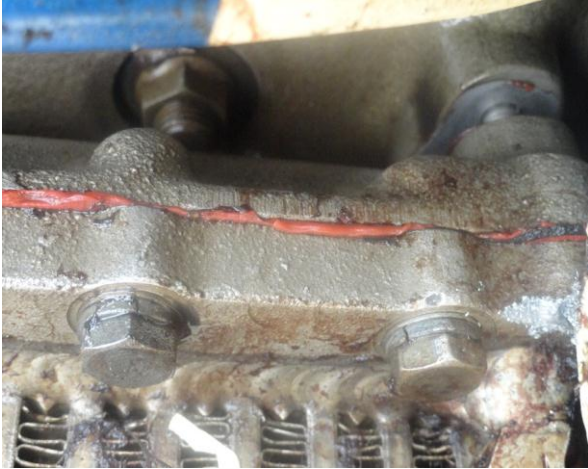
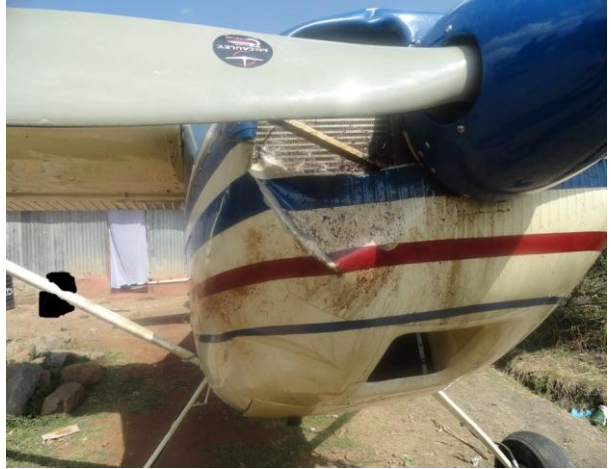
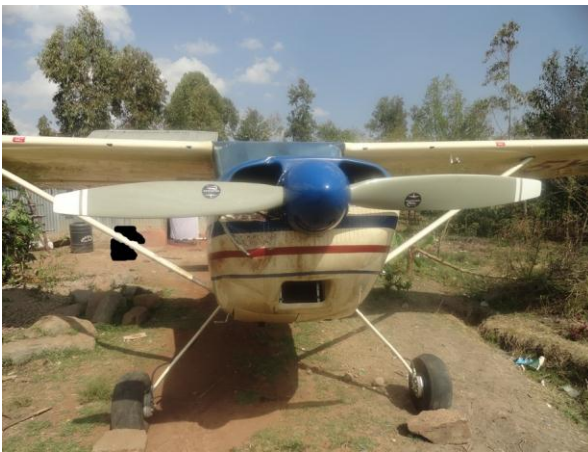
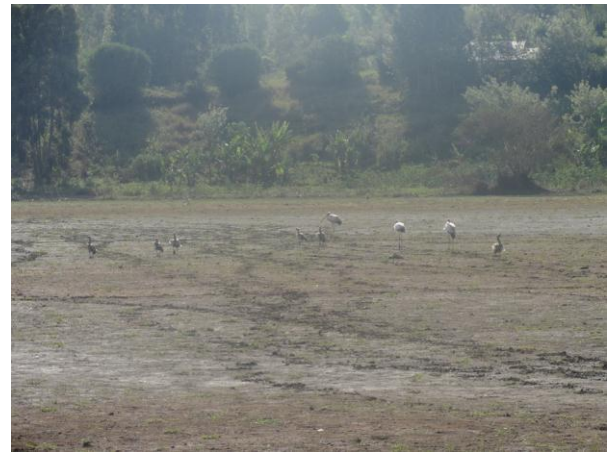
Visual examination of the aircraft on ground revealed evidence of bird remains and oil on the surface of the engine, engine cowling, oil cooler, windshield, right side of the fuselage, vertical stabilizer and right horizontal stabilizer. Damage to the aircraft was limited to oil cooler, engine cowling and the right surface of the fuselage. The impact with the bird left dents, scratches and a crack on the engine cowling and the fuselage. There was also a visible stud on the oil cooler separated from its original position. A close examination of the damage indicated that the bird struck the lower right side of the engine cooler and the cowling. The bird was likely flying upwards from below the aircraft. The aircraft touched down at a heading of approximately 161° SE. It then rolled for approximately 435 meters before coming to rest.

The area close to the location of the bird strike was swampy and there was a man-made water dam nearby. This served as an attraction for various types of birds including the Marabou stork. The altitude of the incident site was 6500 feet AMSL.

Photographs showing the aircraft after landing following bird strike and the lake inhabited by birds

It is recommended that KCAA to conduct risk analysis of the impending bird activity at the vicinity of the Control Zone Boundary near Karai with the objective of assessing the suitability of issuing a NOTAM as appropriate.
