**AIRCRAFT ACCIDENT INVESTIGATION DEPARTMENT**

**INVESTIGATION REPORT 01/02/2021**

**REPORT ON THE ACCIDENT TO AGUSTA WESTLAND  
AW119 MK II REGISTRATION 5Y-NPW OPERATED BY  
THE NATIONAL POLICE SERVICE AIR WING  
AT MERU, KENYA ON 13 JUNE 2020**

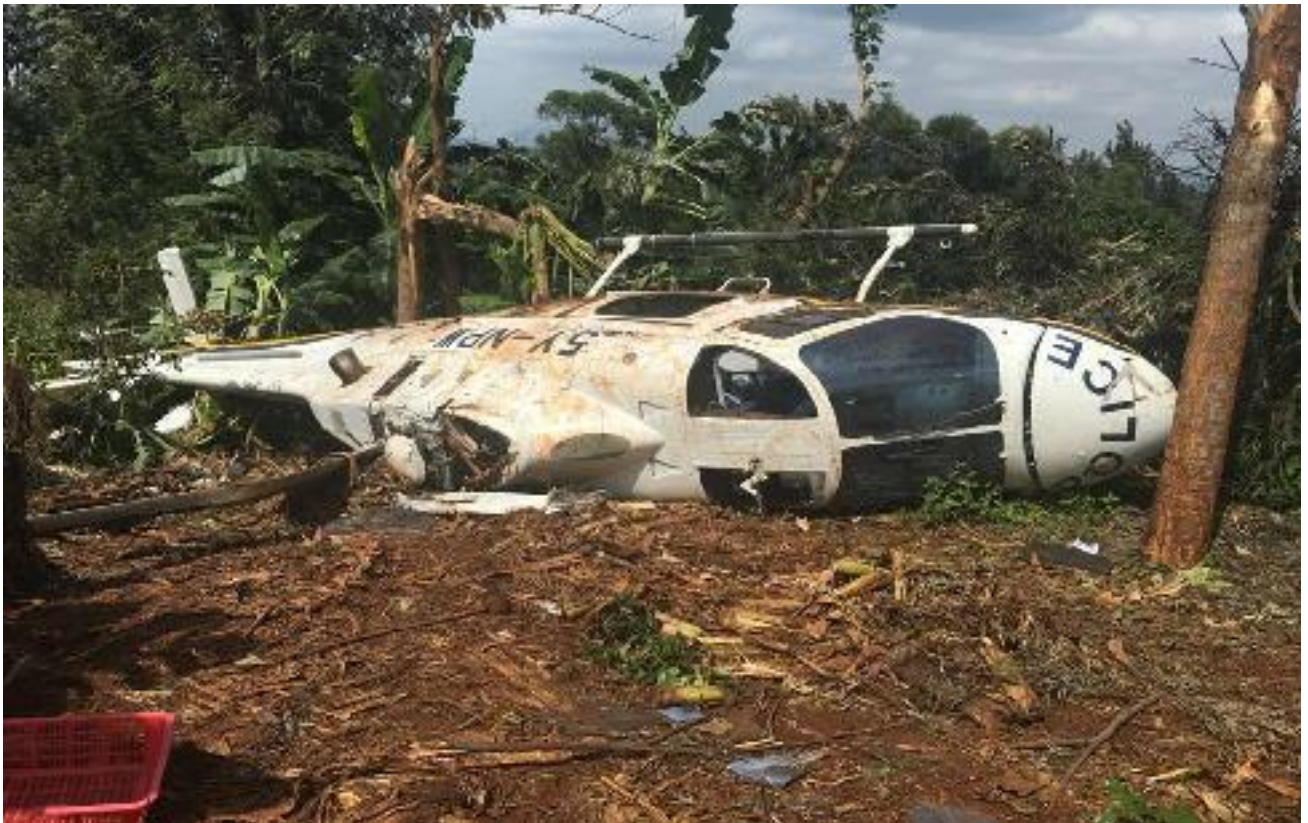
The four glass-fibre composite blades, severed from the main hub at the root. Pitch links and the damper still connected from the main hub. The port side of the helicopter did not exhibit deformation.

Figure 1: Wreckage of the damaged aircraft

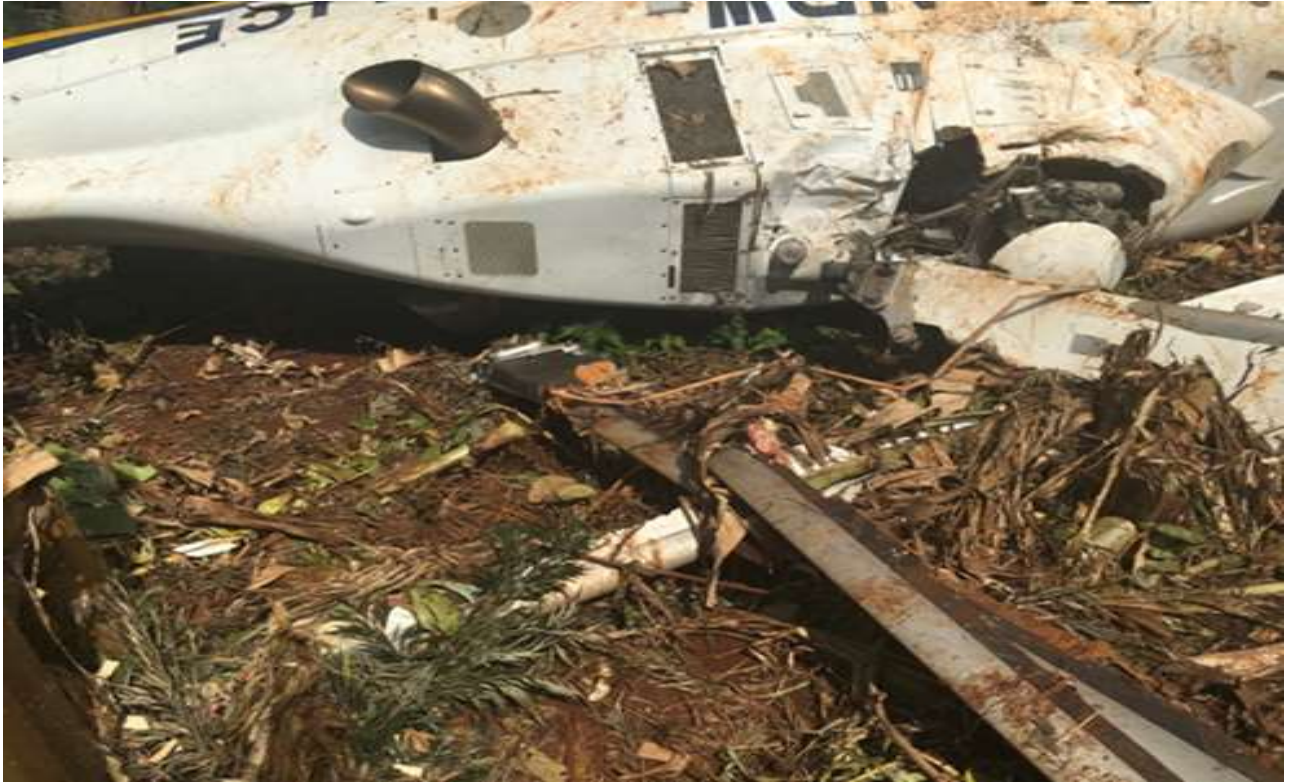
**Figure 2: Main rotor blades distorted from the main rotor hub**

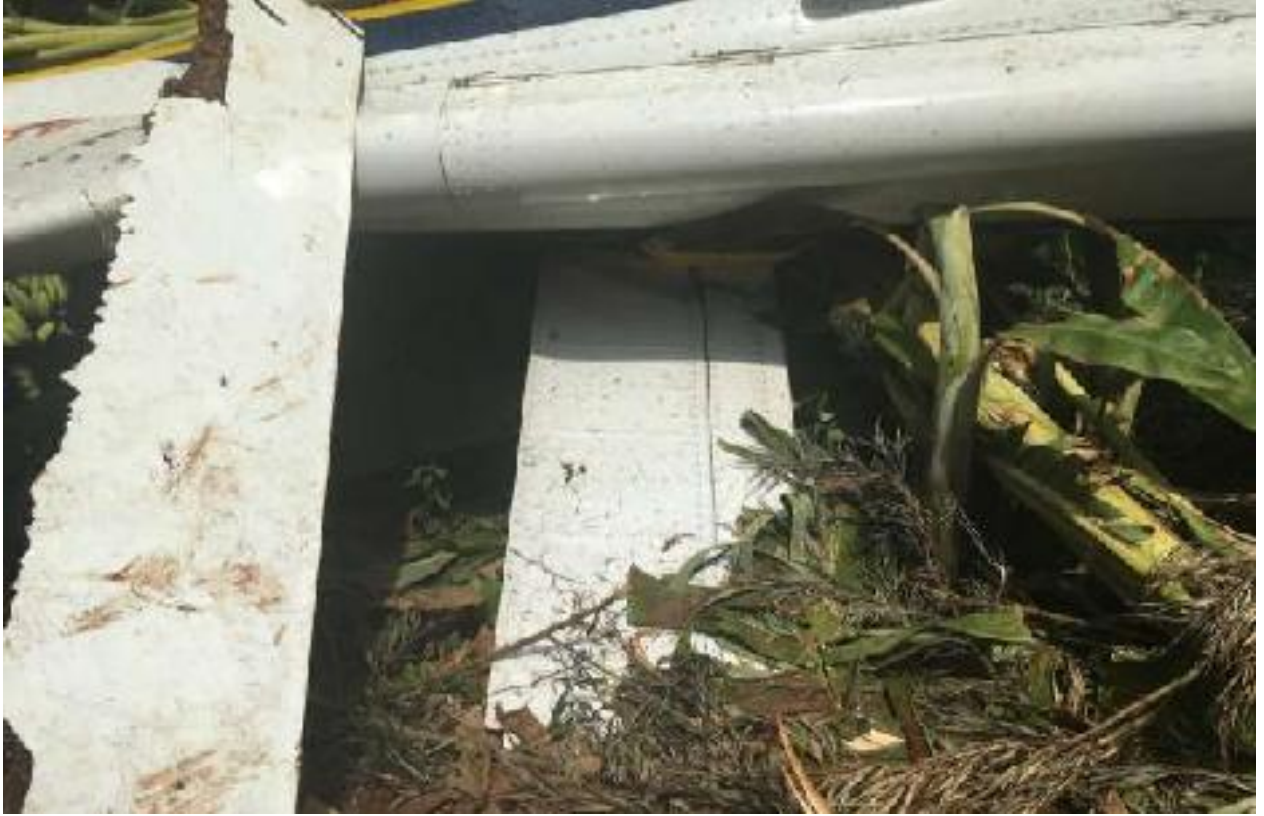
**Figure 3: Damaged trailing edge of one of the main rotor blades**

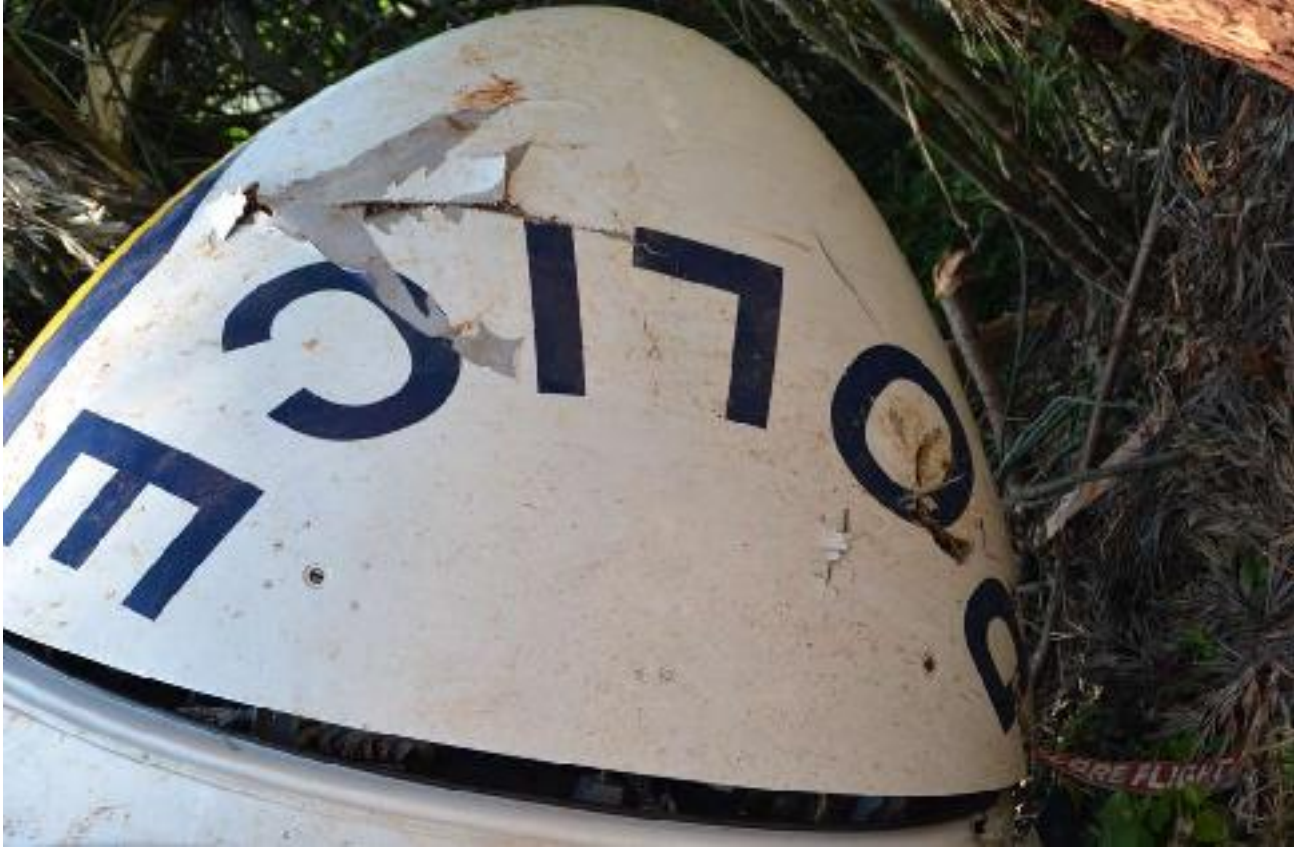
**Figure 4 : The damaged section of the fuselage**

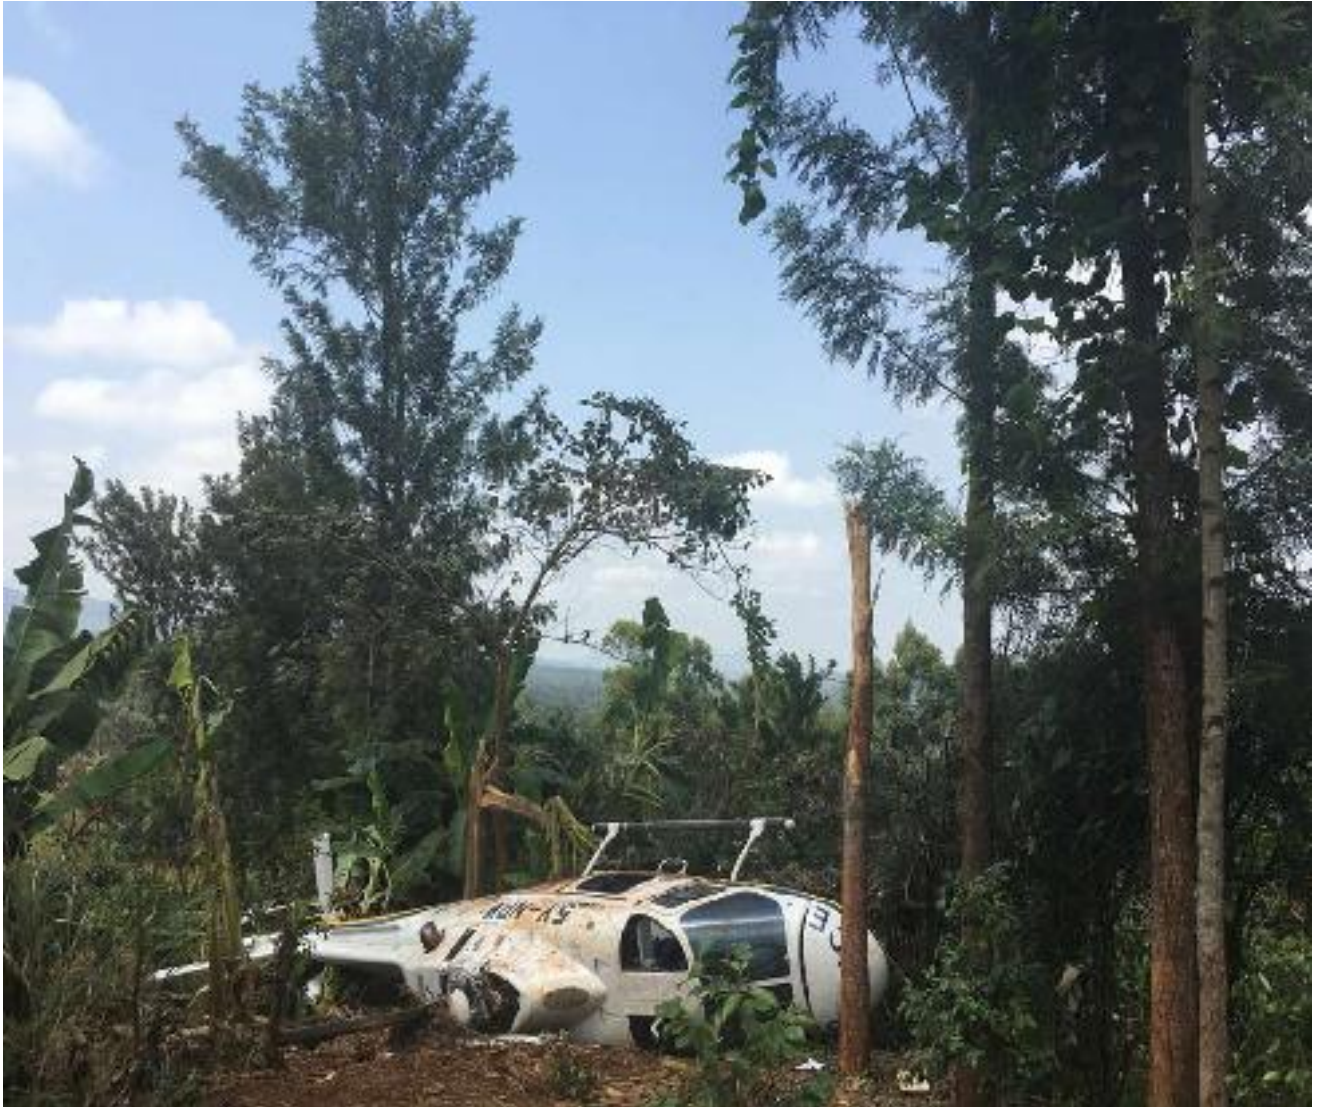
Trees around the accident site and in the path of the flight were cut from the top by the main rotor blades of the helicopter. Both the surrounding trees and part of the ground suffered lesions after contacting the main rotor blades.

**Figure 5 : The wreckage at the accident site.**

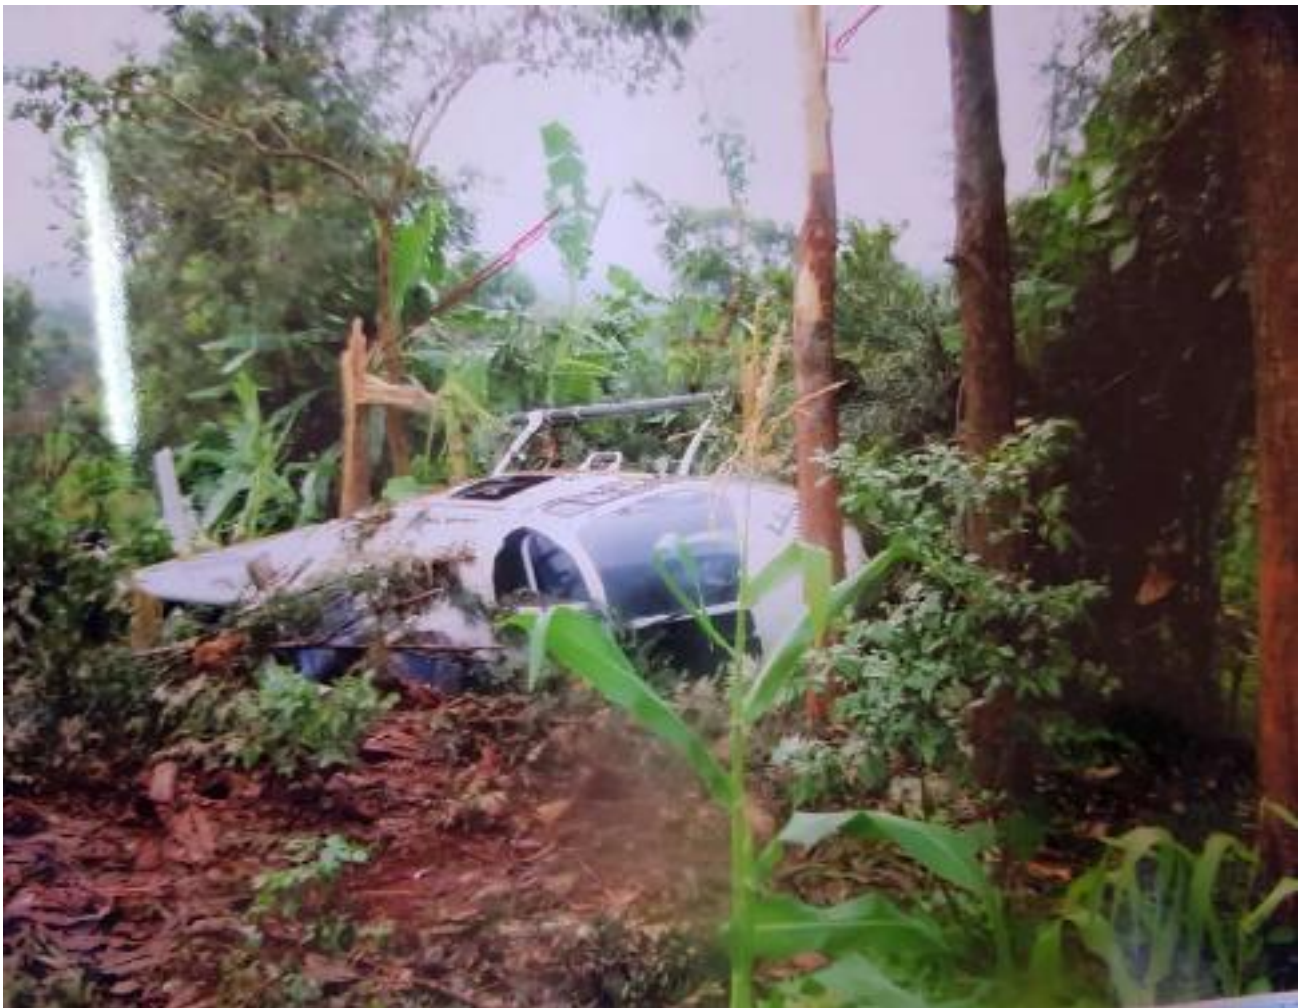
Figure 10 : A picture taken by one of the witnesses moments after the accident depicting fog in Kaithe

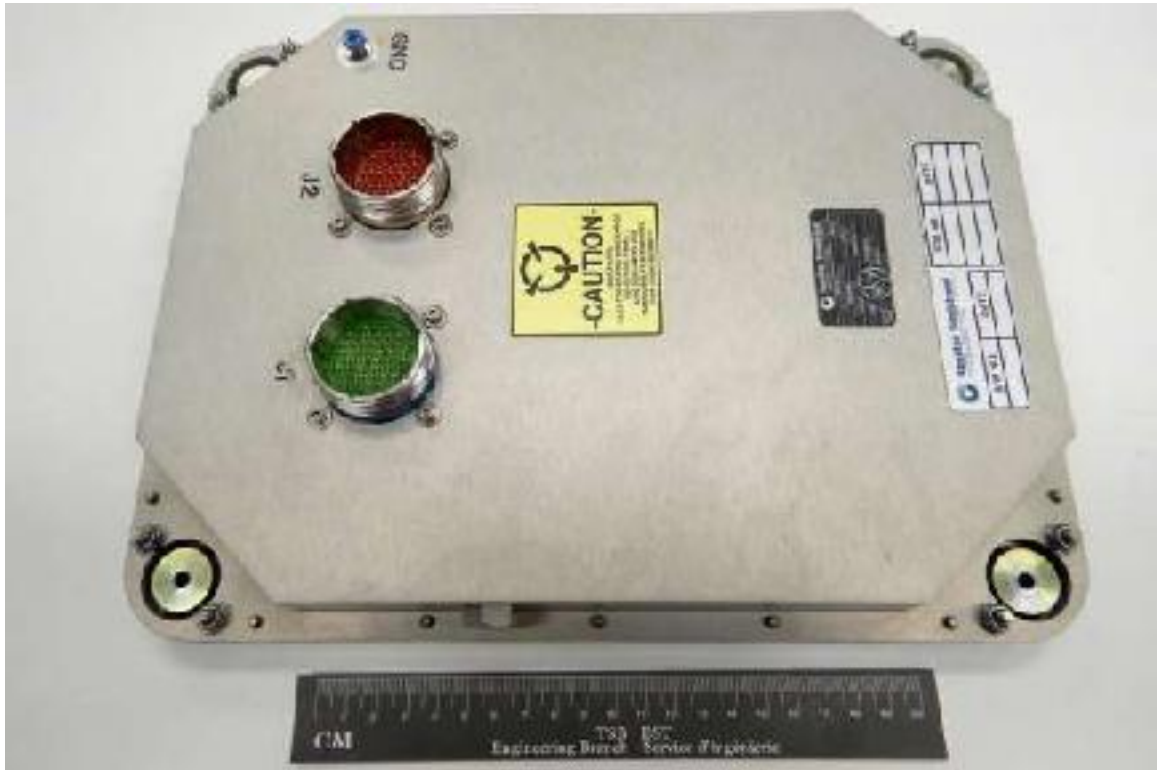
The EEC received (Figure 1) appeared undamaged other than some superficial scratches to the case. The case was opened and the circuitry was microscopically examined (Figure 2) prior to any recovery attempts to ensure it would not be damaged when power was applied to the unit; no damage was noted to the circuit board, connections, or any of the components.

Figure 1: EEC as received.

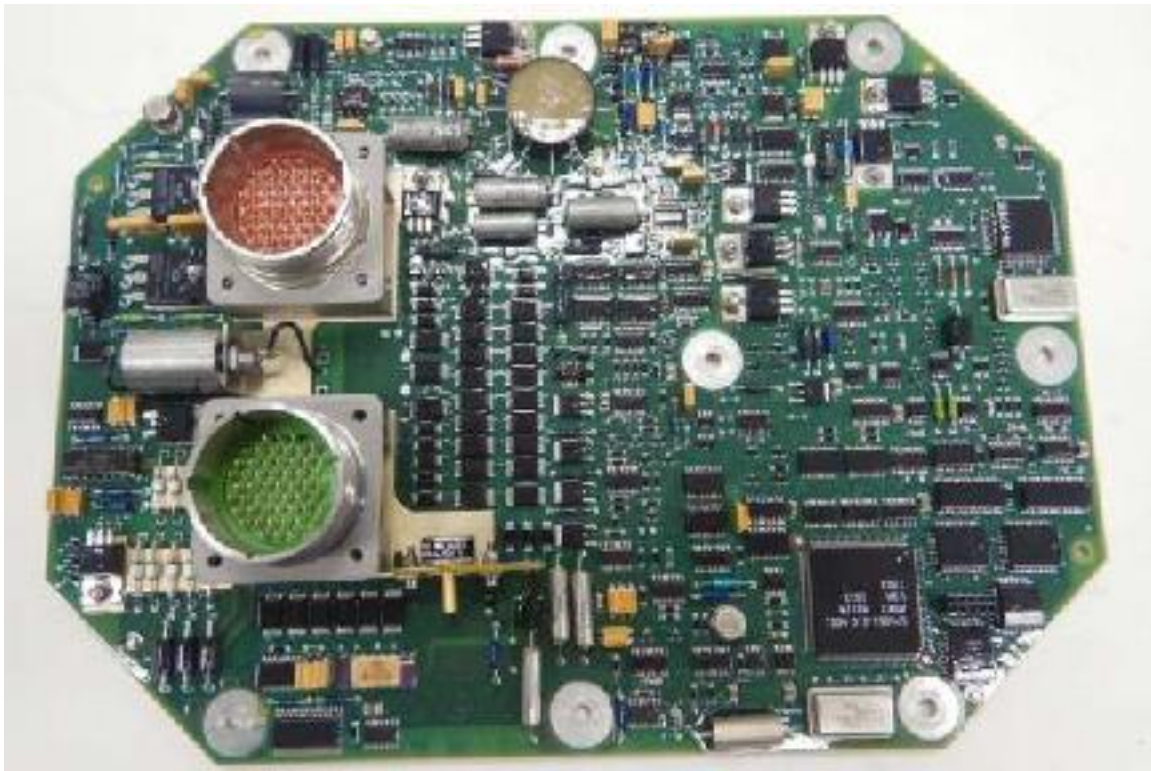
Figure 2: EEC circuit board.

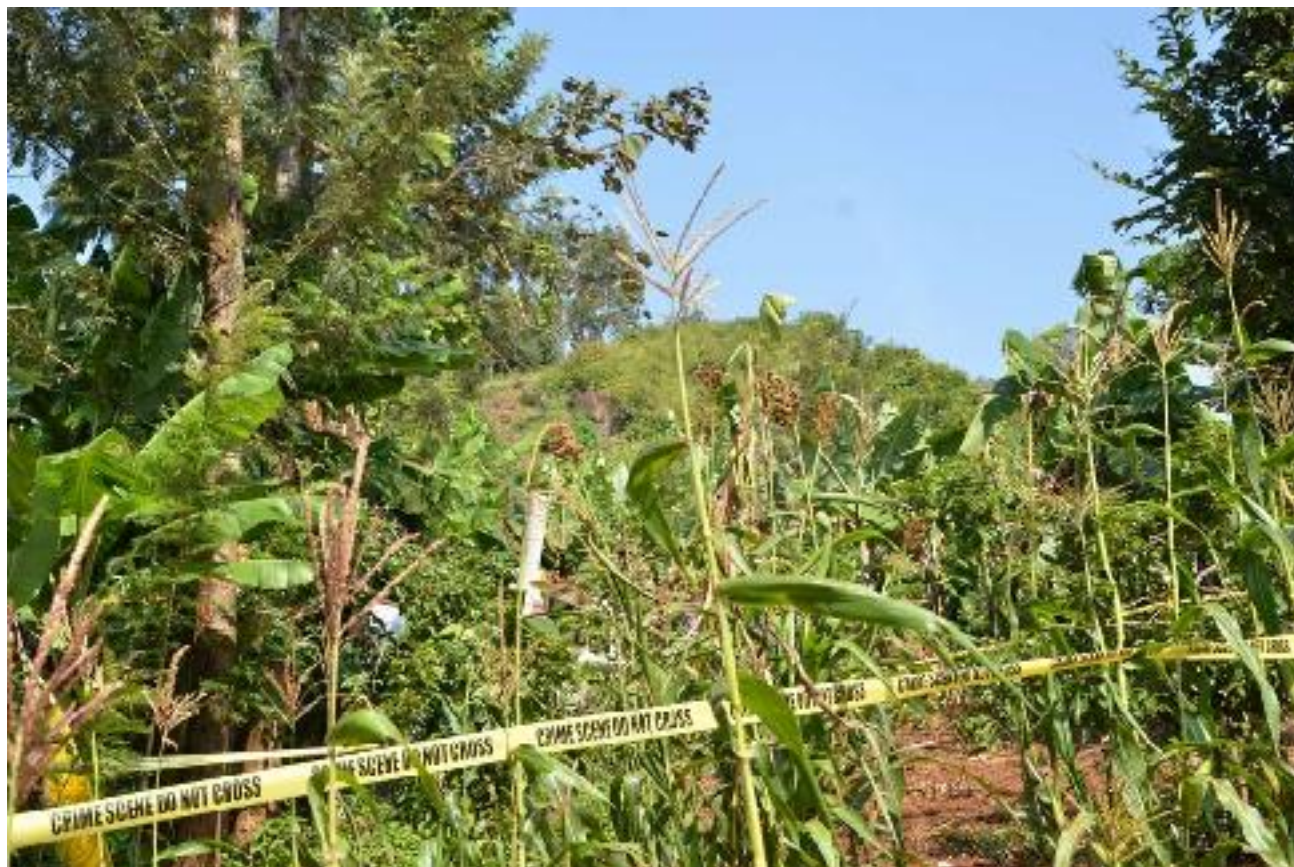
Figure 11: The helicopter collided with terrain at Kaithe location 5nm South East of Meru town close to Cyompiou hill

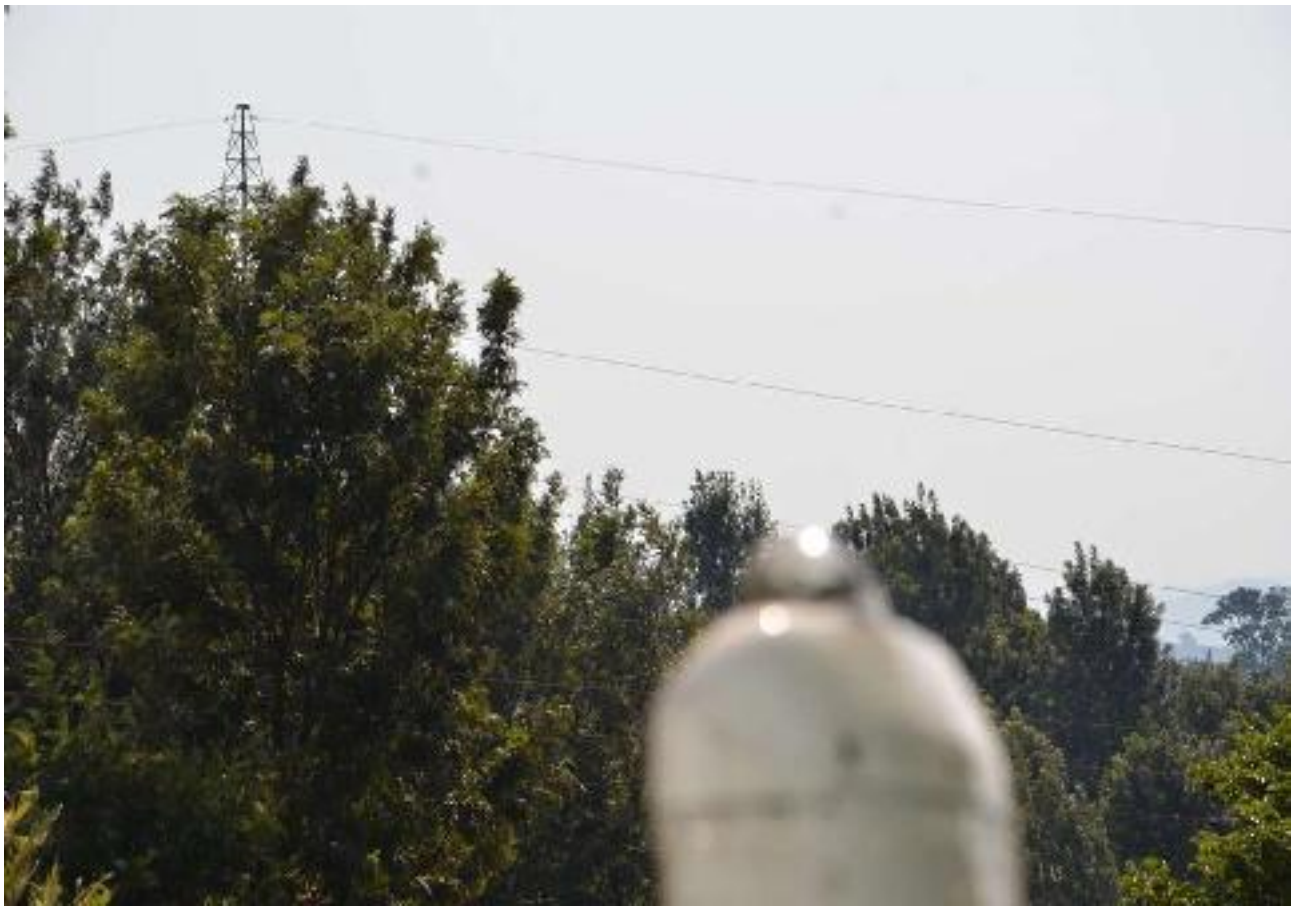
hand turn to avoid an aerial mast before the blade clipped a tree, then nosedived. It then collided with another tree and tumbled to the ground.

**Figure 12: The aircraft evaded the mast shown in the picture**

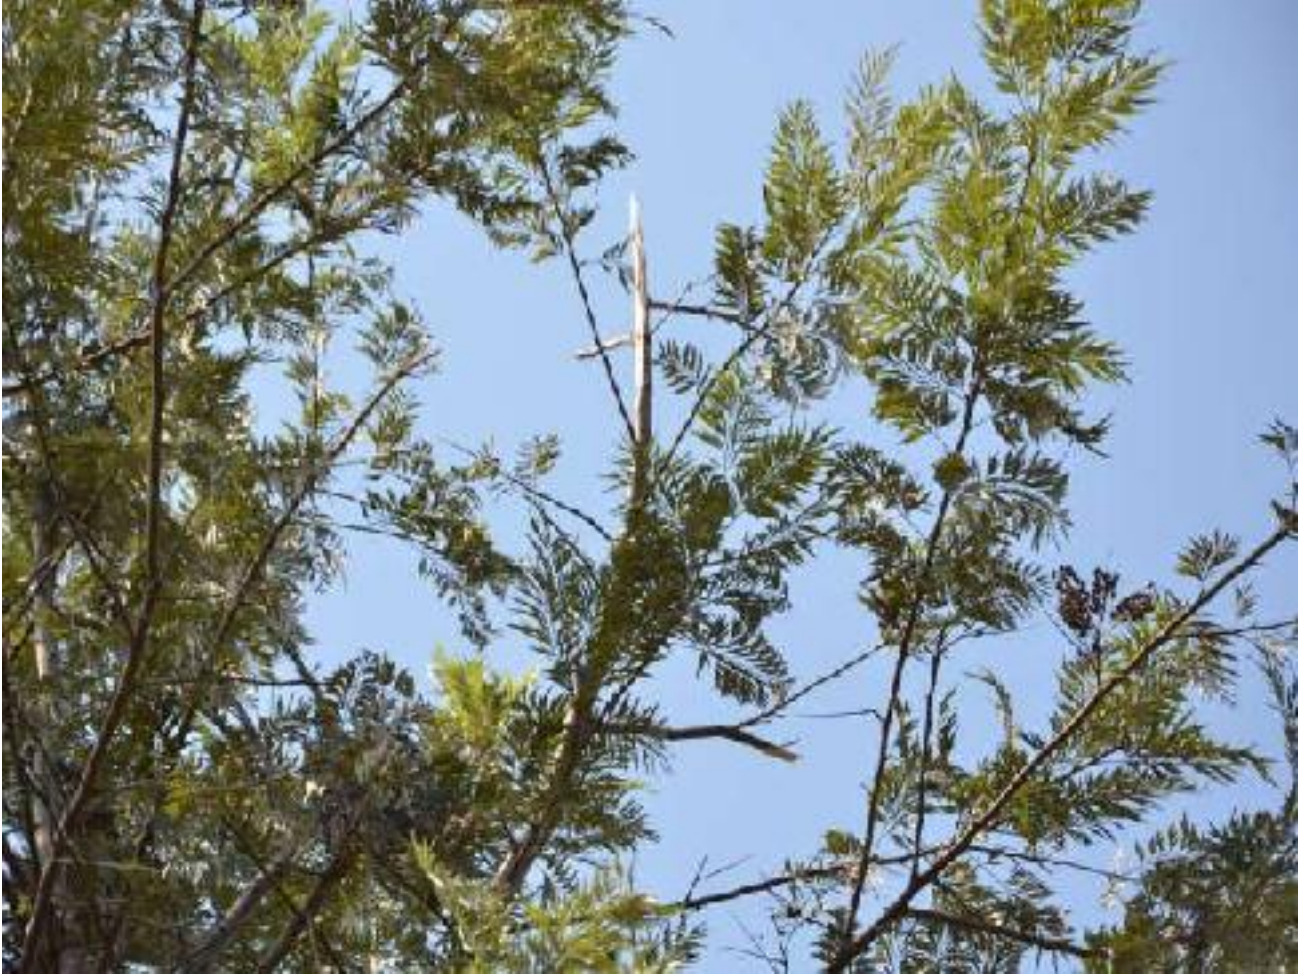
**Figure 13: The tree branch that first came in contact with the main helicopter rotors**

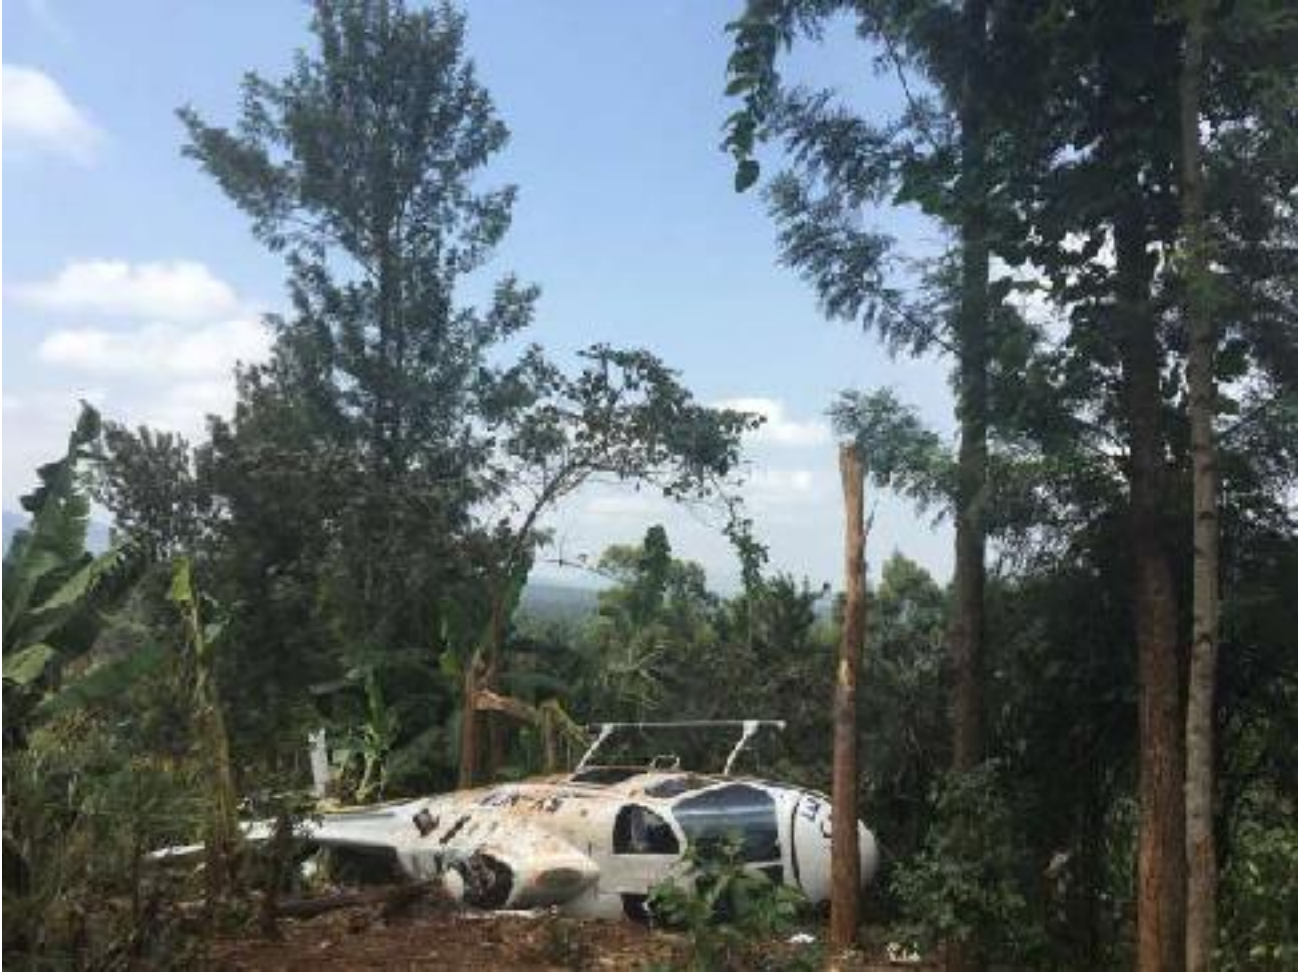
**Figure 14: The wreckage and the trees that were involved in the occurrence**

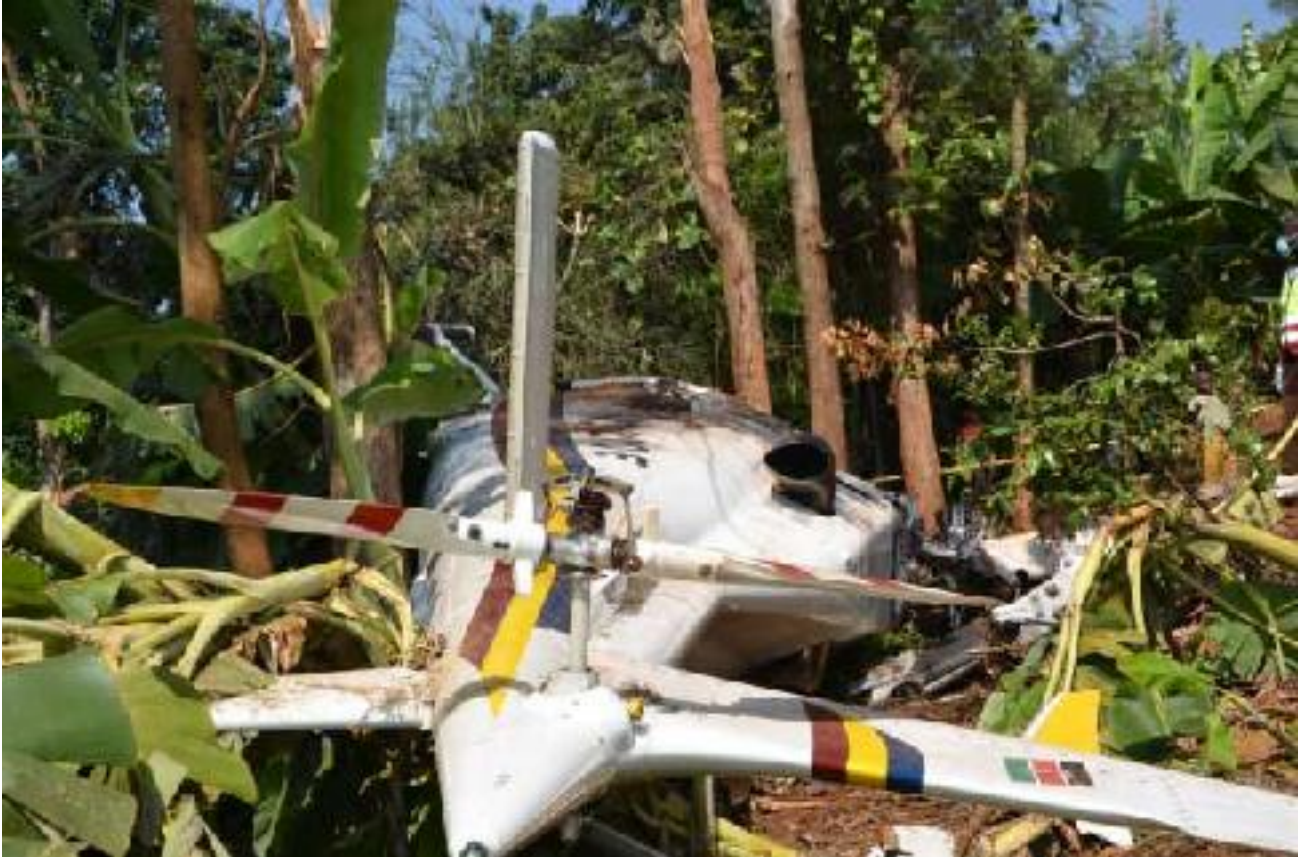
**Figure 16: The helicopter tail rotor still intact**

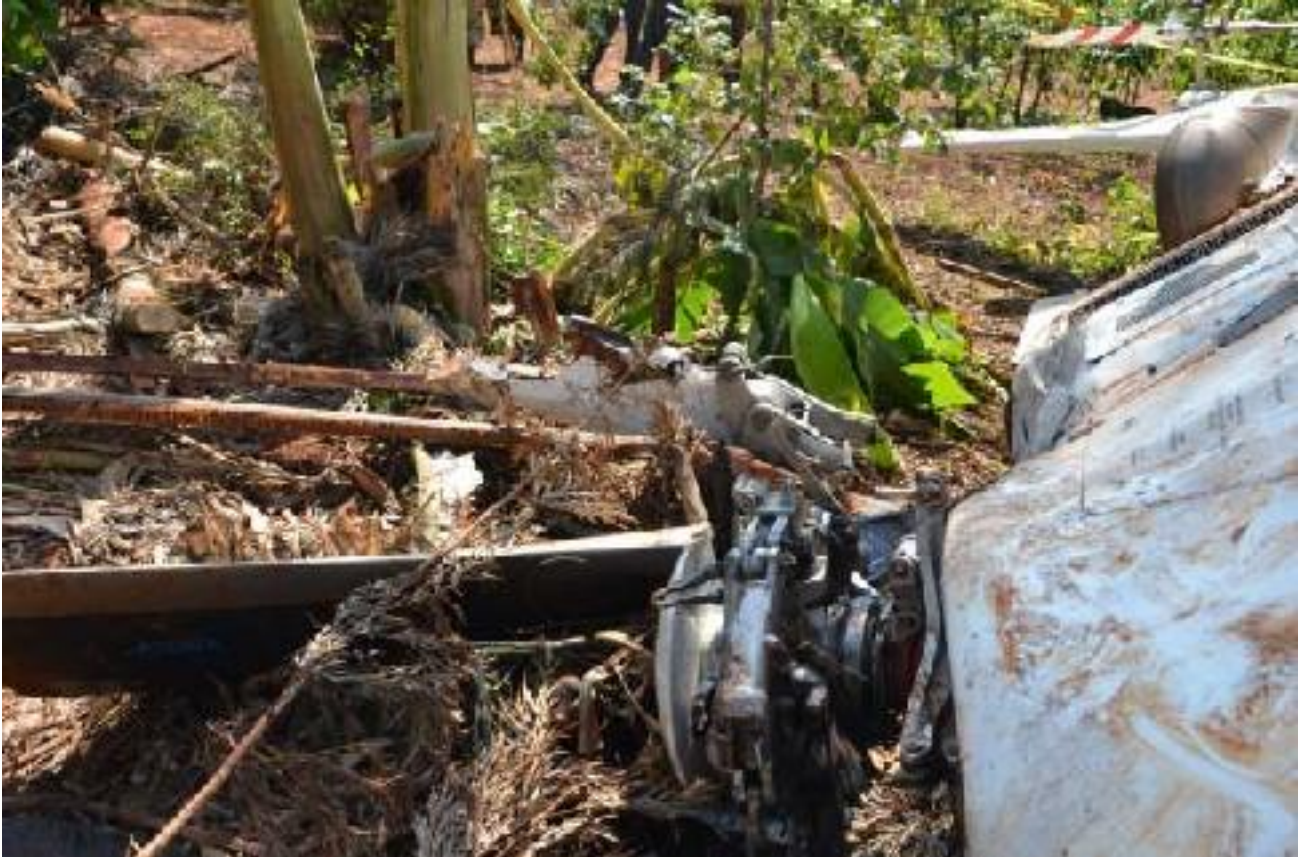
The exam of the damage sustained by the main rotor blades showed that, at the moment of the collision with the ground, the 5Y-NPW rotors were turning at high speed; just on account of aerodynamic and inertial forces indicated by the shearing off of the blades but still attached to respective pitch control levers. All the four composite main rotor blades had fractured from the root. The severed blades were consistent with blade failure on impact with the ground.

**Figure 17: The sheared off main rotors**

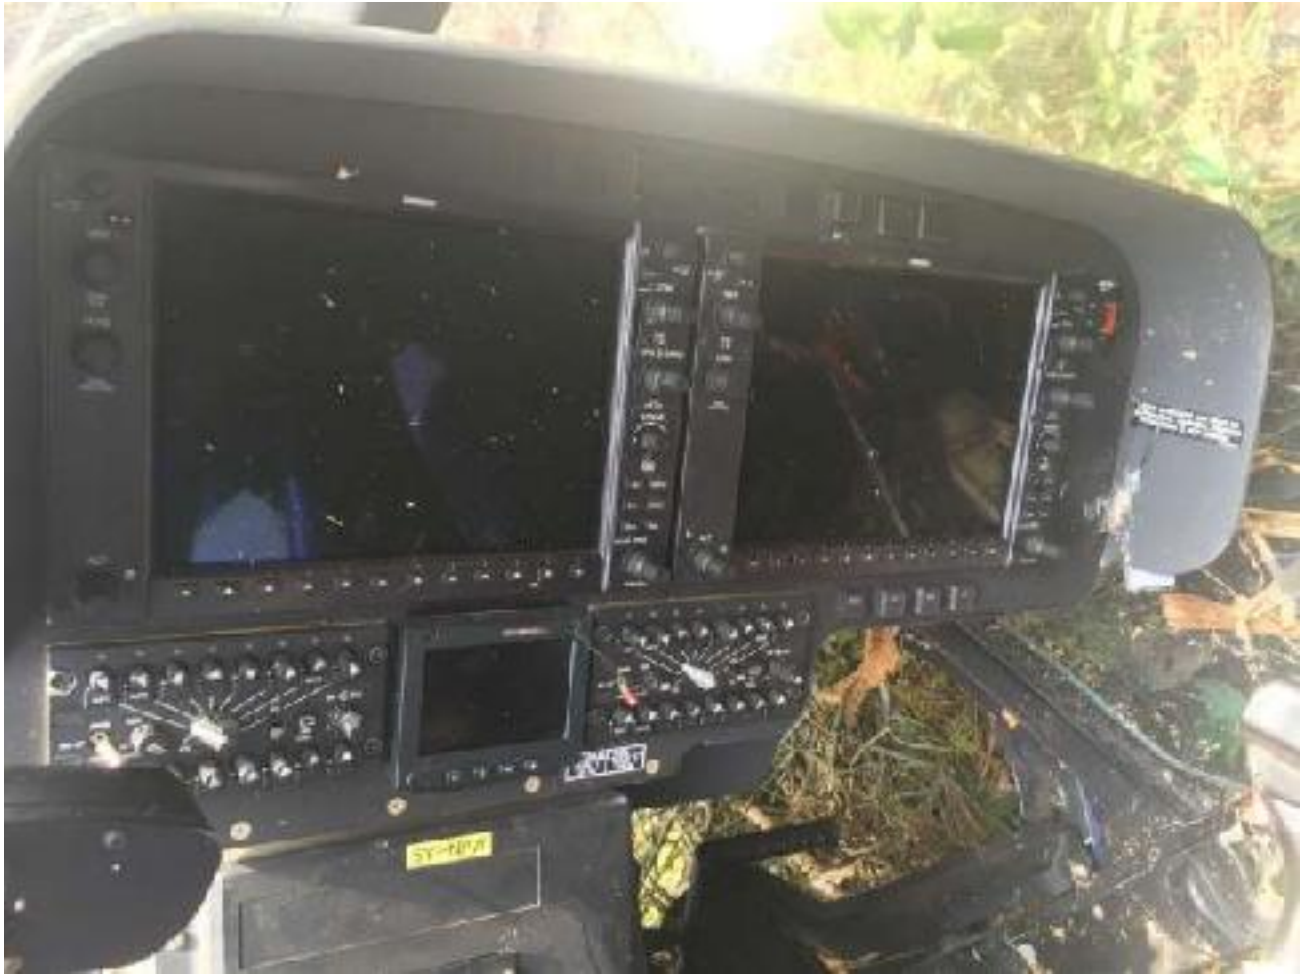
The swash plate assembly remained installed on the main rotor shaft centering plate. The cabin was intact. The cyclic, collective, throttle, and the pedals appeared normal with no visible deformations. The cockpit and the instrument panel were generally intact. Both the Electronic Display Units (EDUs) 1 and 2 (primary and secondary) were still in place. Pitch link fractures exhibited signatures consistent with overload.

Figure 18: The aircraft cabin, with EDU 1 and 2

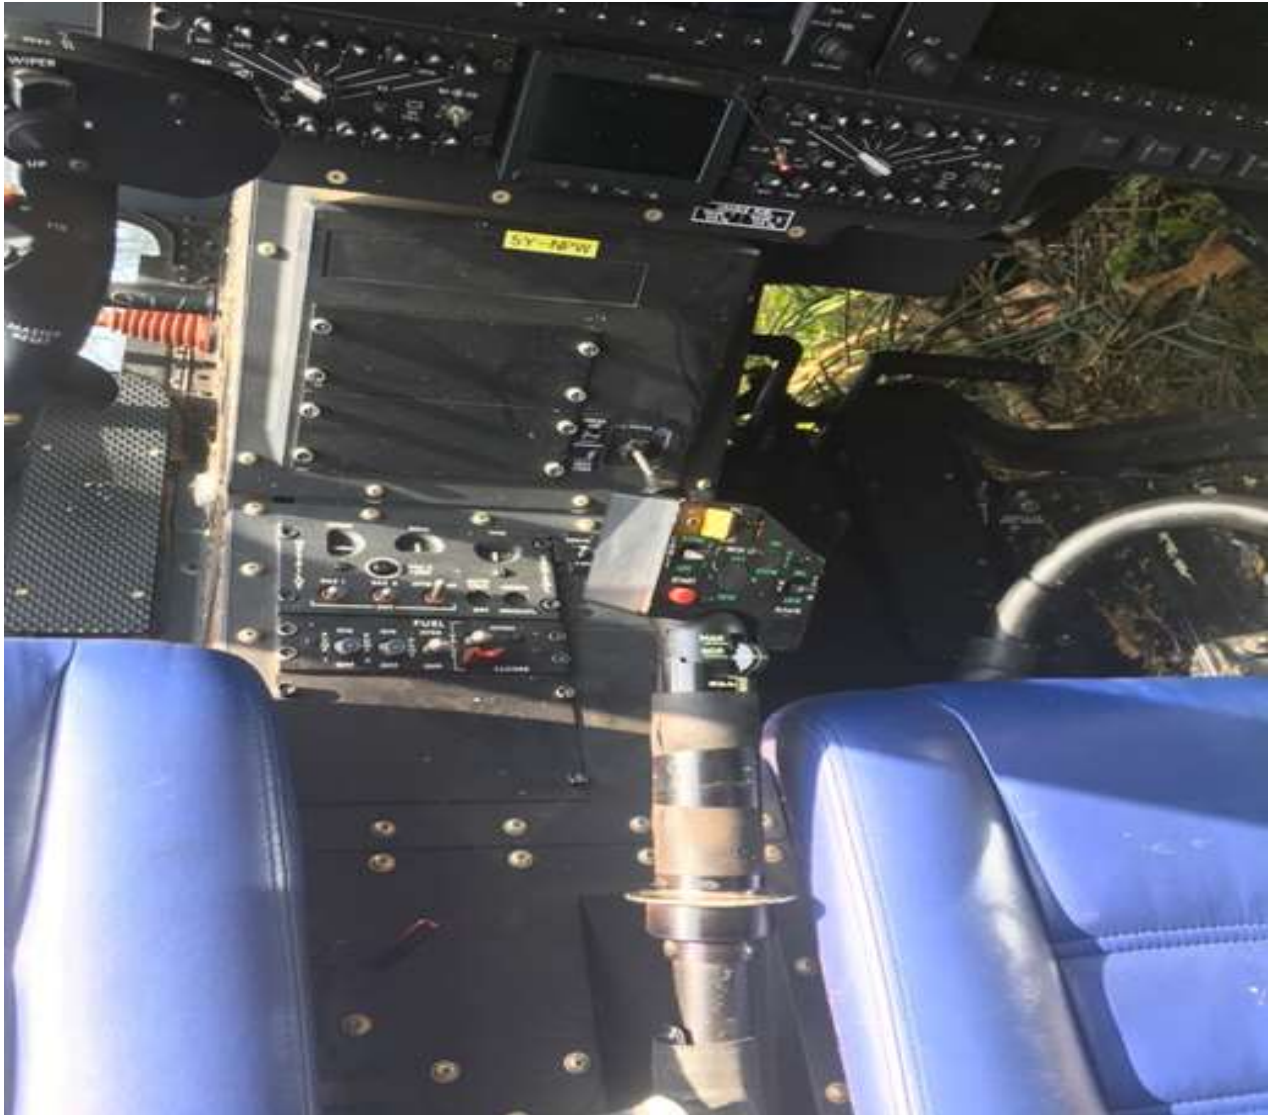
Figure 19: Throttle and collective control

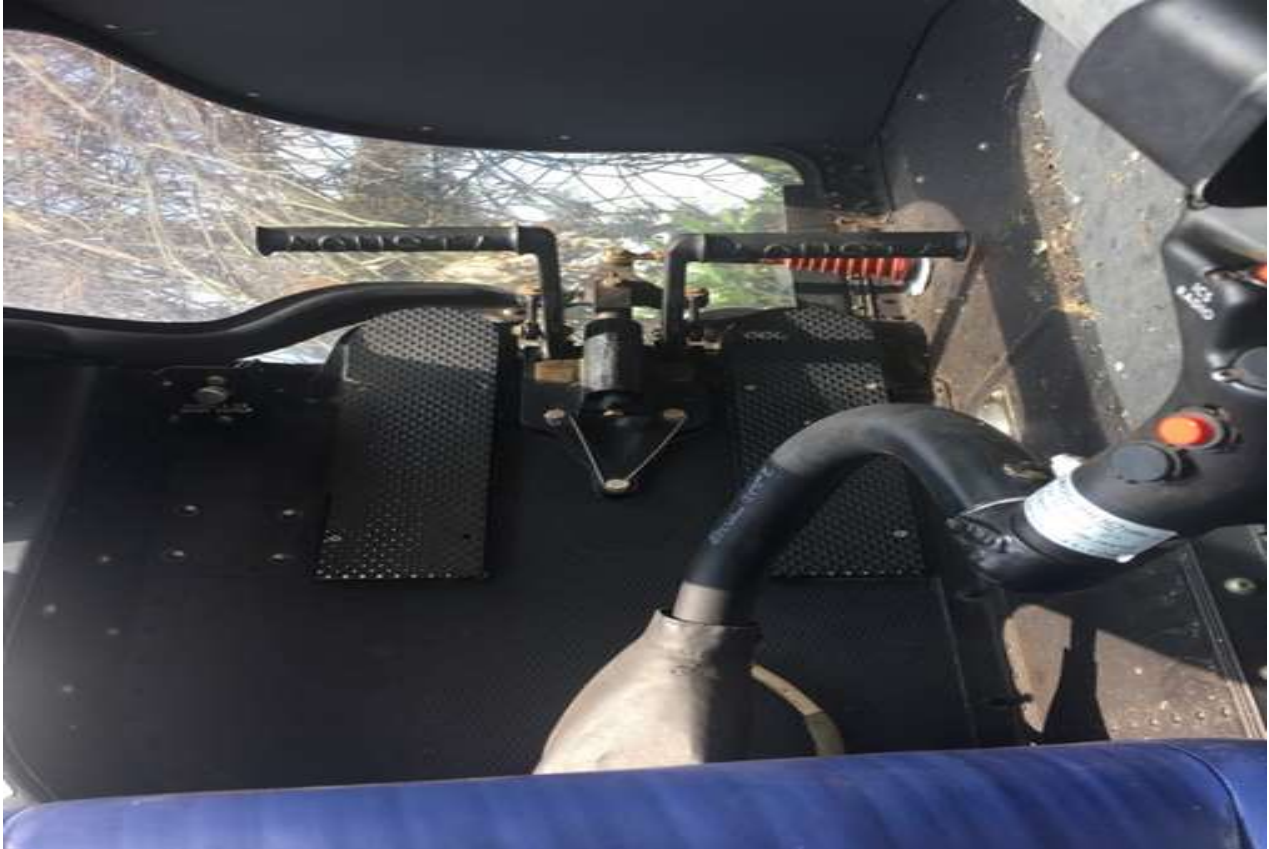
**Figure 20: The cyclic control and pedals**

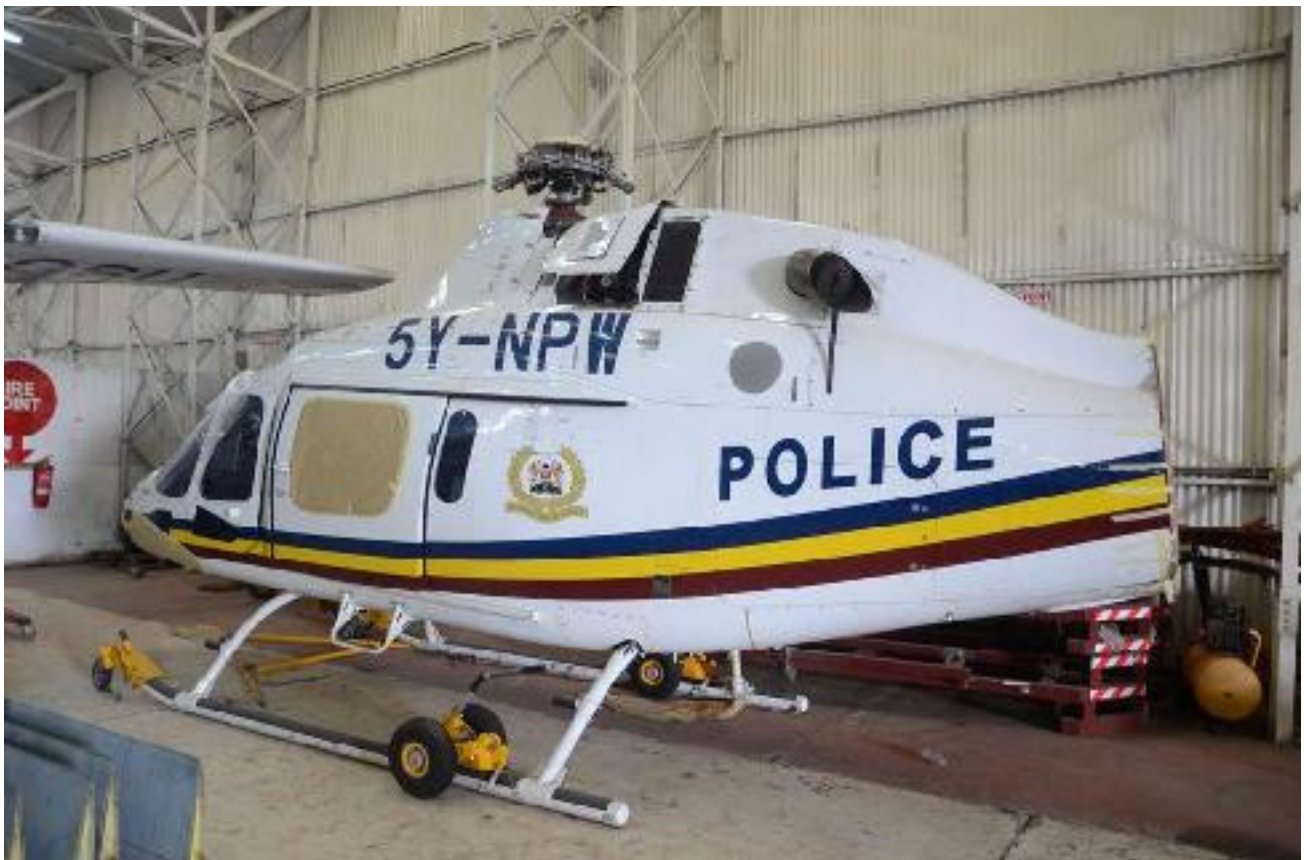
The helicopter was salvaged, transported to Wilson airport, Nairobi and further examined. The sponson was removed prior to shipment to Nairobi. The fuselage skin belly skin panels generally did not exhibit deformations. The antennae remained attached to the tail boom.

Figure 21: 5Y-NPS at Wilson airport NPSAW hangar after recovery

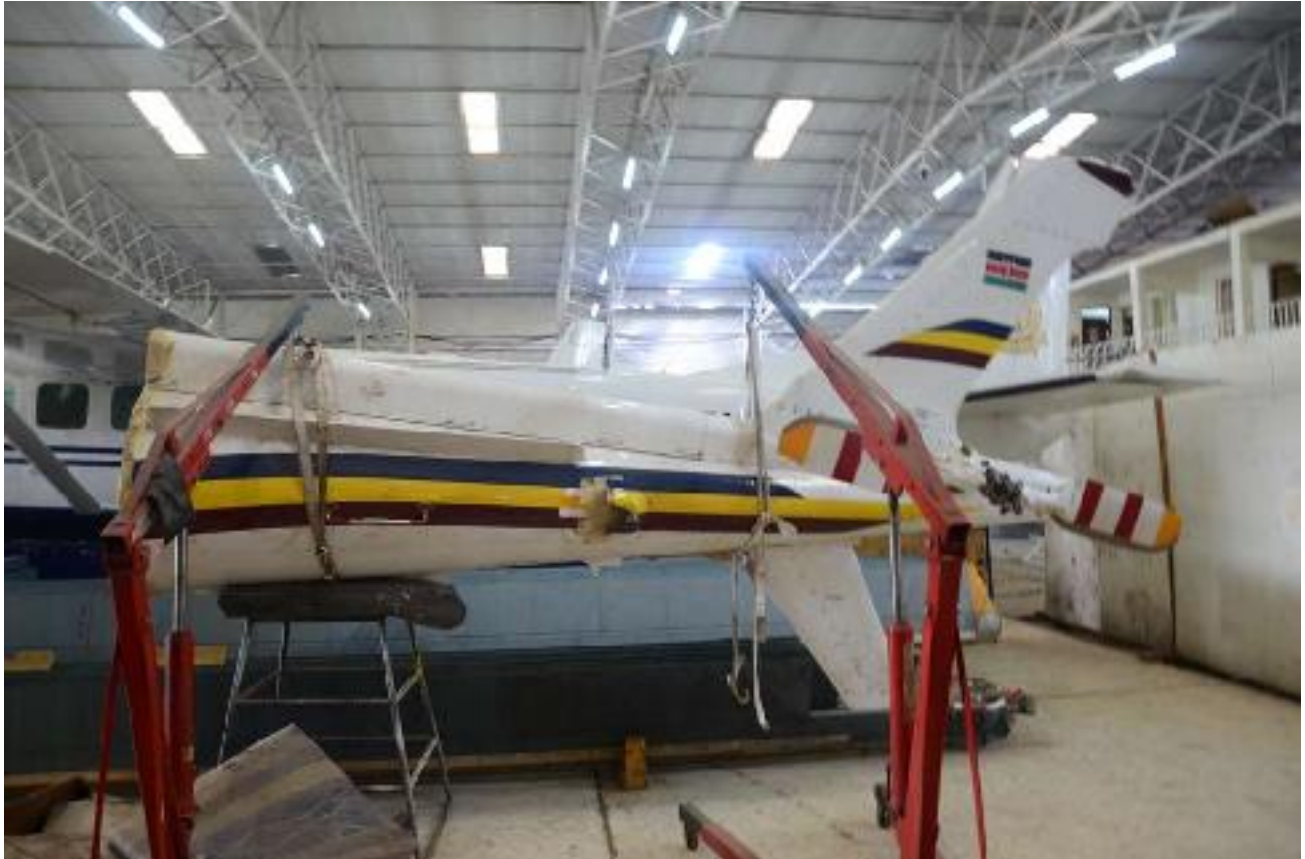
Figure 22: 5Y-NPW tail boom at NPSAW hangar at Wilson airport after recovery
