DEPARTMENT OF AIR ACCIDENT INVESTIGATION

# CIVIL AIRCRAFT ACCIDENT REPORT

CAV/ACC/LMB/09

AIRCRAFT: CESSNA U206G

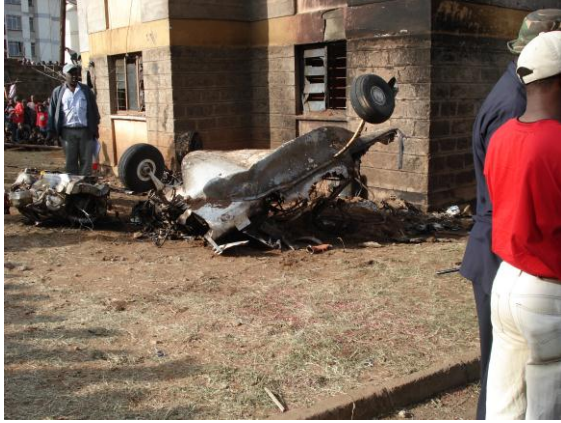
The aircraft was destroyed by both the impact and the post crash fire. The propellers dislodged from the engine that lay inverted separately from the fuselage.

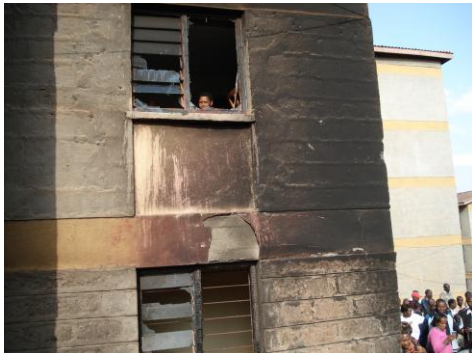
The intense heat from the ensuing inferno caused the window panes on the crash building to shatter and section of the building wall was smouldered.

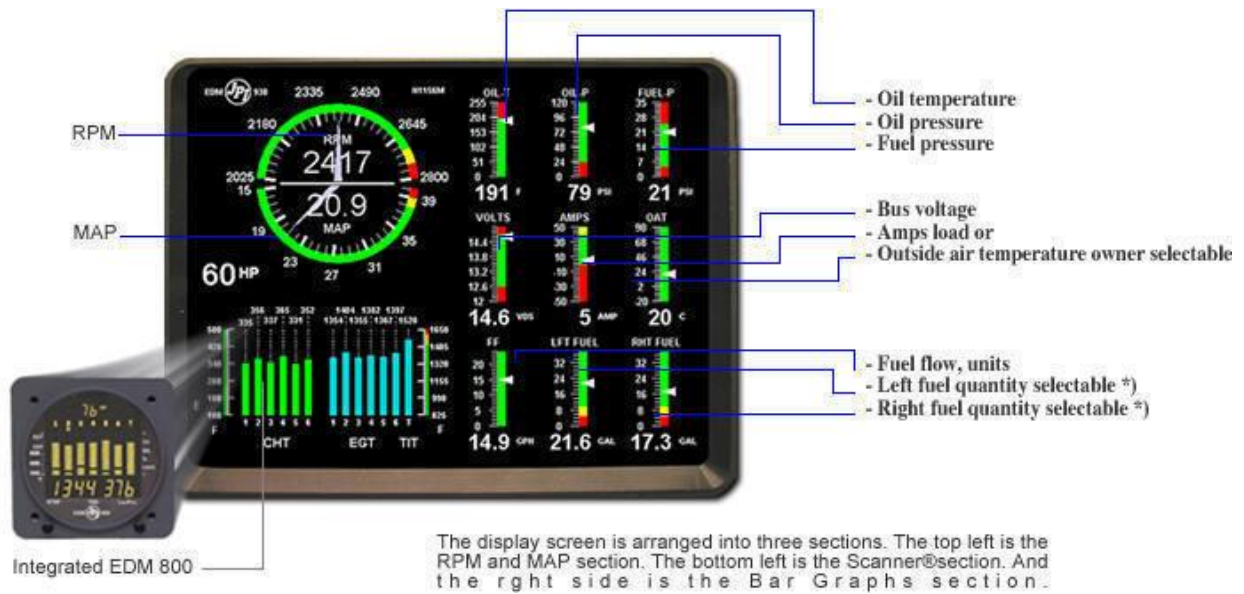
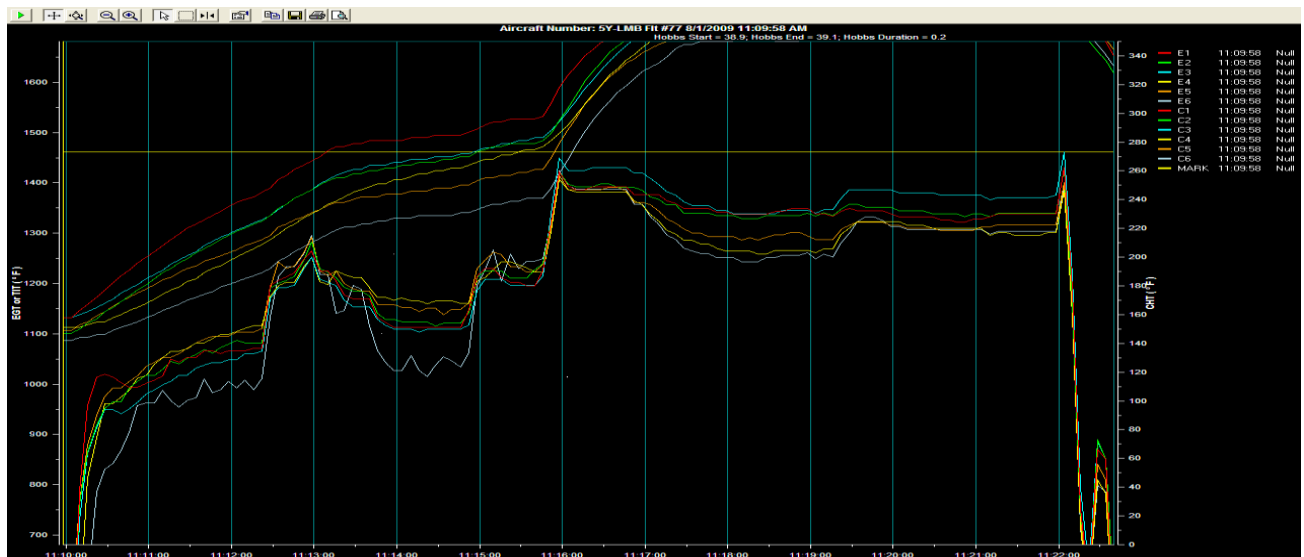
One of the parameters indicated and recorded by the EDM is the fuel flow and fuel level in each tank in relation to the bank angle of the air craft.

When the air craft banks to the left side, the fuel flow to the engine from the left fuel tank increases, and vice versa.

The data collected from the JPI Engine Data Monitor EDM 930 indicated fuel starvation to the engine resulting to loss of engine power and subsequent engine cessation.
