AIR ACCIDENT INVESTIGATION DEPARTMENT

PRELIMINARY REPORT

OPERATOR:	Heliprops Ltd
AIRCRAFT TYPE:	Cessna 210 L
MANUFACTURER:	Cessna Aircraft Company
YEAR OF MANUFACTURE:	1976
AIRCRAFT REGISTRATION:	5Y-BHT
AIRCRAFT SERIAL NUMBER:	21061146
DATE OF REGISTRATION:	26 th July 1991
TYPE OF ENGINE:	T.C.M 10-550-F (10B)
DATE OF ACCIDENT:	19 April 2013
TIME OF ACCIDENT:	0939
LOCATION OF ACCIDENT:	Wilson Airport (1°19'32" S 36°47' 46" E)
TYPE OF FLIGHT:	Commercial (Passenger)
PERSONS ON BOARD:	Crew - 1 Passenger -2
INJURIES:	None
NATURE OF DAMAGE:	Minor
PILOT FLYING EXPERIENCE:	13370hrs

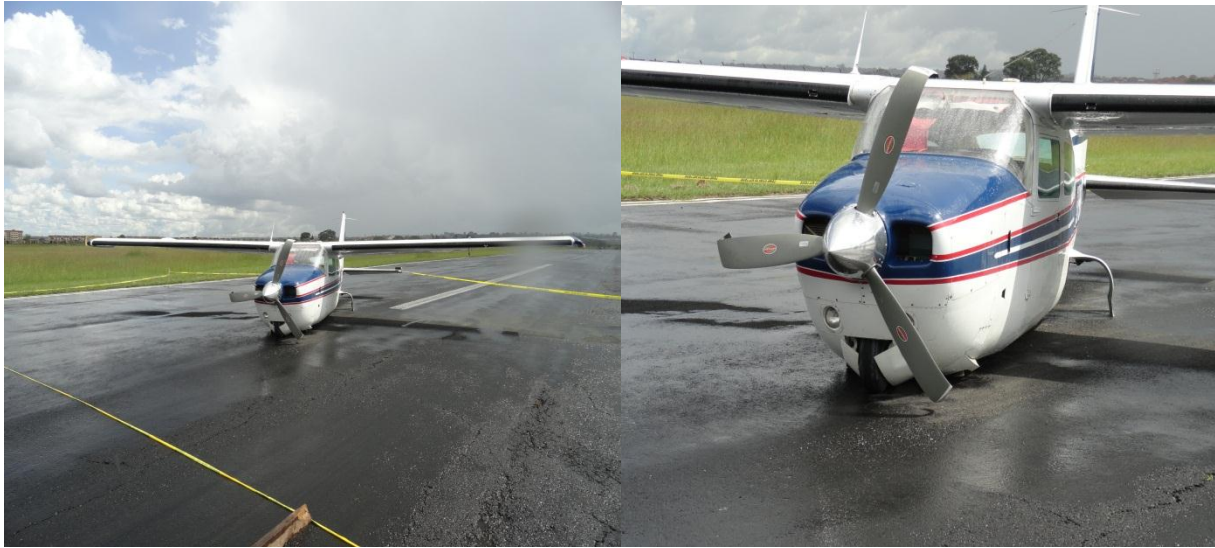
The aircraft contacted the ground with rear gear doors first after which the propellers struck the ground. The aircraft came to a stop at the centre of the runway, 275 meters from the initial point of contact with the ground. The occupants evacuated the aircraft with no injuries reported. The aircraft suffered minor damages. Investigators found the landing gear well tucked in their respective wheel wells.
