**MINISTRY OF TRANSPORT AND INFRASTRUCTURE**  
**STATE DEPARTMENT OF TRANSPORT**  
**AIR ACCIDENT INVESTIGATION**  
**PRELIMINARY REPORT**

OPERATOR:	West Rift Ltd
AIRCRAFT TYPE/MANUFACTURER:	Cessna 150
YEAR OF MANUFACTURE:	1973
AIRCRAFT REGISTRATION:	5Y-BRO
AIRCRAFT SERIAL NUMBER:	150-75167
DATE OF REGISTRATION:	21/01/2015
TYPE OF ENGINE:	Lycoming 0-320-E2D
DATE OF OCCURRENCE:	15/06/2015
TIME OF OCCURRENCE:	1306
LOCATION OF OCCURRENCE:	Wilson Airport
TYPE OF FLIGHT:	Training
NUMBER OF PERSONS ON BOARD:	Crew -2
INJURIES:	Nil
NATURE OF DAMAGE:	Substantial
CATEGORY OF OCCURRENCE:	Serious incident
PIC'S FLYING EXPERIENCE:	2213 hours

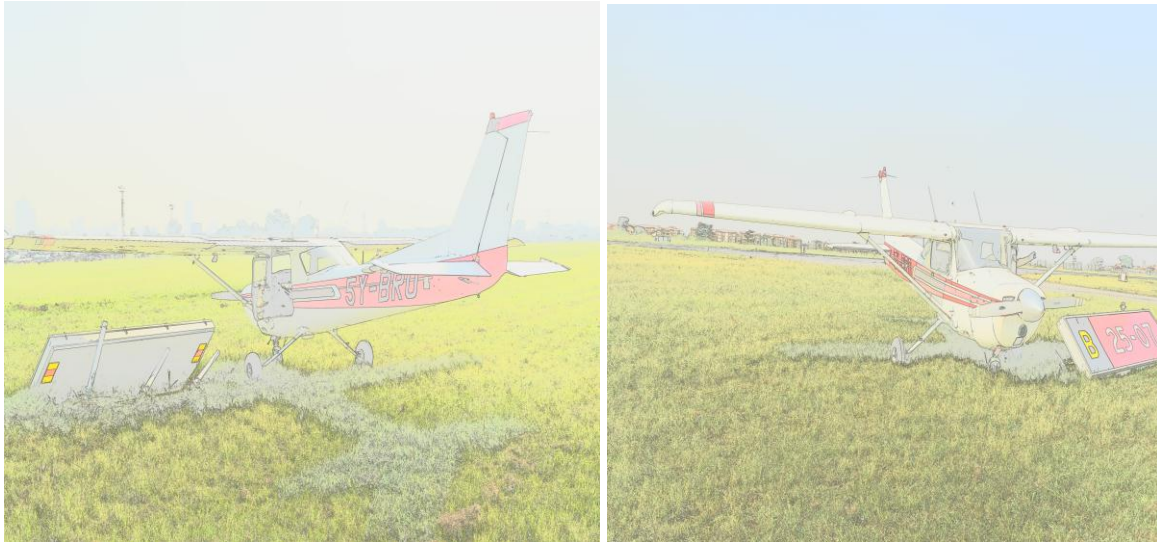
On 15th June 2015 at 1306 a Cessna 150 aircraft registration 5Y-BRO on flight training had a runway excursion while landing on runway 07 Wilson airport. The flight instructor with a student pilot took off at 12:45 runway 14 for flight training circuits at the aerodrome. At 1320 the instructor requested air traffic control unit for landing which was approved. On landing runway 07 the aircraft lost control while trying to exit the runway via taxiway B. The aircraft veered off the runway and collided with the taxiway signage before it stopped. There were no reported injury on the occupants but the aircraft sustained substantial damage.

Post-flight inspection of the accident aircraft revealed that the port wing contacted the ground and got dented at the wing tip. The propeller blades bent aft after contacting the taxiway signage. The port fuel tank also broke on the upper side. The nose wheel steering arm collapsed.
