MINISTRY OF TRANSPORT AND INFRASTRUCTURE
STATE DEPARTMENT OF TRANSPORT
AIR ACCIDENT INVESTIGATION
PRELIMINARY REPORT

1
2
3
4
5
6
7
8
9
10
11
12
13 OPERATOR: Pegusus Flayers (E.A) Ltd
14
15 AIRCRAFT TYPE/MANUFACTURER: Cessna 172, Cessna Aircraft Company
16
17 YEAR OF MANUFACTURE: 09/11/1979
18
19 AIRCRAFT REGISTRATION: 5Y-BUU
20
21 AIRCRAFT SERIAL NUMBER: 17271396
22
23 DATE OF REGISTRATION: 18/01/2007
24
25 TYPE OF ENGINE: AVCO LYCOMING 0-320-H2AD
26
27 DATE OF OCCURRENCE: 01/06/2015
28
29 TIME OF OCCURRENCE: 1415
30
31 LOCATION OF OCCURRENCE: Wilson Airport Runway 14
32
33 TYPE OF FLIGHT: General aviation
34
35 NUMBER OF PERSONS ON BOARD: Crew -1
36
37 INJURIES: Nil
38
39 NATURE OF DAMAGE: Substantial
40
41 CATEGORY OF OCCURRENCE: Serious incident
42
43 PIC'S FLYING EXPERIENCE: 56.55 hours
44
45

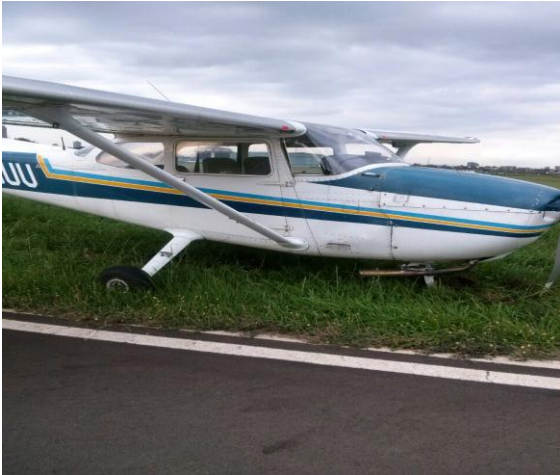
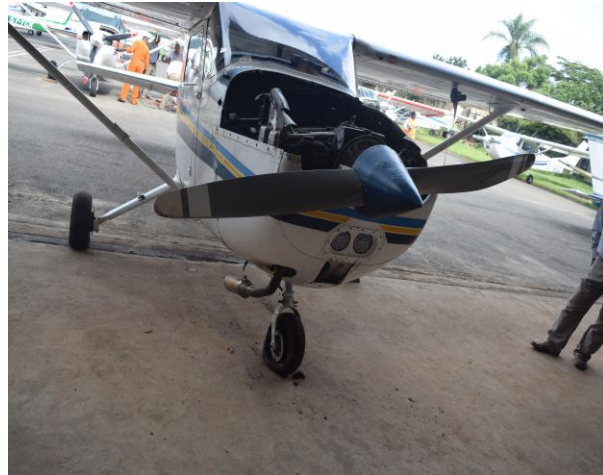
65 Post-flight inspection of the accident aircraft revealed that one propeller blade tip was twisted
66 at the aft section; port wing section suffered dents at the wing-tip, the nose-wheel tyre
67 flattened, firewall buckled and the lower empennage rudder broken.
