**AIR ACCIDENT INVESTIGATION DEPARTMENT**

**PRELIMINARY REPORT**

OPERATOR:	Global Airlift Ltd
AIRCRAFT TYPE/MANUFACTURER:	Hawker Siddeley
YEAR OF MANUFACTURE:	1981
AIRCRAFT REGISTRATION:	5Y-BVQ
AIRCRAFT SERIAL NUMBER:	HS748-2B (1778)
DATE OF REGISTRATION:	31/01/2008
TYPE OF ENGINE& NUMBER	TBN
DATE OF OCCURRENCE:	08-04-2014
TIME OF OCCURRENCE:	0626
LOCATION OF OCCURRENCE:	Runway 07 Wilson airport
TYPE OF FLIGHT:	Test flight
NUMBER OF PERSONS ON BOARD:	Crew -3
INJURIES:	Nil
NATURE OF DAMAGE:	Minor
CATEGORY OF OCCURRENCE:	Incident
NAME OF PIC:	Amin Osman Abass
PIC'S FLYING EXPERIENCE:	CPL

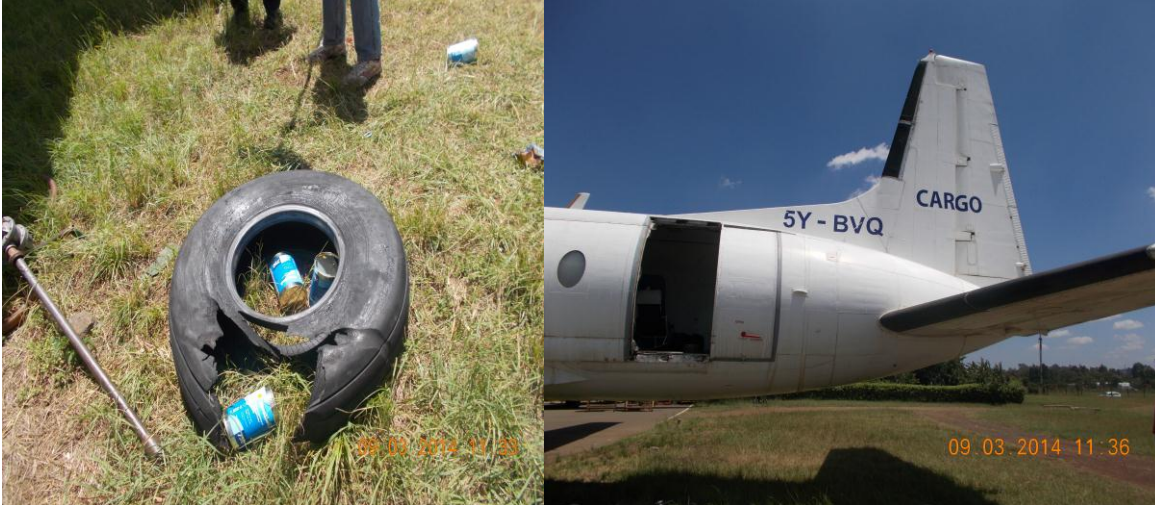
On 08/04/2014 at around 1537, a Hawker Siddeley type of aircraft registration 5Y-BVQ owned by HS748 and operated by Global Airlift Ltd experienced multiple tyre burst on starboard side landing gear while landing on runway 07 at Wilson airport on a flight test for the purpose of issuance of certificate of airworthiness. The aircraft had taken off from the same airport.

The occurrence caused a temporary closure of the airport as the aircraft had blocked both runways rendering them unusable. The aircraft however, the aircraft was towed from the site to apron 4 after replacing the faulty wheels.
