#### **AIR ACCIDENT INVESTIGATION DIVISION**

#### **FINAL REPORT**

AIRCRAFT REGISTRATION : 5Y-BZS, 5Y-BYV & 5Y-CAR

LOCATION OF OCCURRENCE : Apron 2 Wilson Airport

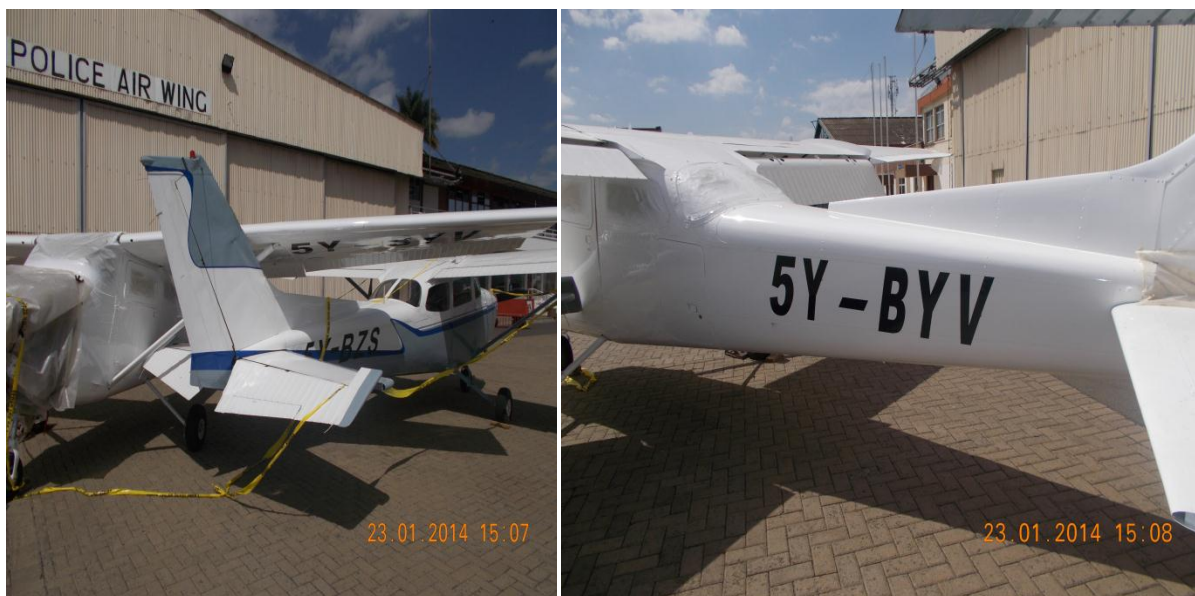
**Photograph: the Cessna 172 after the incident**

While taxiing out, two parked Cessna 172 aircraft registration 5Y-BYV and 5Y-BZS were blown off their chokes by the engines jet blast. The two C172s crashed into each other, resulting into minor damages to 5Y-BZS left aileron and vertical stabilizer.

1. Kenya Airport Authority to provide aircraft tie down knots/rings on parking bays.
2. There is need for Kenya Civil Aviation Authority to conduct safety risk assessment on the operation of CRJ200 and other similar jet engine propelled aircraft at Wilson airport.
