AIR ACCIDENT INVESTIGATION

FACTUAL INCIDENT REPORT

5Y-BZK

CIVIL AIRCRAFT INCIDENT REPORT

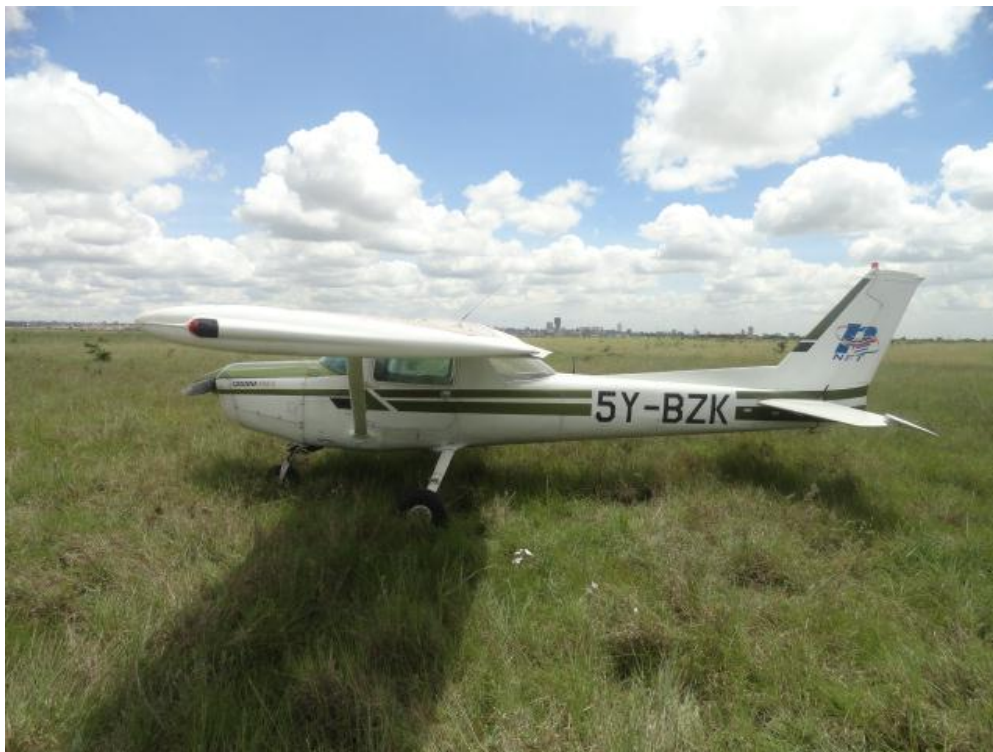
The aircraft did not sustain any visible damage as a result of this incident.

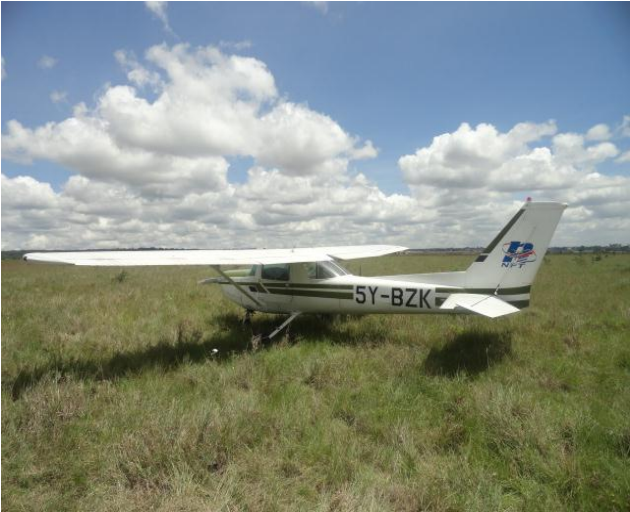
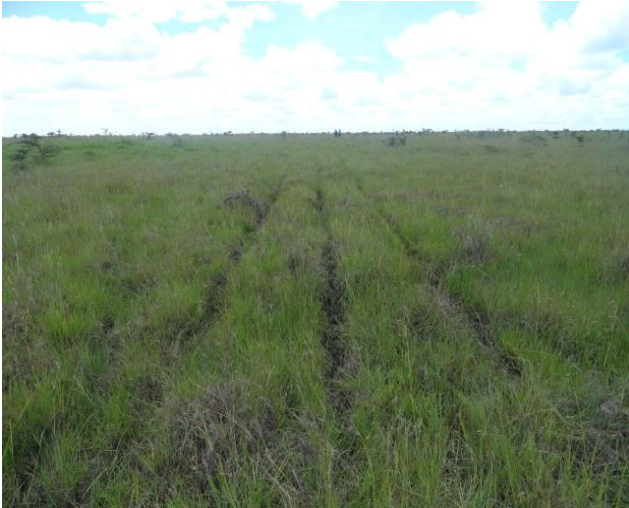
The aircraft structure remained generally intact after the incident with no resultant visible damage. After the forced landing, the aircraft came to rest approximately 1670 meters from the threshold of runway 32 facing a

heading of 225°. The exact incident location was at the coordinates 1°20.63'S 36°49.64'E.
