**AIR ACCIDENT INVESTIGATION DEPARTMENT**

**PRELIMINARY REPORT**

OPERATOR:	Flight Training Centre Limited
AIRCRAFT TYPE/ MANUFACTURER:	Cessna 172N/Cessna Aircraft Corporation
YEAR OF MANUFACTURE:	1978
AIRCRAFT REGISTRATION:	5Y-CBK
AIRCRAFT SERIAL NUMBER:	17270303
DATE OF REGISTRATION:	29 August 2012
TYPE OF ENGINE:	Lycoming 0-320-H2AD
ENGINE SERIAL NUMBER:	L-7829-76
DATE OF OCCURRENCE:	14 June 2013
TIME OF OCCURRENCE:	1155
LOCATION OF OCCURRENCE:	1°20'04''S 36°48'30''E (Nairobi National Park)
TYPE OF FLIGHT:	Training
NUMBER OF PERSONS ON BOARD:	Two
INJURIES:	None
NATURE OF DAMAGE:	Cracks and dents on the landing gear fairings;
CATEGORY OF OCCURRENCE:	Serious Incident
PIC FLYING EXPERIENCE:	1579 hours

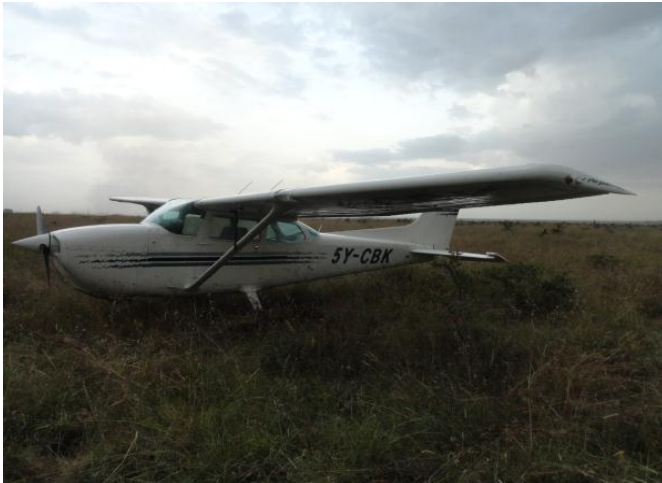
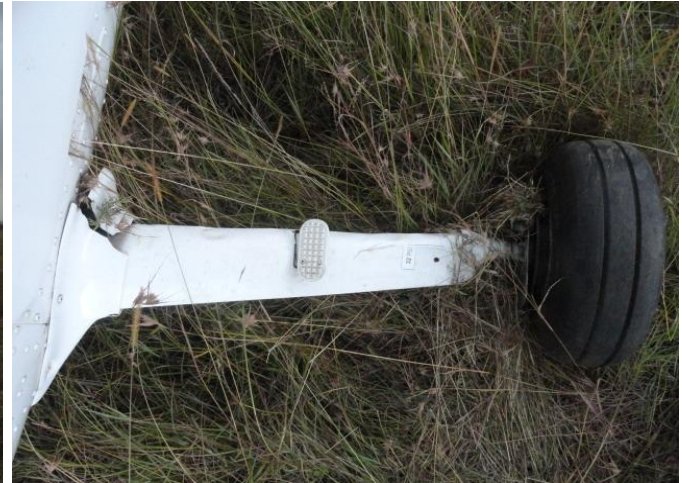
No injuries were reported, although the aircraft suffered some visible damage limited to cracks and dents on the landing gear fairings and surface scratches sustained from contact with bushes.
