MINISTRY OF TRANSPORT AND INFRASTRUCTURE
STATE DEPARTMENT OF TRANSPORT
AIR ACCIDENT INVESTIGATION DIVISION

PRELIMINARY REPORT

OPERATOR/OWNER:	Aviation Plus Limited
AIRCRAFT TYPE/ MANUFACTURER:	Cessna 152 / Cessna Aircraft Company
YEAR OF MANUFACTURE:	1981
AIRCRAFT REGISTRATION:	5Y-CDN
AIRCRAFT SERIAL NUMBER:	152-84839
DATE OF REGISTRATION:	10 December 2013
NUMBER AND TYPE OF ENGINE:	One Lycoming (O-235-L2C)
DATE OF OCCURRENCE:	12 February 2014
TIME OF OCCURRENCE:	0415
LOCATION OF OCCURRENCE:	Kitengela (1°36'14''S, 36°56'00''E)
TYPE OF FLIGHT:	Recovery
NUMBER OF PERSONS ON BOARD:	Two
INJURIES:	None Reported
NATURE OF DAMAGE:	Substantial Damage
CATEGORY OF OCCURRENCE:	Accident
PILOT 1:	Allan Roimen (YK-7922-PL)
PILOT 1 FLYING EXPERIENCE:	Total Flight Time: 50 hours
PILOT 2:	Elizabeth Timona (YK-6934-CL)
PILOT 2 FLYING EXPERIENCE:	Total Flight Time: 2000 hours
PILOT 3:	Francis Kavingo (YK-4591-AL/PL)
PILOT 3 FLYING EXPERIENCE:	Total Flight Time: 13700 hours

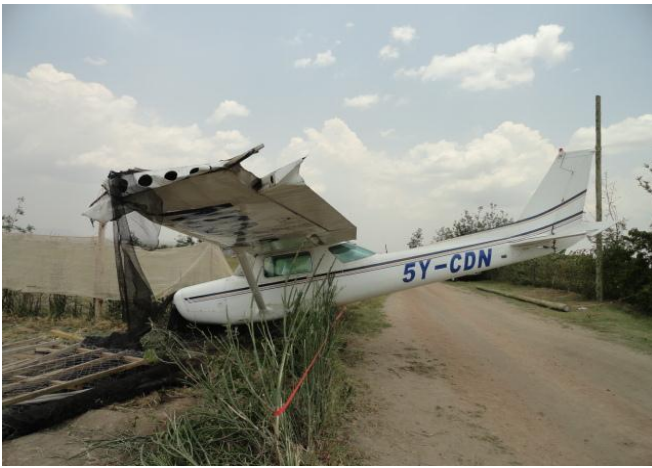
Pilot 3 was notified of the precautionary landing by Pilot 2 at approximately 1000 hours. According to Pilot 2, they checked the fuel level after landing and it was below quarter. Pilot 3 took 40 liters of fuel to the landing site and the aircraft was refueled on his arrival to the site at approximately 1200 hours. Engine ground runs were performed and according to Pilot 3 all the engine parameters were satisfactory and he attempted to takeoff from the grass field. However, the aircraft could not attain speed of more than 30 knots and they aborted the takeoff. At approximately 1305 hours, Pilot 3 made a second attempted takeoff on a nearby road. During the takeoff roll, the aircraft left wing contacted a fence and wooden posts. The aircraft swerved to the left and hit a residential gate, fence and more posts coming to rest perpendicular to the road. There were no injuries reported but the aircraft sustained substantial damage. The left wing tip was ripped off, nose wheel broke off, the right wing was bent, the leading edges of both wings were dented and punctured, and the left aileron was dislodged and bent on the left side.
