MINISTRY OF TRANSPORT AND INFRASTRUCTURE
STATE DEPARTMENT OF TRANSPORT
AIR ACCIDENT INVESTIGATION DIVISION

PRELIMINARY REPORT

OPERATOR/OWNER:	Aviation Plus Limited
AIRCRAFT TYPE/ MANUFACTURER:	Cessna 152 / Cessna Aircraft Company
YEAR OF MANUFACTURE:	1981
AIRCRAFT REGISTRATION:	5Y-CDN
AIRCRAFT SERIAL NUMBER:	152-84839
DATE OF REGISTRATION:	10 December 2013
NUMBER AND TYPE OF ENGINE:	One Lycoming (O-235-L2C)
DATE OF OCCURRENCE:	12 February 2014
TIME OF OCCURRENCE:	0415
LOCATION OF OCCURRENCE:	Kitengela (1°36'14''S, 36°56'00''E)
TYPE OF FLIGHT:	Recovery
NUMBER OF PERSONS ON BOARD:	Two
INJURIES:	None Reported
NATURE OF DAMAGE:	Substantial Damage
CATEGORY OF OCCURRENCE:	Accident
PILOT 1:	Allan Roimen (YK-7922-PL)
PILOT 1 FLYING EXPERIENCE:	Total Flight Time: 50 hours
PILOT 2:	Elizabeth Timona (YK-6934-CL)
PILOT 2 FLYING EXPERIENCE:	Total Flight Time: 2000 hours
PILOT 3:	Francis Kavingo (YK-4591-AL/PL)
PILOT 3 FLYING EXPERIENCE:	Total Flight Time: 13700 hours

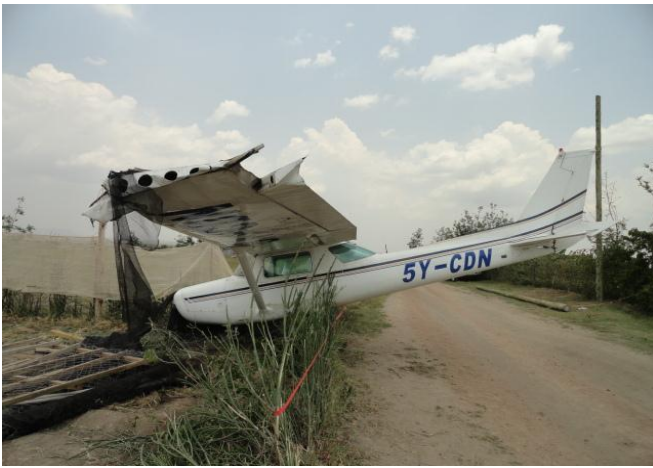
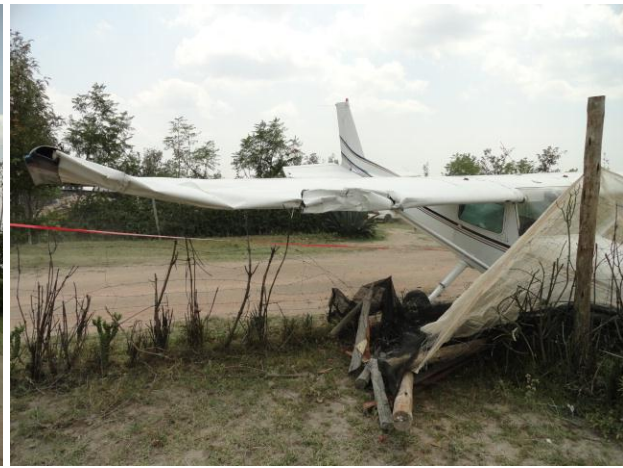
Pilot 3 was notified of the precautionary landing by Pilot 2 at approximately 1000 hours. According to Pilot 2, they checked the fuel level after landing and it was below quarter. Pilot 3 took 40 liters of fuel to the landing site and the aircraft was refueled on his arrival to the site at approximately 1200 hours. Engine ground runs were performed and according to Pilot 3 all the engine parameters were satisfactory and he attempted to takeoff from the grass field. However, the aircraft could not attain rolling speed of more than 30 knots and they aborted the takeoff. At approximately 1305 hours, Pilot 3 made a second attempted takeoff on a nearby road. During the takeoff roll, the aircraft left wing contacted a fence and wooden posts. The aircraft swerved to the left and hit a residential gate, fence and more posts coming to rest perpendicular to the road. There were no injuries reported but the aircraft sustained substantial damage. The left wing tip was ripped off, nose wheel broke off, the right wing was bent, the leading edges of both wings were dented and punctured, and the left aileron was dislodged and bent on the left side.
