**MINISTRY OF TRANSPORT AND INFRASTRUCTURE**  
**STATE DEPARTMENT OF TRANSPORT**  
**AIR ACCIDENT INVESTIGATION**  
**PRELIMINARY REPORT**

OPERATOR/OWNER : Tarquin Wood  
AIRCRAFT TYPE/MANUFACTURER : Maule M5/Maule Aircraft Corporation  
YEAR OF MANUFACTURE : 1979  
AIRCRAFT REGISTRATION : 5Y-CDR  
AIRCRAFT SERIAL NUMBER : 7287C  
DATE OF REGISTRATION : 13 November 2013  
NUMBER AND TYPE OF ENGINE : One Lycoming O-540  
DATE OF OCCURRENCE : 07 August 2015  
TIME OF OCCURRENCE : 1300 hours  
LOCATION OF OCCURRENCE : Homa Lime Airstrip  
(0°08'25"S, 35°15'22")  
DEPARTURE AERODROME : Olerai Airstrip  
DESTINATION AERODROME : Homa Lime Airstrip  
TYPE OF FLIGHT : Private  
NUMBER OF PERSONS ON BOARD : Three  
INJURIES : None  
NATURE OF DAMAGE : Substantial  
CATEGORY OF OCCURRENCE : Accident  
PIC FLYING EXPERIENCE : PPL: 650 hours

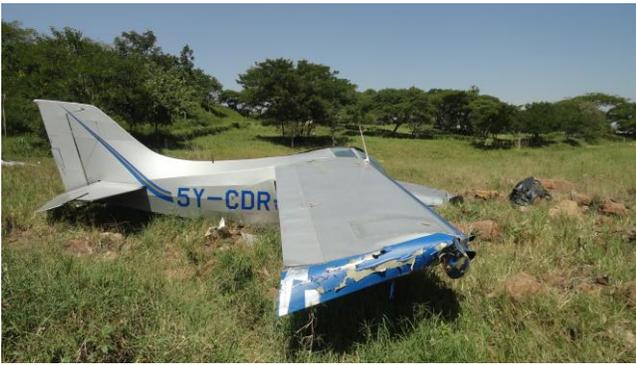
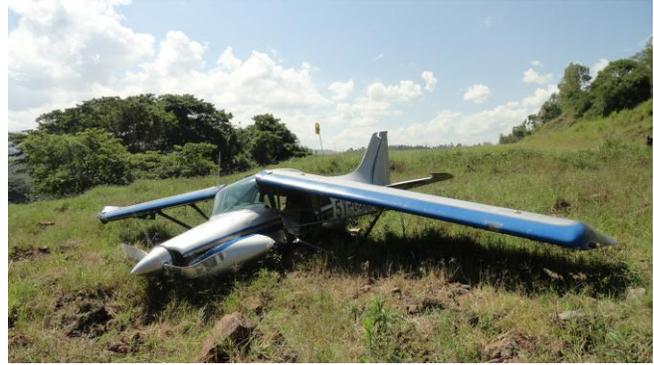
The aircraft took off from Olerai Airstrip near Narok on 7 August 2015 at approximately 1230 hours with three persons on board for a flight to Koru. As they overflew Kericho area, the pilot reported that it started raining and visibility was approximately 8KM. The flight was generally uneventful and the aircraft landed on runway 30 of Homa Lime Airstrip at approximately 1300 hours. The pilot landed long and the aircraft bounced on touchdown. The pilot reported that the aircraft started skidding upon application of brakes and could not stop within the runway length. The aircraft overran the runway into ditches and rocks at the end of the runway coming to rest at a heading of approximately 310°. The aircraft main landing gear was broken and the lower fuselage section was substantially damaged. The wings were also substantially damaged and one of the propeller blades was bent.
