MINISTRY OF TRANSPORT AND INFRASTRUCTURE
STATE DEPARTMENT OF TRANSPORT
AIR ACCIDENT INVESTIGATION DIVISION

PRELIMINARY REPORT

OPERATOR:	Flight Training Centre Limited
AIRCRAFT TYPE/ MANUFACTURER:	Cessna 152/ Cessna Aircraft Company
YEAR OF MANUFACTURE:	TBA
AIRCRAFT REGISTRATION:	5Y-CDW
AIRCRAFT SERIAL NUMBER:	15281099
DATE OF REGISTRATION:	16 December 2013
NUMBER AND TYPE OF ENGINE:	One Lycoming (O-235-L2C)
DATE OF OCCURRENCE:	28 April 2015
TIME OF OCCURRENCE:	0703
LOCATION OF OCCURRENCE:	Wilson Airport, Runway 07
TYPE OF FLIGHT:	Training
NUMBER OF PERSONS ON BOARD:	One
INJURIES:	None
NATURE OF DAMAGE:	Substantial
CATEGORY OF OCCURRENCE:	TBA
PIC:	Ali Ndoria Nganga (YK-9414-SL)
PIC FLYING EXPERIENCE:	SPL: ~20 hours

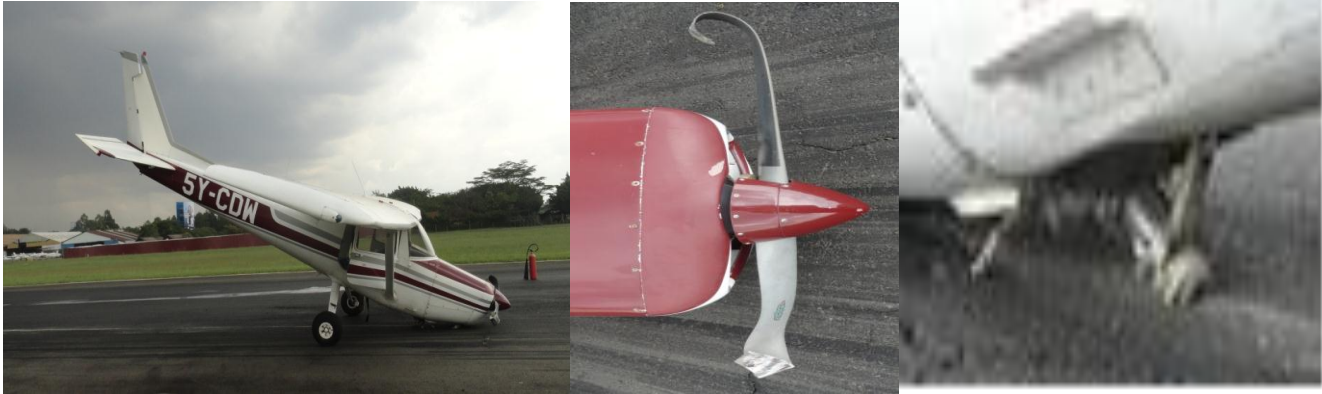
Accident Photos

The aircraft sustained substantial damage as follows: the nose wheel detached from fuselage; wrinkling of firewall; engine mount bars exhibited bending and failure; propeller strike, bent propeller blades; abrasion marks on lower nose section fuselage including oleo strut and exhaust pipe.
