MINISTRY OF TRANSPORT AND INFRASTRUCTURE
STATE DEPARTMENT OF TRANSPORT
AIR ACCIDENT INVESTIGATION DEPARTMENT

PRELIMINARY REPORT

OPERATOR/OWNER : Ace Air Limited
AIRCRAFT TYPE/ MANUFACTURER : Cessna U206/Cessna Aircraft Company
YEAR OF MANUFACTURE : 1979
AIRCRAFT REGISTRATION : 5Y-CFB
AIRCRAFT SERIAL NUMBER : U20605210
DATE OF REGISTRATION : 20August 2014
NUMBER AND TYPE OF ENGINE : One TCM IO-550-F
DATE OF OCCURRENCE : 16 November 2014
TIME OF OCCURRENCE : 0915 hours
LOCATION OF OCCURRENCE : DelMonte Farm in Gatwanyaga near Ndula Marker
(1°02'38"S, 37°12'35")
TYPE OF FLIGHT : Private
NUMBER OF PERSONS ON BOARD : One
INJURIES : None
NATURE OF DAMAGE : Engine structural damage
CATEGORY OF OCCURRENCE : Serious incident
PILOT IN COMMAND : Eric Marigi (YK-5004-CL)
PIC FLYING EXPERIENCE : 1253 hours

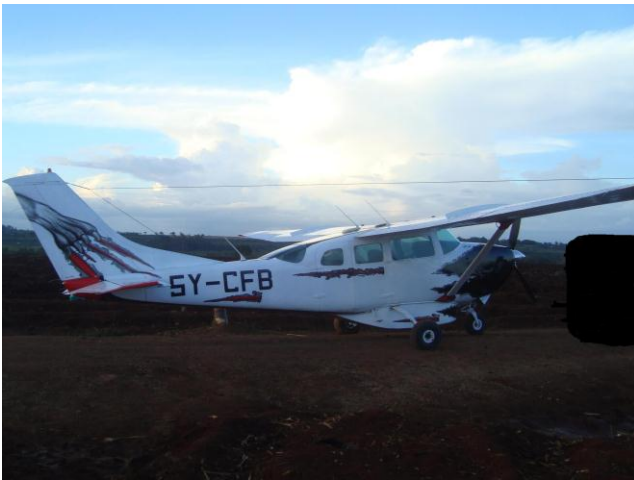
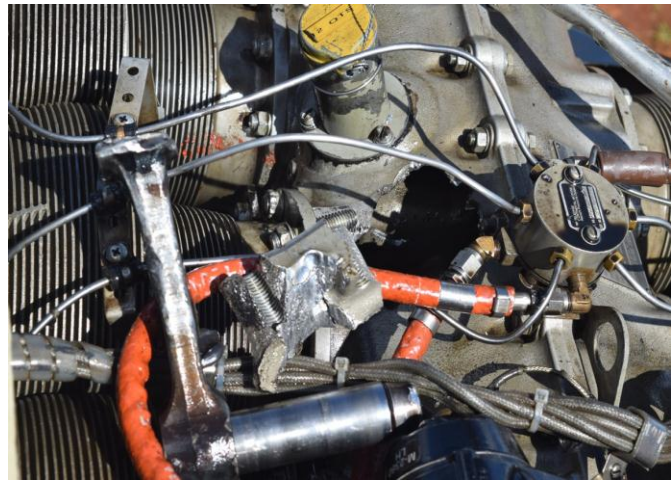
The damage sustained by the aircraft was limited to the engine and engine cowling. Preliminary examination of the aircraft engine revealed an internal structural failure of cylinder № 4 connecting rod and a section of the crankcase. A small section of the engine cowling was also torn.
