**AIR ACCIDENT INVESTIGATION**

**PRELIMINARY REPORT**

OPERATOR:	DAC AVIATION (EA) LTD
AIRCRAFT TYPE:	CESSNA CARAVAN C208B
AIRCRAFT MANUFACTURER:	CESSNA COMPANY USA
YEAR OF MANUFACTURE:	2013
AIRCRAFT REGISTRATION:	5Y DAA
AIRCRAFT SERIAL NUMBER:	208C5025
DATE OF REGISTRATION:	25 Sept, 2013
TYPE OF ENGINE:	Pratt & Whitney (Canada) PT6A-140
DATE OF OCCURRENCE:	21 Aug, 2014
TIME OF OCCURRENCE:	0830
LOCATION OF OCCURRENCE:	Shamwana Airstrip, D.R.Congo
TYPE OF FLIGHT:	Charter
NUMBER OF PERSONS ON BOARD:	Crew - 2; Passengers – 6
INJURIES:	Minor (1)
NATURE OF DAMAGE:	Substantial
CATEGORY OF OCCURRENCE:	Accident
NAME OF PIC:	Lee Mwenga
PIC'S FLYING EXPERIENCE:	Total 2,500Hrs; TBC Hrs on type

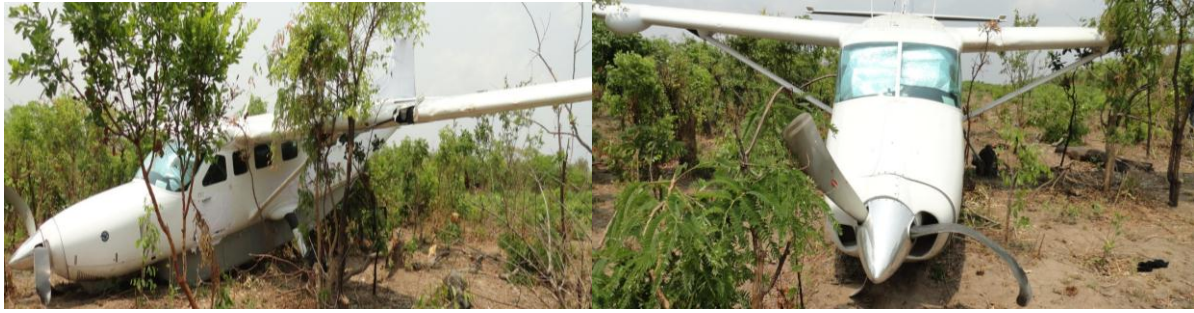
## PHOTO

The aircraft overran the runway and came to rest at approximately 100m from the threshold of runway 19.

Sections of the aircraft were substantially damaged when it came into contact with the bush line. This includes broken nose landing gear spring, bent nose landing gear steering rod, damaged forward cargo pod, left wing along the leading edge, broken left hand landing and taxi light lens, damaged propeller and the nose landing gear fairing too.
