**MINISTRY OF TRANSPORT AND INFRASTRUCTURE**  
**STATE DEPARTMENT OF TRANSPORT**  
**AIR ACCIDENT INVESTIGATION**  
**PRELIMINARY REPORT**

OPERATOR:	PRIVATE
AIRCRAFT TYPE/ MANUFACTURER:	PA 28-236 (DAKOTA)
YEAR OF MANUFACTURE:	1979
AIRCRAFT REGISTRATION:	5Y -DMS
AIRCRAFT SERIAL NUMBER:	28-79112117
DATE OF REGISTRATION:	9 FEBRUARY 2007
TYPE OF ENGINE:	Lycoming O-540J3A5D
DATE OF OCCURRENCE:	31 MAY 2015
TIME OF OCCURRENCE:	1600
LOCATION OF OCCURRENCE:	RIRONI, LIMURU S 1°9'57.55" E 36°09' 39.38"
TYPE OF FLIGHT:	PRIVATE
NUMBER OF PERSONS ON BOARD:	<b>One</b>
INJURIES:	FATAL
NATURE OF DAMAGE:	Substantial
CATEGORY OF OCCURRENCE:	Accident
PIC'S FLYING EXPERIENCE:	270 hours

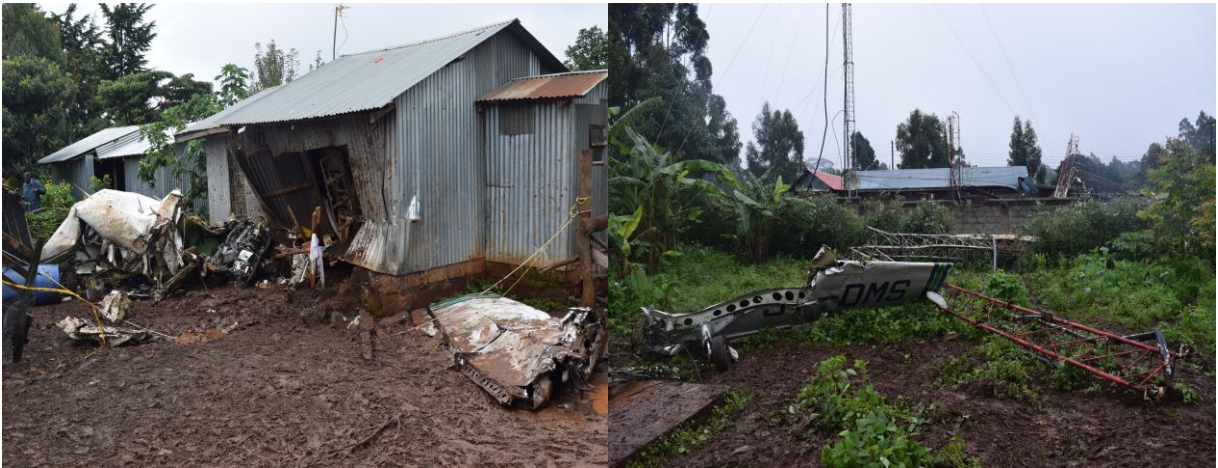
The aircraft collided with a TV and Radio mast that was 90 meters tall. The mast was ripped off and a second mast that was 72 m tall was also destroyed at the top. The aircraft crashed about three hundred meters from the taller of the masts. At the final site of the crash the aircraft plunged to the ground in a nose down attitude damaging a residential house. The crash was fatality. Post impact fire was noted on the aircraft tail fin, right wing and on a temporary makeshift house.
