AIR ACCIDENT INVESTIGATION DIVISION

PRELIMINARY REPORT

AIRCRAFT TYPE/ MANUFACTURER : PA28-181

AIRCRAFT REGISTRATION : 5Y-GTH

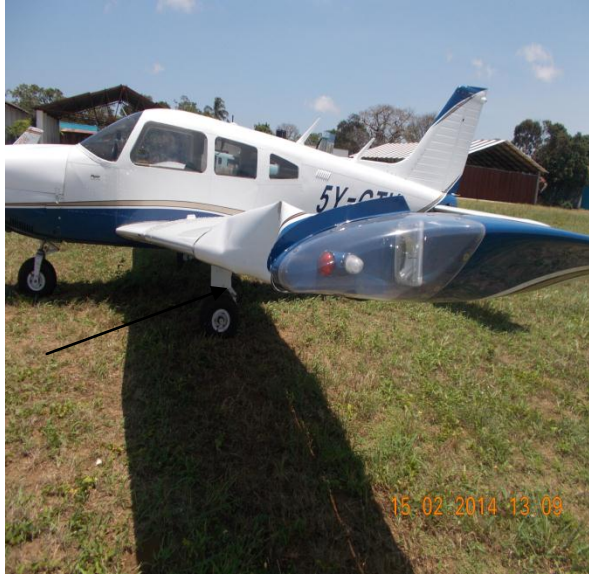
Damaged aircraft port wing

On 10 March, 2014 at around 1626, a Piper 28 aircraft registration 5Y-GTH owned by Skylink Flight Services Ltd with two onboard for a night training mission while taking-off lost control and crash landed 80m from end threshold runway 35 at Malindi airport. The port wing of the aircraft hit an approach light 6m tall before it came to rest at a distance 80m from end threshold runway 35. The aircraft impact with an approach light caused a dip dent on the aircraft port wing and noticeable separation of the wing from the main fuselage. There were no injuries to persons onboard.

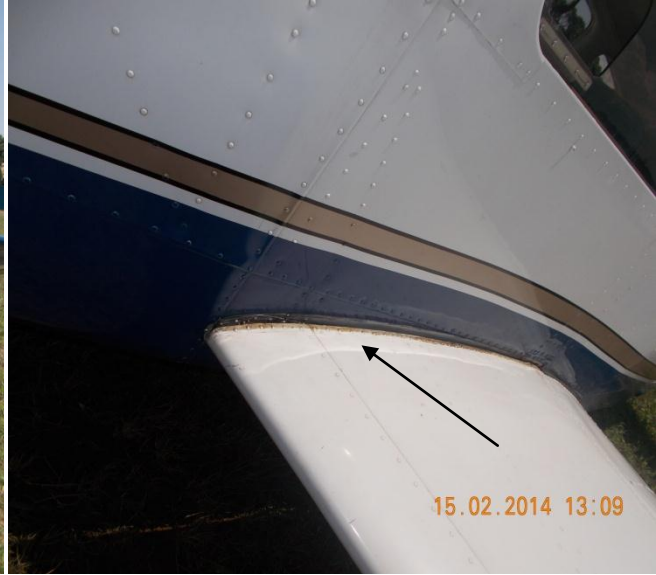
Noticeable port wing separation with fuselage
