MINISTRY OF TRANSPORT AND INFRASTRUCTURE
STATE DEPARTMENT OF TRANSPORT
AIR ACCIDENT INVESTIGATION
PRELIMINARY REPORT

OPERATOR:	Helicopter Charter East Africa Ltd
AIRCRAFT TYPE/ MANUFACTURER:	Robinson R22 Raven II/ Robinson Helicopter Co.
YEAR OF MANUFACTURE:	2010
AIRCRAFT REGISTRATION:	5Y-HCA
AIRCRAFT SERIAL NUMBER:	12970
DATE OF REGISTRATION:	15 October 2010
NUMBER AND TYPE OF ENGINE:	One Lycoming IO-540
DATE OF OCCURRENCE:	18 July 2015
TIME OF OCCURRENCE:	Between 0630 and 0700
LOCATION OF OCCURRENCE:	Suguta Valley, 1°39'50"N 36°22'39"E
TYPE OF FLIGHT:	Commercial (Scenic)
NUMBER OF PERSONS ON BOARD:	Four
INJURIES:	None/minor
NATURE OF DAMAGE:	Substantial
CATEGORY OF OCCURRENCE:	Accident
PIC:	Andrew Francombe (YK-4830-CL (H))
PIC FLYING EXPERIENCE:	CPL: ~6,000 hours

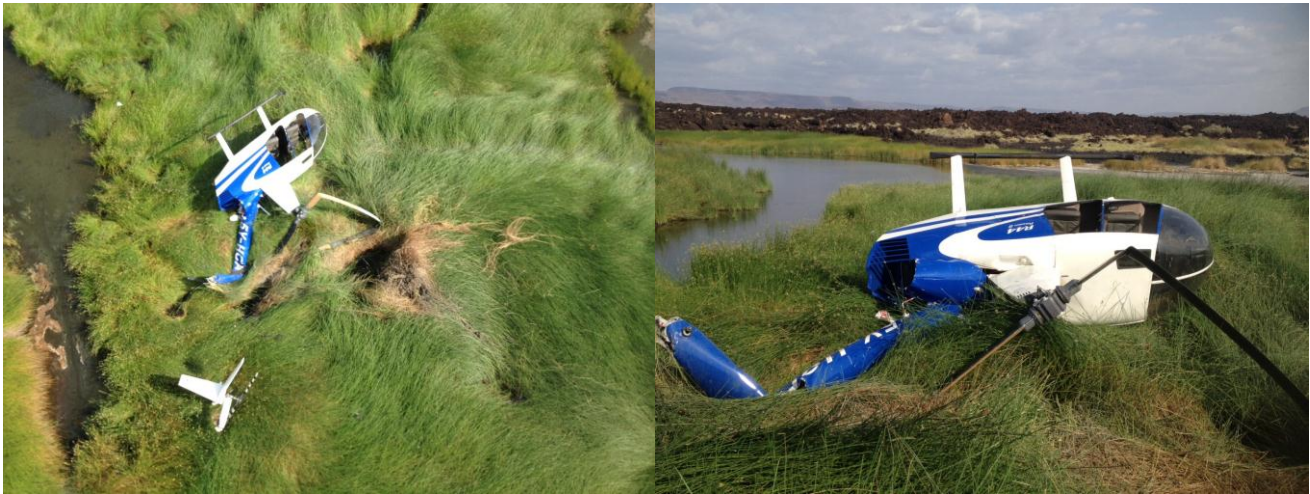
Accident Photos

The aircraft sustained substantial damage as follows: main rotor blades extensively damaged, tail boom detached from fuselage, empennage section consisting of tail rotor, TR gearbox, vertical and horizontal stabilizer separated from tail boom body, semi circular crack on left side of glare shield approximately 50cm in diameter.
