**MINISTRY OF TRANSPORT AND INFRASTRUCTURE**  
**STATE DEPARTMENT OF TRANSPORT**  
**AIR ACCIDENT INVESTIGATION**  
**PRELIMINARY REPORT**

OPERATOR:	Helicopter Charter East Africa Ltd
AIRCRAFT TYPE/ MANUFACTURER:	Robinson R44 Raven II/ Robinson Helicopter Co.
YEAR OF MANUFACTURE:	2013
AIRCRAFT REGISTRATION:	5Y-HCC
AIRCRAFT SERIAL NUMBER:	13728
DATE OF REGISTRATION:	11 December 2014
NUMBER AND TYPE OF ENGINE:	One Lycoming IO-540-AE1A5
DATE OF OCCURRENCE:	27 July 2015
TIME OF OCCURRENCE:	1415
LOCATION OF OCCURRENCE:	Nyahururu, 0°2'34"N 36°18'0"E
TYPE OF FLIGHT:	Commercial
NUMBER OF PERSONS ON BOARD:	Three
INJURIES:	Minor/serious
NATURE OF DAMAGE:	Substantial
CATEGORY OF OCCURRENCE:	Accident
PIC FLYING EXPERIENCE:	CPL: ~6,000 hours(~800 hours on helicopter)

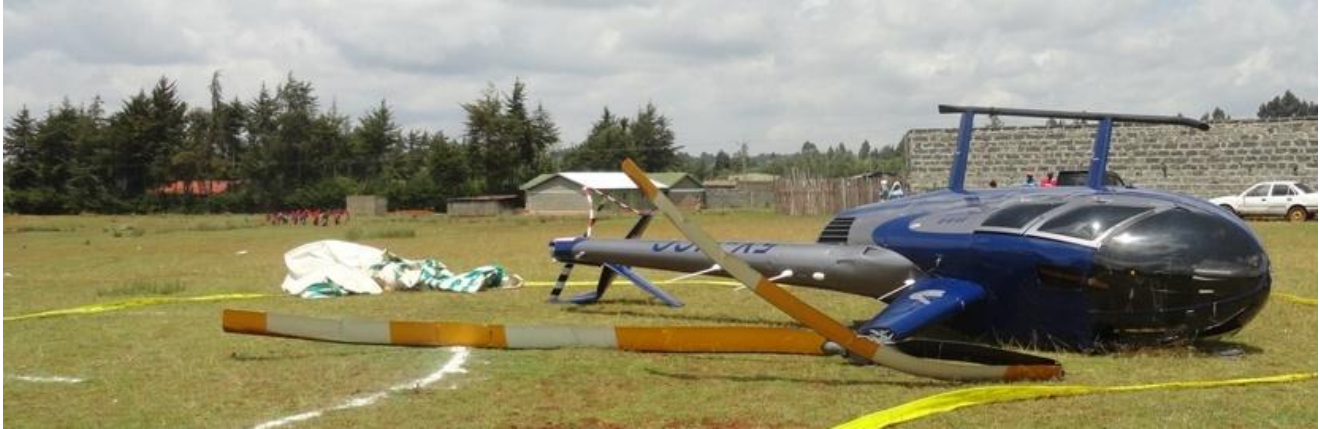
Accident Photos

The aircraft sustained substantial damage as follows: main rotor blades extensively damaged, empennage section consisting of tail rotor, TR gearbox, vertical and horizontal stabilizer partially separated from tail boom body, substantial damage to glare shield, substantial damage to the landing gear, left skid.
