MINISTRY OF TRANSPORT AND INFRASTRUCTURE

AIR ACCIDENT INVESTIGATION

PRELIMINARY REPORT

OPERATOR:	Skyward Express Limited
AIRCRAFT TYPE/ MANUFACTURER:	Fokker 27-Mark 50/Fokker Aircraft B.V
YEAR OF MANUFACTURE:	1989
AIRCRAFT REGISTRATION:	5Y-SIB
AIRCRAFT SERIAL NUMBER:	20167
DATE OF REGISTRATION:	22 September 2014
TYPE OF ENGINE:	21 August, 2013
DATE OF OCCURRENCE:	04 Janaury 2015
TIME OF OCCURRENCE:	0802
LOCATION OF OCCURRENCE:	Jomo Kenyatt International Airport, Kenya
TYPE OF FLIGHT:	Commercial,
NUMBER OF PERSONS ON BOARD:	Crew – 4, 6-Passengers
INJURIES:	None
NATURE OF DAMAGE:	Serious
CATEGORY OF OCCURRENCE:	Accident
NAME OF PIC:	Joseph Kimathi Arithi
PIC'S FLYING EXPERIENCE:	15500 Hours

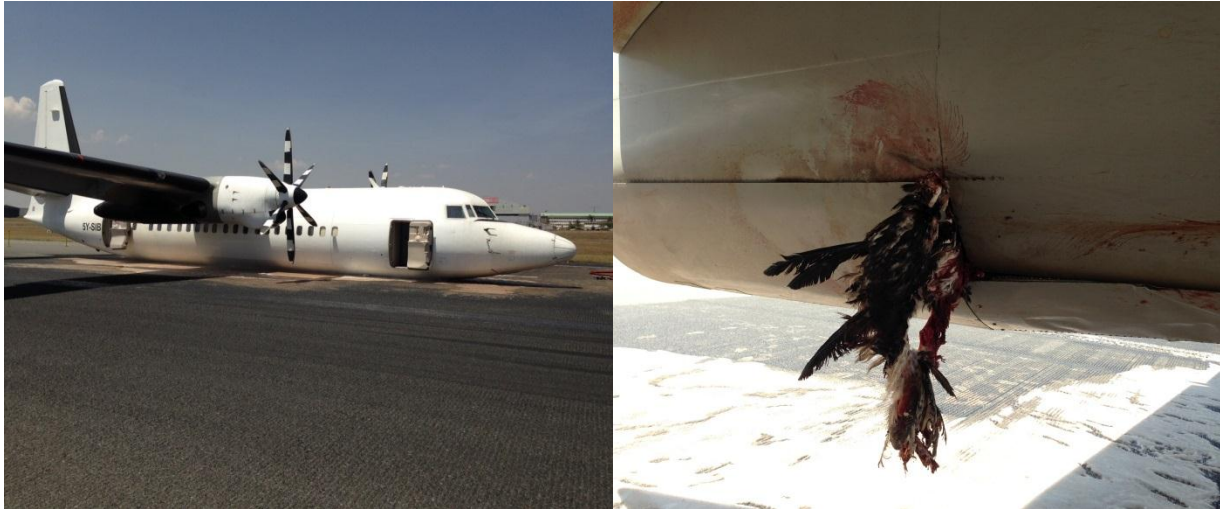
The crew subsequently decided to perform a belly landing (with all gear up) and landed the aircraft at JKIA runway 06 at about 0802 skidding to a halt 2km from the threshold on the runway. Emergency services subsequently applied foam to cool the belly of the aircraft and prevent any possible fire. No injuries were reported.

A post removal inspection revealed evidence of a bird strike lodged into the left main gear structure.
