AIR ACCIDENT INVESTIGATION DEPARTMENT

FINAL SERIOUS INCIDENT REPORT 5Y-VVY 08.01.2013

CIVIL AIRCRAFT SERIOUS INCIDENT REPORT

AIRCRAFT MODEL : DHC-8-402

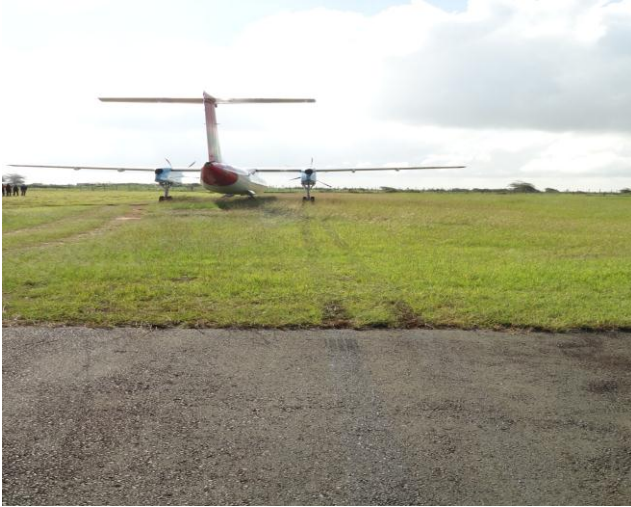
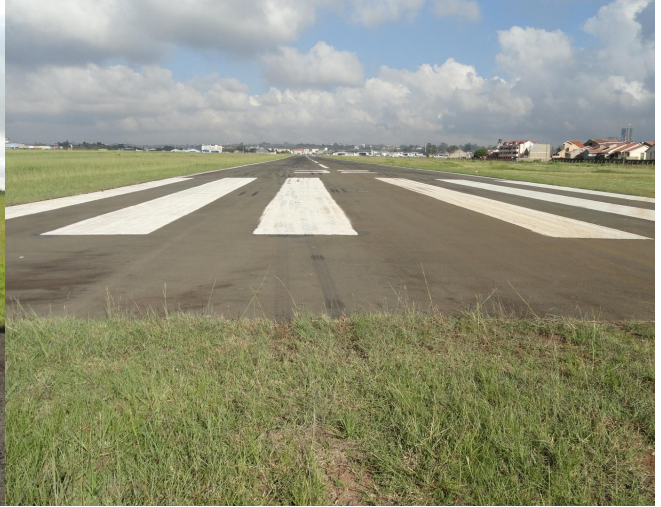
The aircraft remained intact with minor tyre damage during this incident. It overran runway 14 by approximately 67 meters from the threshold of runway 32. Tyre marks of braking action on the runway were visible after the intersection of runways 07 and 14 and just before the end of runway 14. The tyre marks indicated an aircraft motion from the right hand of the runway centerline towards the centre.

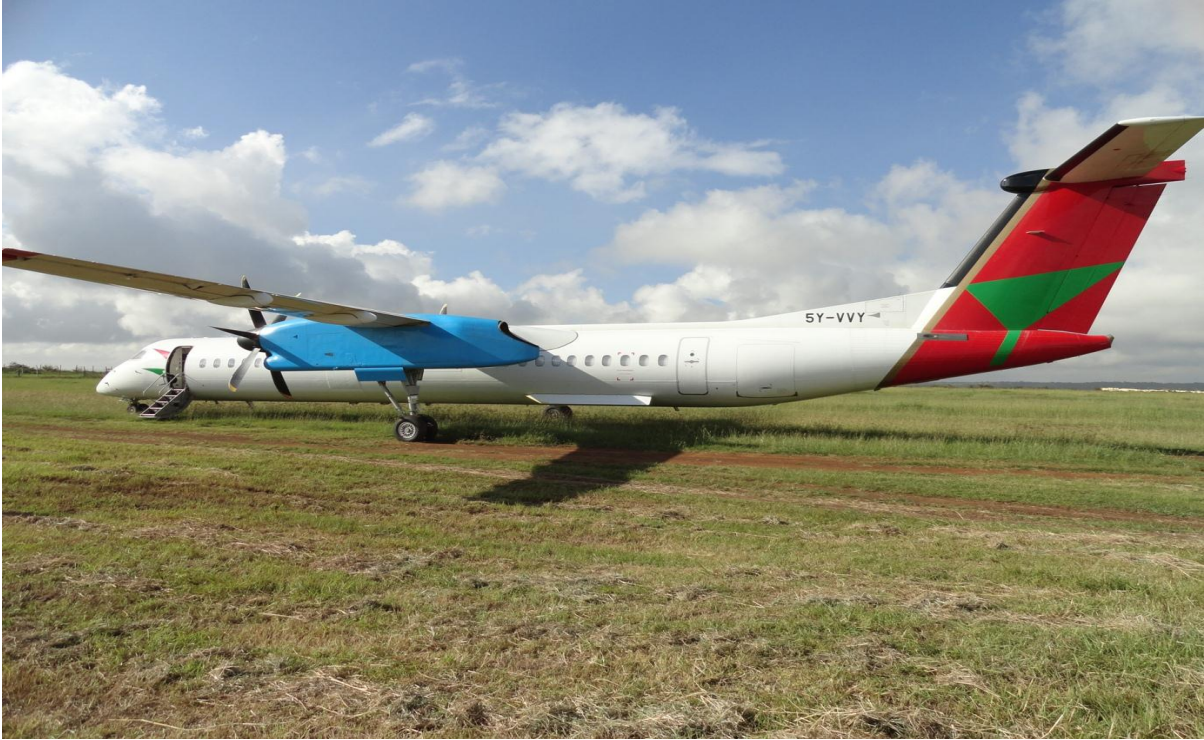
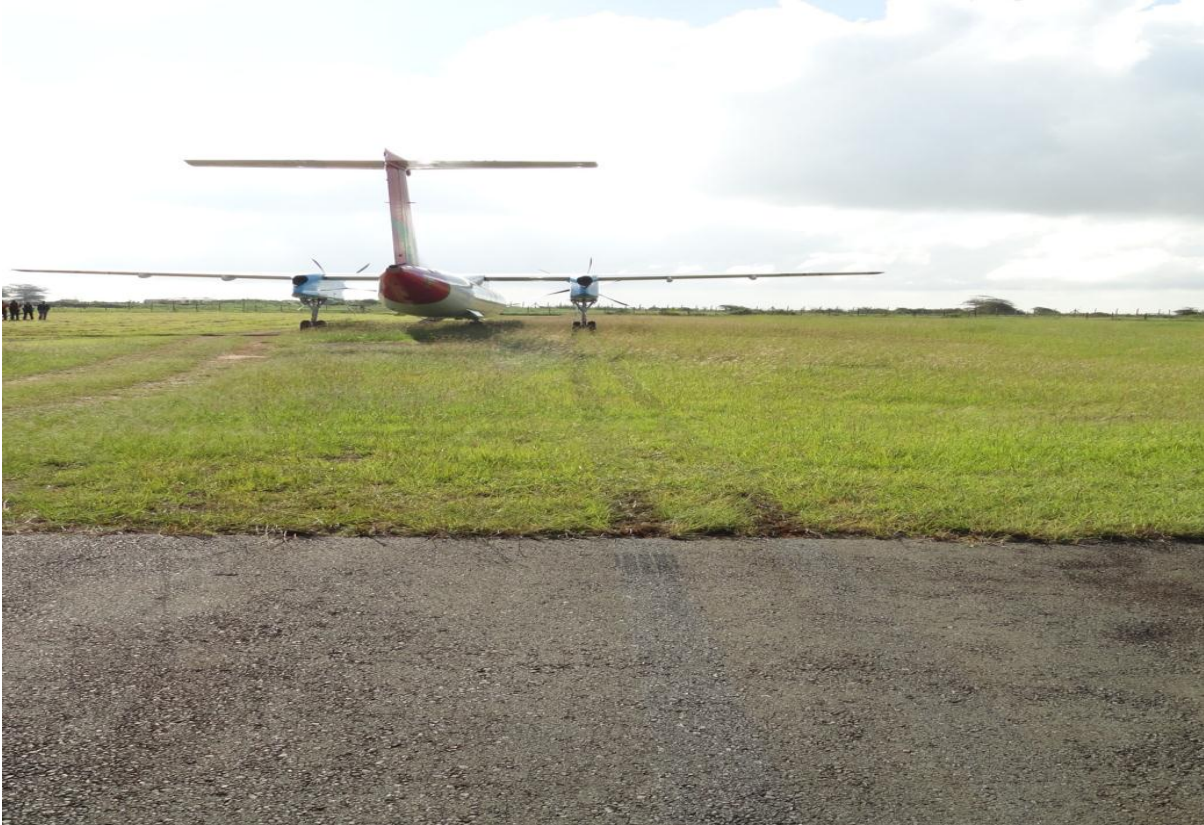
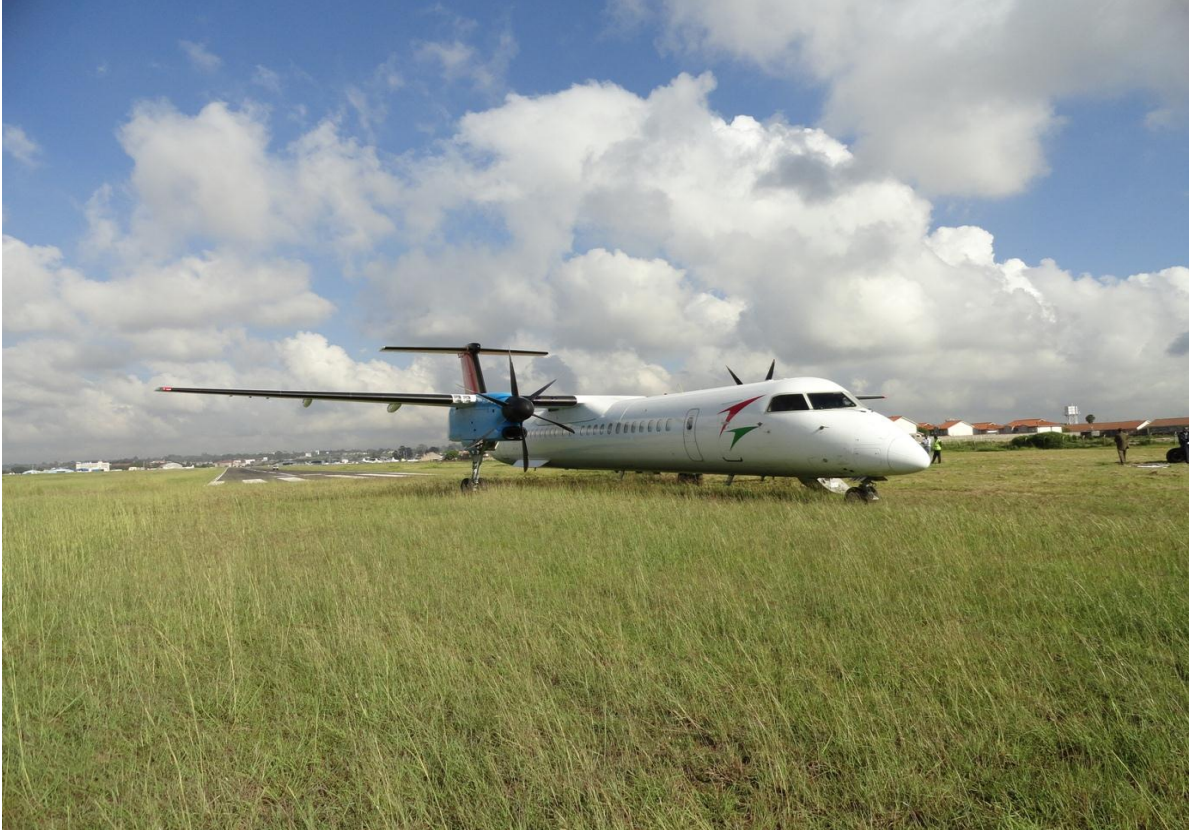
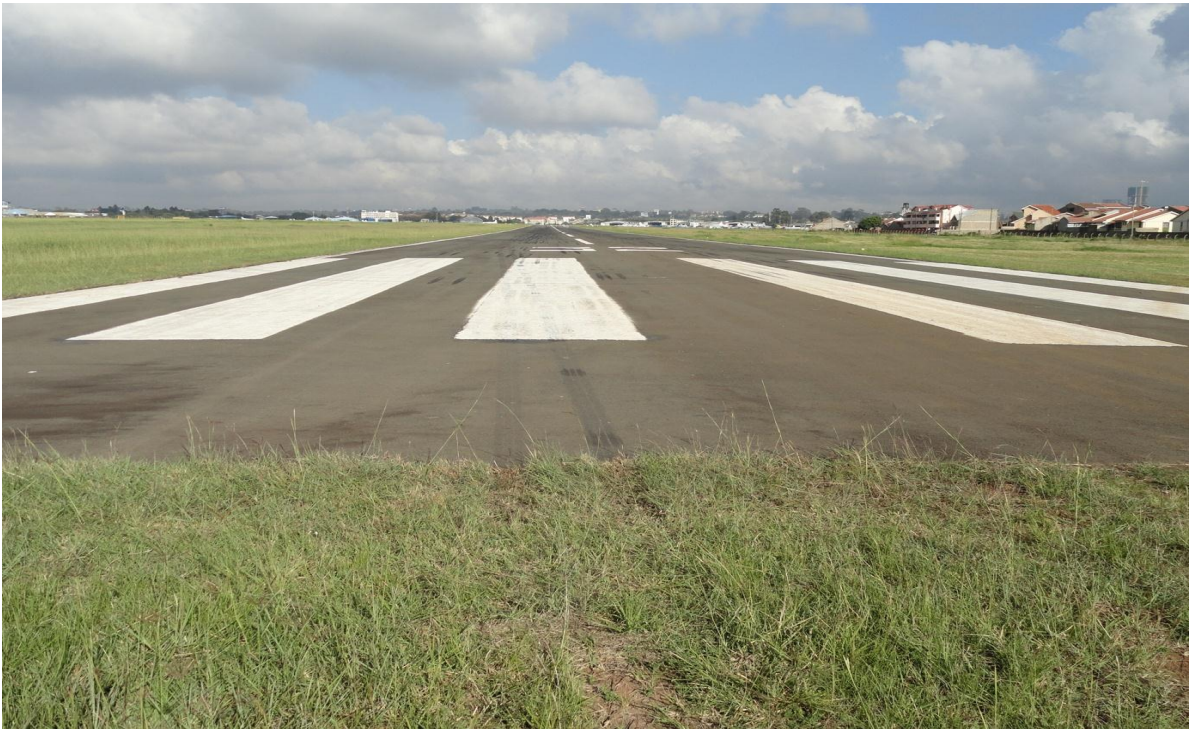
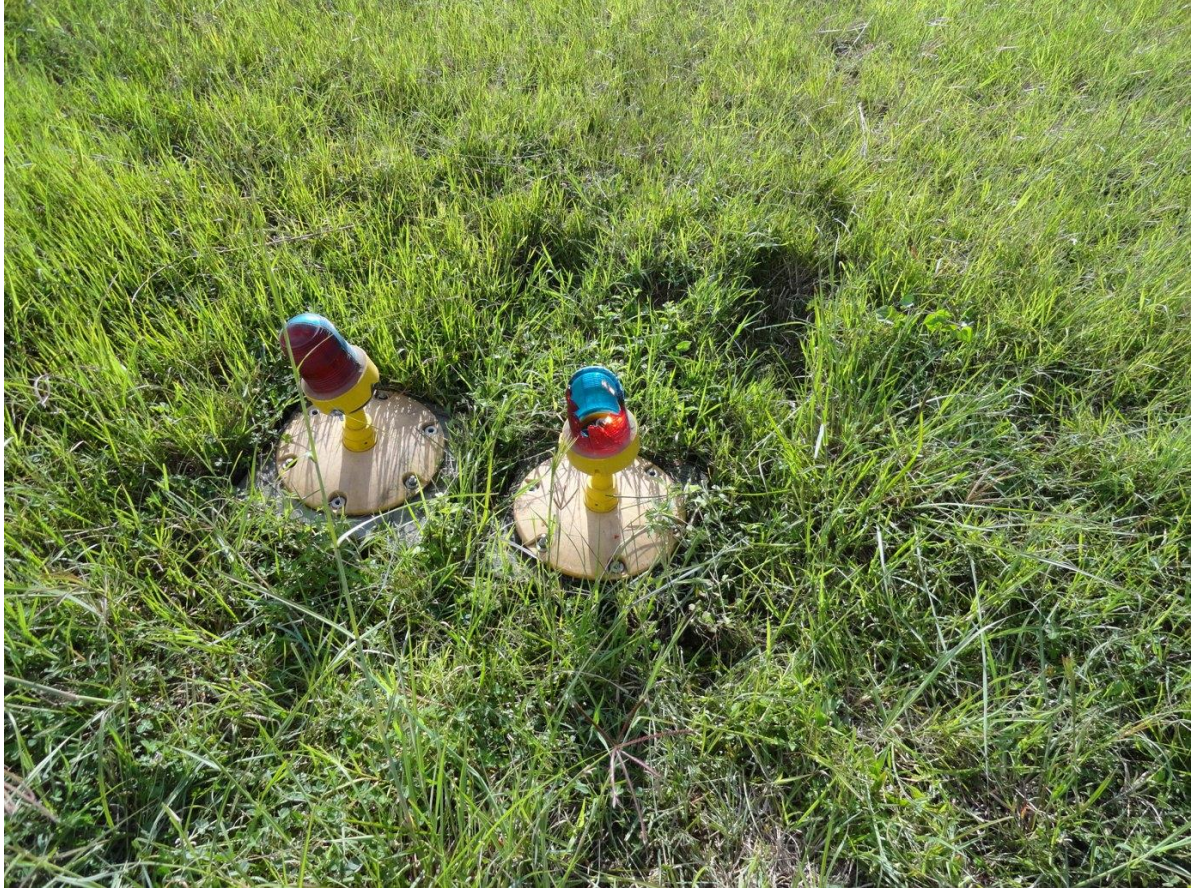
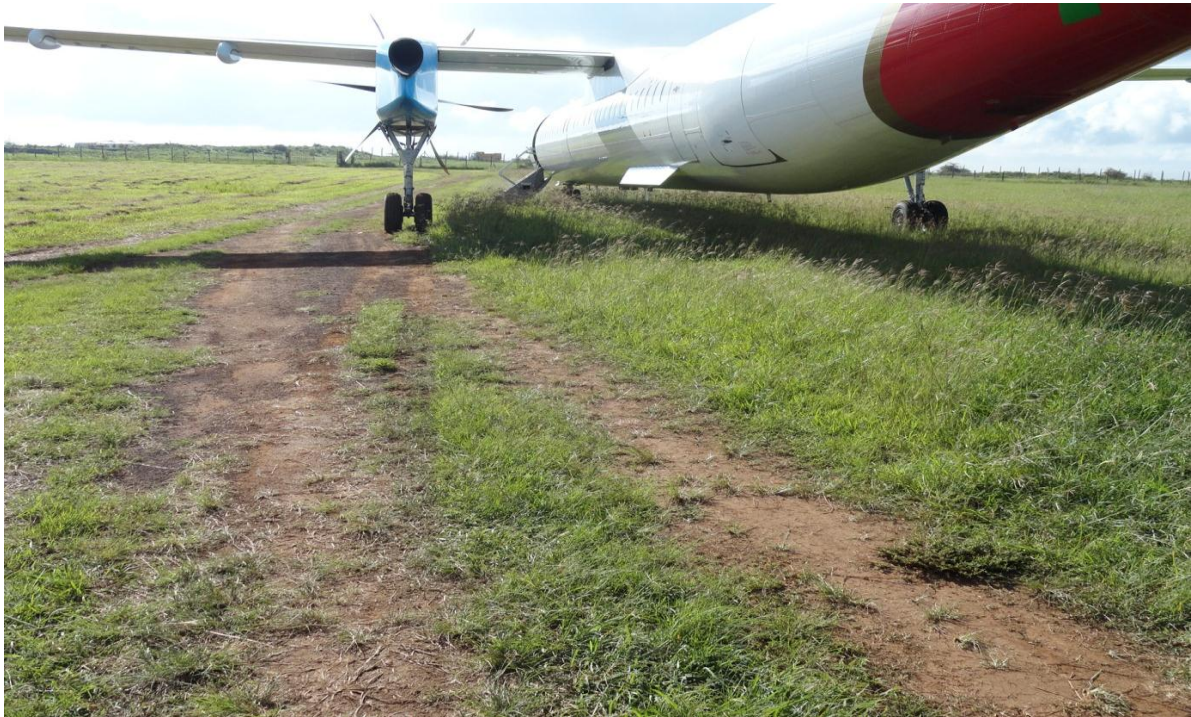
Appendix II - Aircraft Photographs

The aircraft sustained minor visible damage on its nose and main landing gear tyres.
