# MINISTRY OF TRANSPORT, INFRASTRUCTURE, HOUSING AND URBAN DEVELOPMENT

## AIR ACCIDENT INVESTIGATION

### PRELIMINARY REPORT

OPERATOR:	Z BOSKOVIC
AIRCRAFT TYPE/MANUFACTURER:	Cessna 206/Cessna Co. USA
YEAR OF MANUFACTURE:	1974
AIRCRAFT REGISTRATION:	5Y - AUN
AIRCRAFT SERIAL NUMBER:	206-02531
DATE OF REGISTRATION:	1974
TYPE OF ENGINE:	IO-520-F3B
DATE OF OCCURRENCE:	06/07/2016
TIME OF OCCURRENCE:	1445
LOCATION OF OCCURRENCE:	Mara, S 01°43'30.9" E 035°23'0.4"
TYPE OF FLIGHT:	Commercial
NUMBER OF PERSONS ON BOARD:	01
INJURIES:	Minor
NATURE OF DAMAGE:	Substantial
CATEGORY OF OCCURRENCE:	Accident
PIC'S FLYING EXPERIENCE:	CPL, 5800 hours

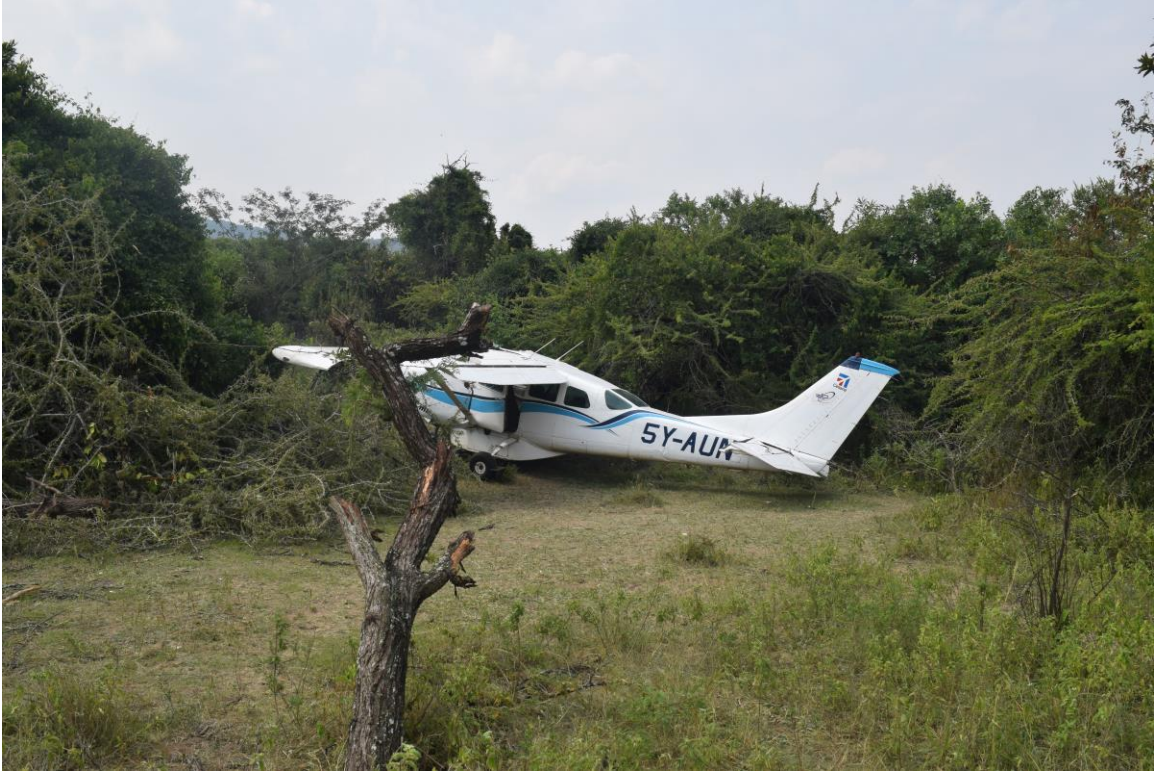
Both left and right wings were damaged on the leading edge. The flaps control was broken. The wings struts attachments to the fuselage were severed. The under carriage was also damaged. The cockpit glass canopy was shattered. One of the blades had a spiral twist and broken at the hub. The aircraft remained intact and there was no dispersion of debris.
