**MINISTRY OF TRANSPORT, INFRASTRUCTURE, HOUSING
AND URBAN DEVELOPMENT**
STATE DEPARTMENT OF TRANSPORT
AIR ACCIDENT INVESTIGATION

PRELIMINARY REPORT

OPERATOR:	Derek Seton
AIRCRAFT TYPE/MANUFACTURER:	Cessna 210L/Cessna Co. USA
YEAR OF MANUFACTURE:	1976
AIRCRAFT REGISTRATION:	5Y-BHT
AIRCRAFT SERIAL NUMBER:	21061146
DATE OF REGISTRATION:	26/07/1991
TYPE OF ENGINE:	One Continental
DATE OF OCCURRENCE:	28/04/2016
TIME OF OCCURRENCE:	1205
LOCATION OF OCCURRENCE:	Nairobi Wilson
TYPE OF FLIGHT:	Private
NUMBER OF PERSONS ON BOARD:	1
INJURIES:	Nil
NATURE OF DAMAGE:	Minor
CATEGORY OF OCCURRENCE:	Incident
PIC'S FLYING EXPERIENCE:	PPL/13700 Hours

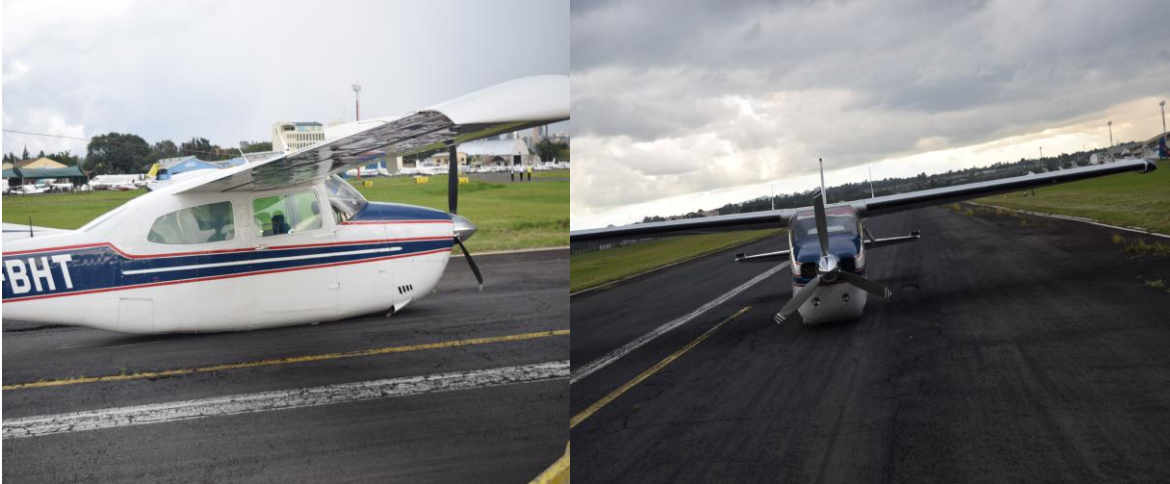
5Y-BHT on its belly after the occurrence

The aircraft made contact with the runway with its belly and the propeller blades hit the runway surface several times causing them to bend. The aircraft came to a halt 231m on the runway from its first point of impact. The pilot exited the aircraft unaided without any injury. There was no pre or post occurrence fire

Post-incident inspection of the aircraft revealed significant bent on both blades of the propeller and minimal bruises on the lower fuselage
