MINISTRY OF TRANSPORT AND INFRASTRUCTURE
STATE DEPARTMENT OF TRANSPORT
AIR ACCIDENT INVESTIGATION

PRELIMINARY REPORT

OPERATOR:	Stuart Herd
AIRCRAFT TYPE/ MANUFACTURER:	Cessna T210N/ Cessna Aircraft Corporation
YEAR OF MANUFACTURE:	1981
AIRCRAFT REGISTRATION:	5Y-BME
AIRCRAFT SERIAL NUMBER:	21064239
DATE OF REGISTRATION:	15 June 2011
TYPE OF ENGINE:	Continental IO-550-P2B
DATE OF OCCURRENCE:	02 January 2016
TIME OF OCCURRENCE:	1345
LOCATION OF OCCURRENCE:	Uhuru Gardens 1°19'35"S, 36°48'6"E
TYPE OF FLIGHT:	General aviation
NUMBER OF PERSONS ON BOARD:	Crew - 1; Passengers - 3
INJURIES:	None
NATURE OF DAMAGE:	Substantial
CATEGORY OF OCCURRENCE:	Accident
PILOT FLYING EXPERIENCE:	~280 hours

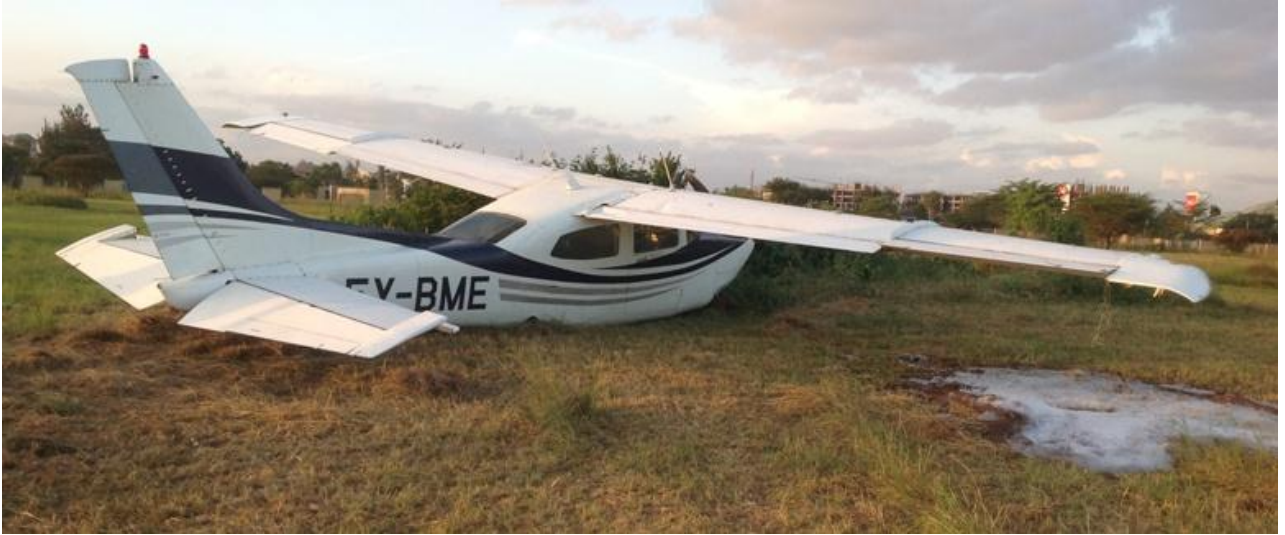
The pilot elected to perform an emergency power out landing in a nearby field. Aircraft had a hard landing with subsequent damage to starboard wingtip, propeller blades and both main and nose landing gears and subsequently came to rest skewed to the right.

All occupants exited the aircraft without any reported injuries. Fuel was observed leaking from the starboard wing fuel tank vent at wing tip trailing edge. The pilot sought assistance from dispatch office at Aeroclub of East Africa and requested the information to be relayed to Wilson Air Traffic Control tower about the occurrence. Fire and rescue services responded shortly thereafter and doused the spilled fuel by foam as a precautionary measure.

Approximately 70 litres of AVGAS was drained off the tanks. The first point of impact was observed to be approximately 30 metres from where the aircraft came to rest.
