**MINISTRY OF TRANSPORT AND INFRASTRUCTURE**  
**STATE DEPARTMENT OF TRANSPORT**  
**AIR ACCIDENT INVESTIGATION**

**PRELIMINARY REPORT**

AIRCRAFT REGISTRATION: 5Y-BSI

DATE OF OCCURRENCE: 27 November 2016

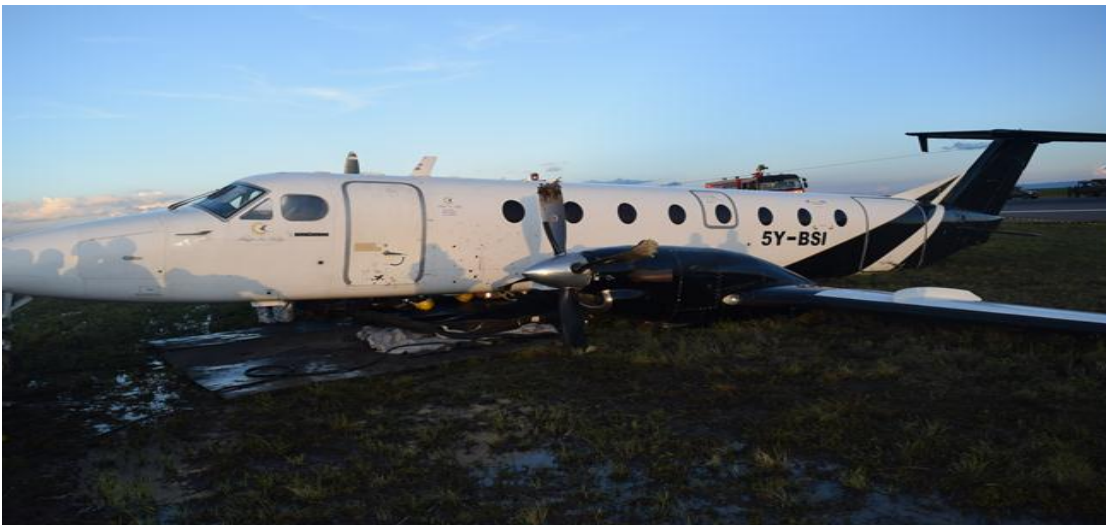
The aircraft was substantially damaged, with visible damages on the left wing, Left engine, left under carriage and the under belly.

*Picture: 5Y-BSI after the accident*
