AIRCRAFT ACCIDENT INVESTIGATION

**PRELIMINARY ACCIDENT REPORT 5Y-CAC
05.06.2018**

**CESSNA CARAVAN 208B
THE ABERDARES RANGE, NJAMBINI**

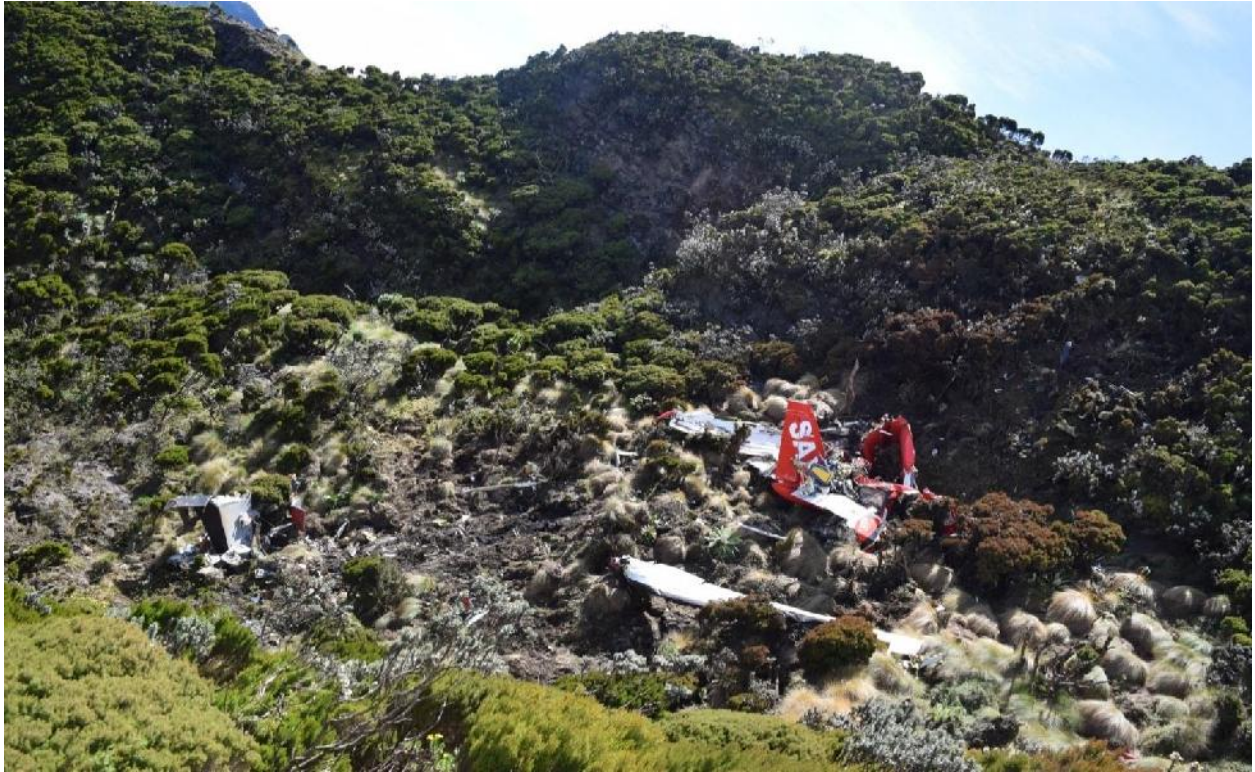
Figure 1: The wreckage of the damaged aircraft

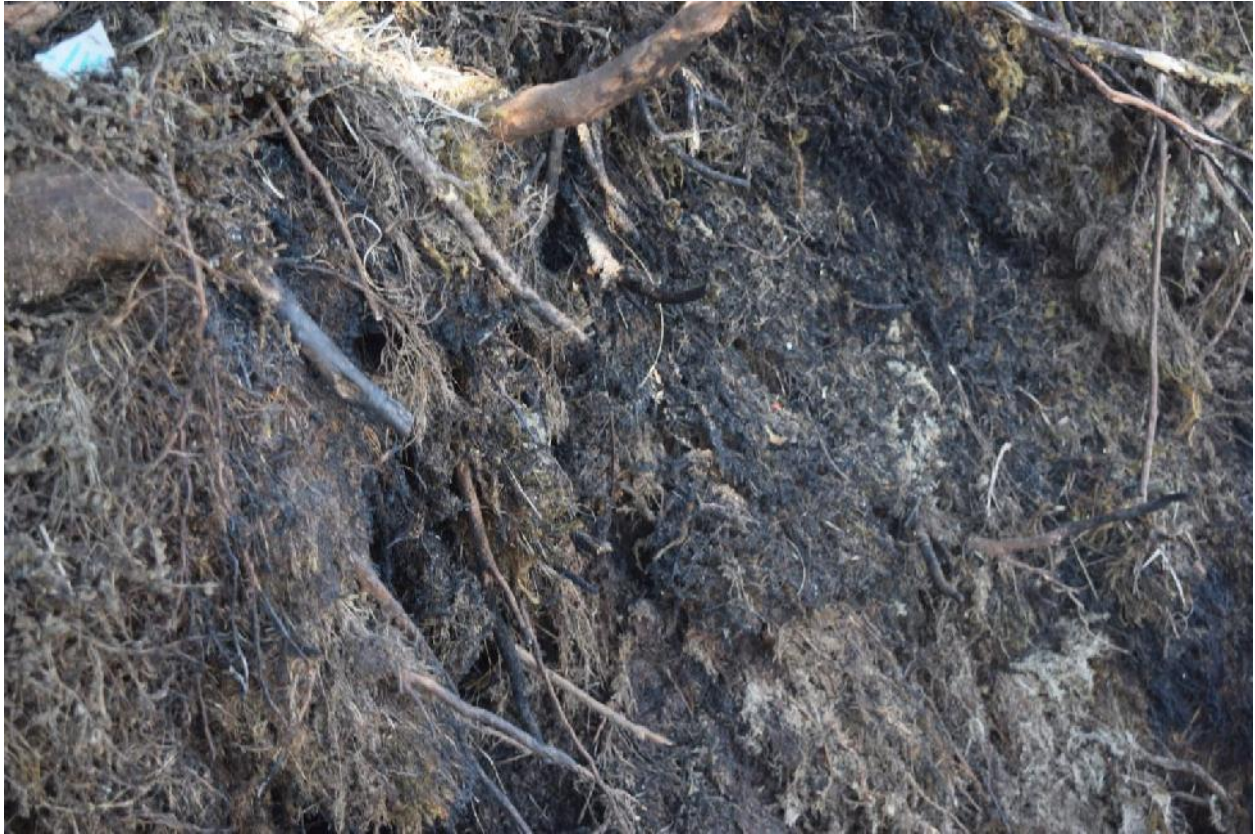
Figure 2: The effect of the fuel spillage from the accident aircraft on the vegetation

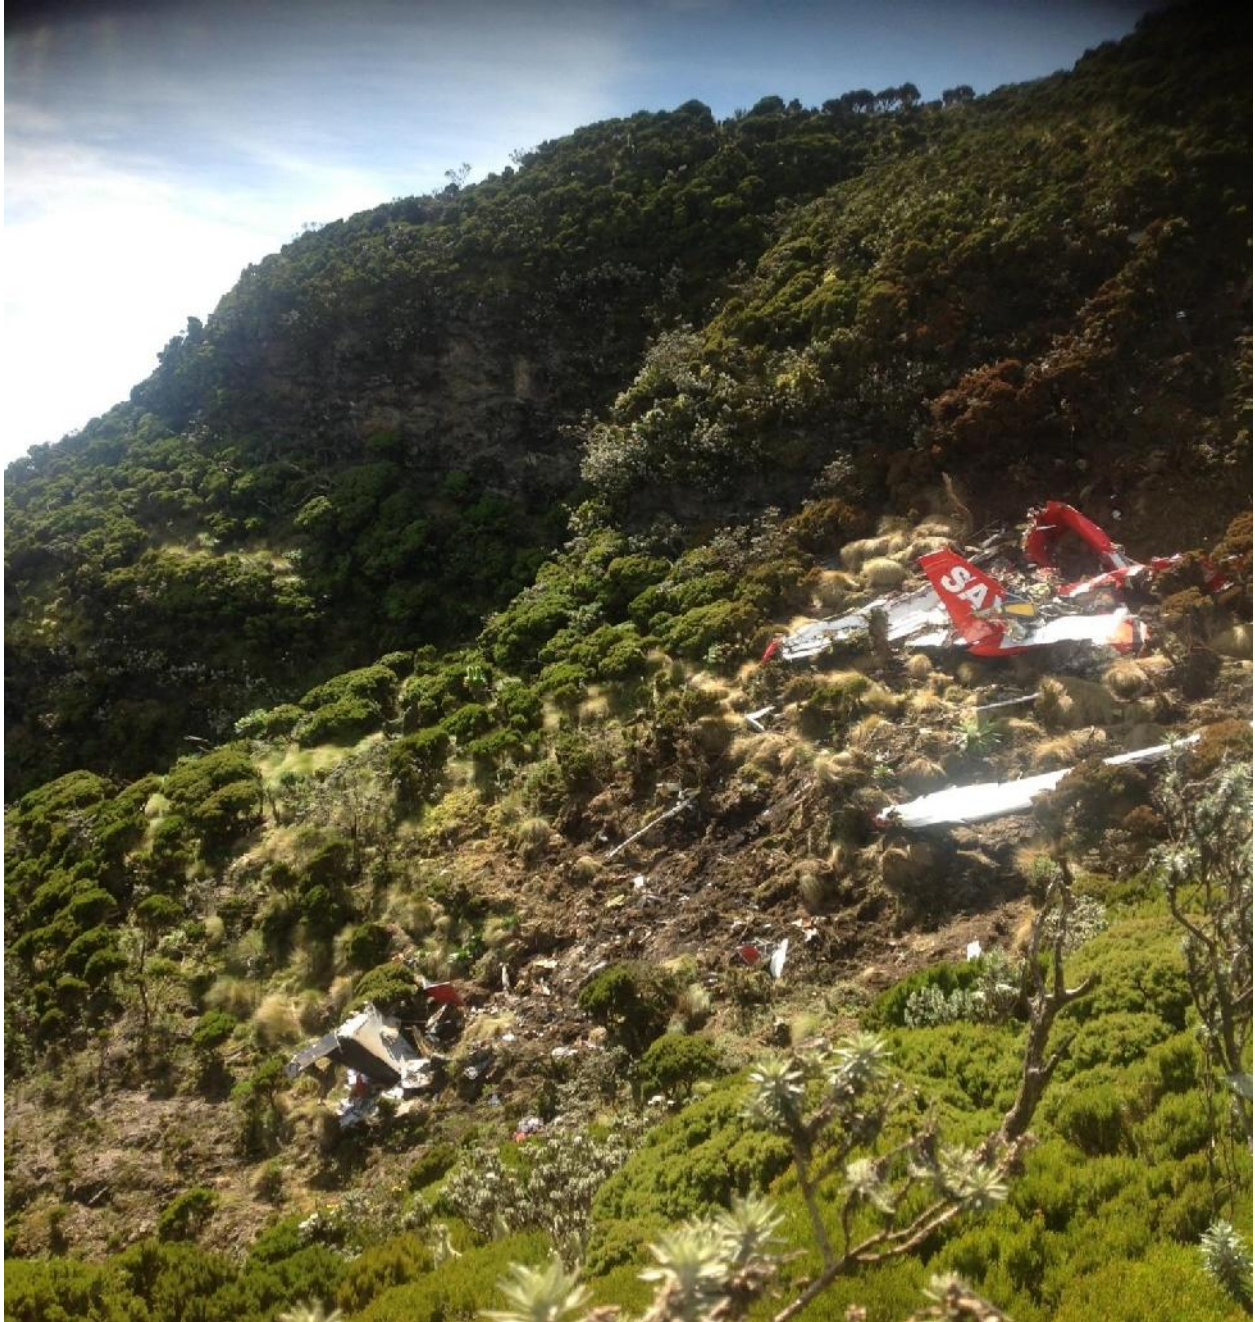
The wreckage was confined within the same area.

Figure 5: The wreckage of the damaged aircraft

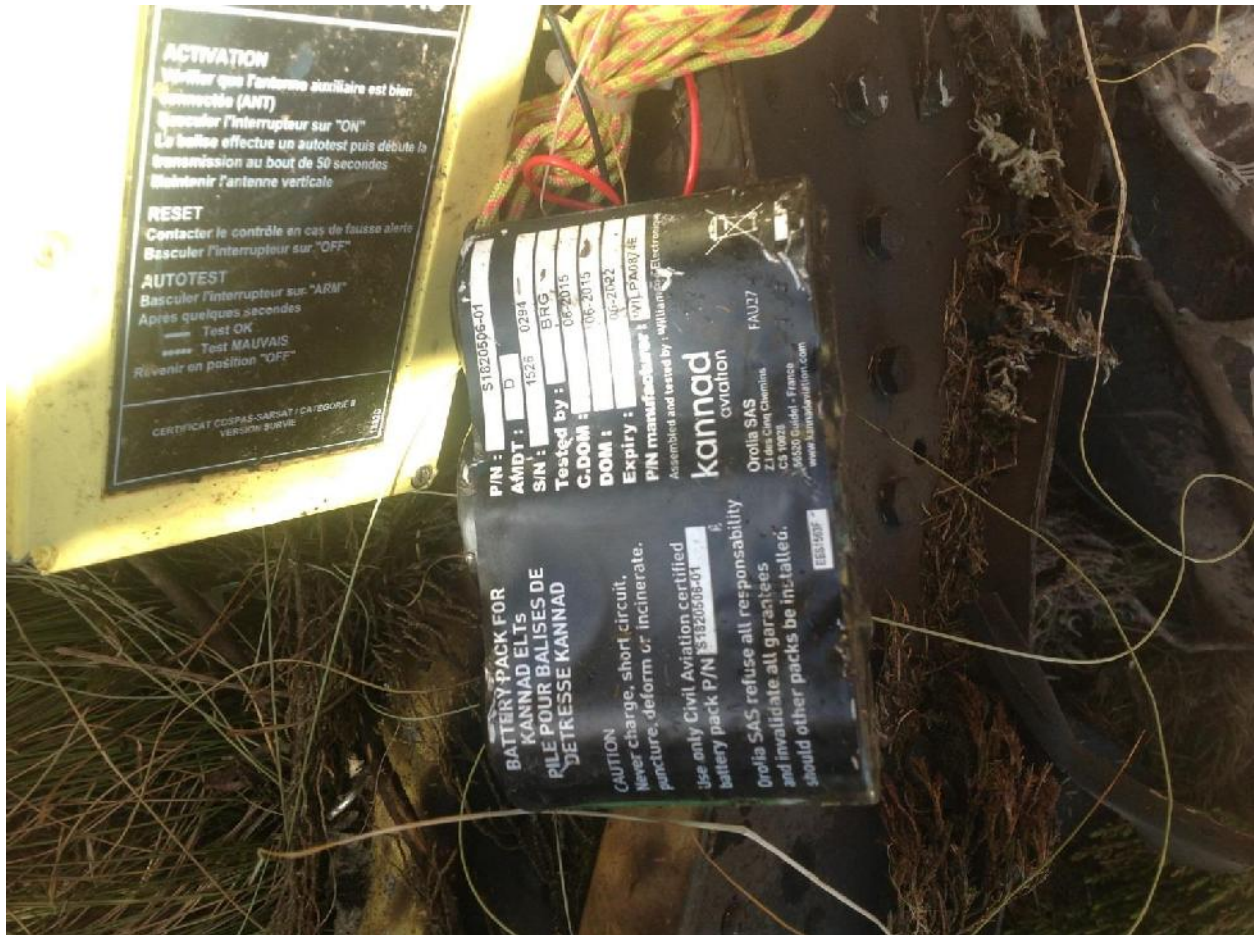
the ELT was noted to be out of its mounting tray having been dislodged and ejected from mounted antenna and the remote cockpit switch. The remote control panel wires were broken near the plug on the ELT. The antenna had broken off by ground contact, and its cable was detached from the assembly. Due to loss of the antenna, no 406 MHz signal was recorded by the search and rescue Coordination Centre (JRCC), nor was a 121.5 MHz signal received by search and rescue aircraft.

Figure 6: The Kannad ELT

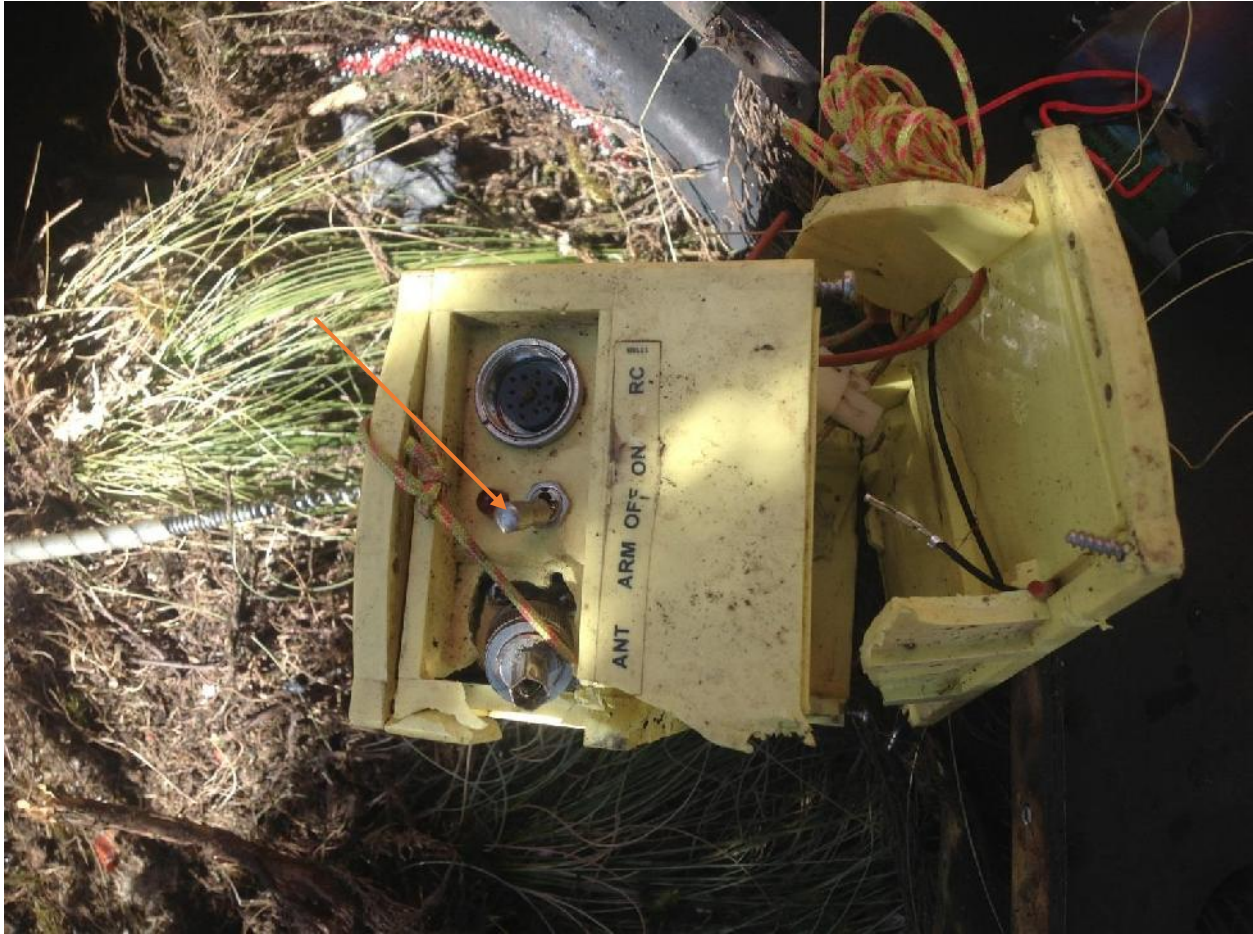
Figure 7: The damaged ELT in armed position

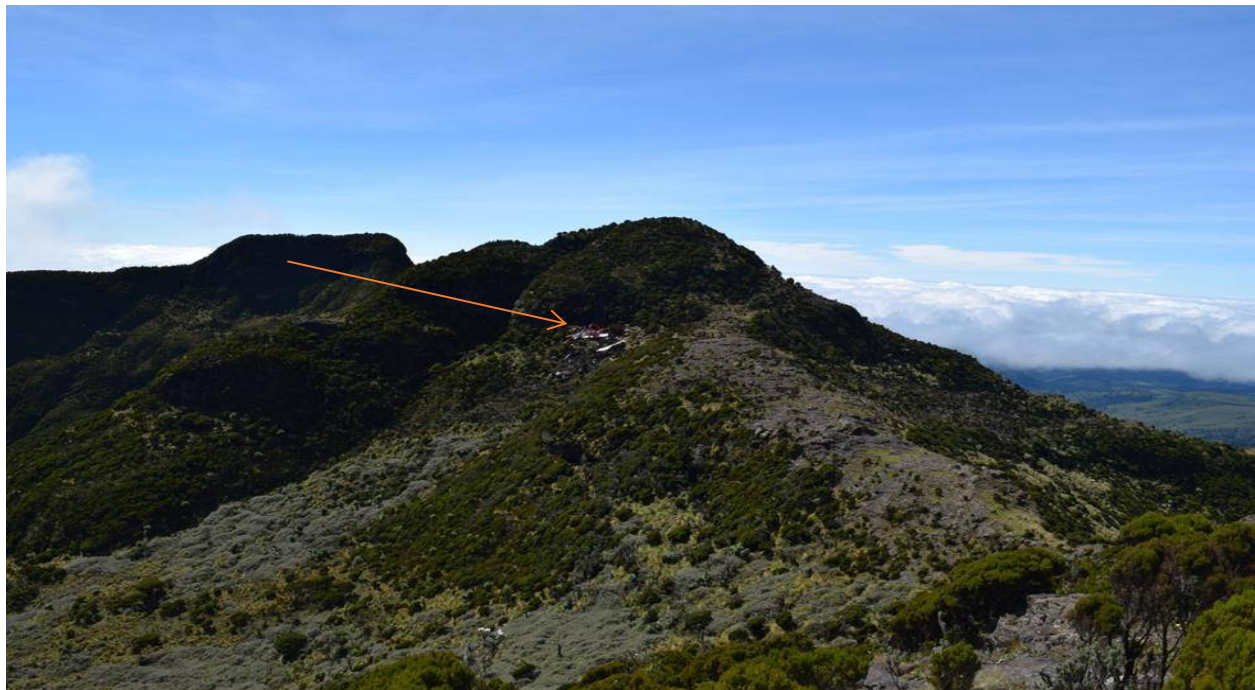
Figure 8: A section of the Aberdare ranges where the accident took place

On the east, the range slopes more gently. The terrain consists of densely covered Bamboo forest with the highest point of the cliff with an elevation of 13,120 feet above mean sea level. The point of impact was at an elevation of 11200 feet asl, 38 feet below the top of the vertical cliff. The cockpit was crushed, and the forward passenger cabin was distorted, with the forward cabin bulkhead mostly dislodged from its attachments. The aircraft seemed to have impacted the obstacle in a straight and level configuration.
