AIR ACCIDENT INVESTIGATION

PRELIMINARY REPORT

OPERATOR:	Kenya Wildlife Service
AIRCRAFT TYPE/ MANUFACTURER:	Husky A-1/ Aviat Aircraft Inc
YEAR OF MANUFACTURE:	1993
AIRCRAFT REGISTRATION:	5Y-KWB
AIRCRAFT SERIAL NUMBER:	1228
DATE OF REGISTRATION:	12 May 1994
NUMBER AND TYPE OF ENGINE:	One Avco Lycoming O-360-C1G
DATE OF OCCURRENCE:	01 September 2016
TIME OF OCCURRENCE:	0530
LOCATION OF OCCURRENCE:	Kanjaro airstrip, Tsavo West National Park, Taita Taveta County
NUMBER OF PERSONS ON BOARD:	One
INJURIES:	None
NATURE OF DAMAGE:	Minor
CATEGORY OF OCCURRENCE:	Incident
PIC FLYING EXPERIENCE:	CPL

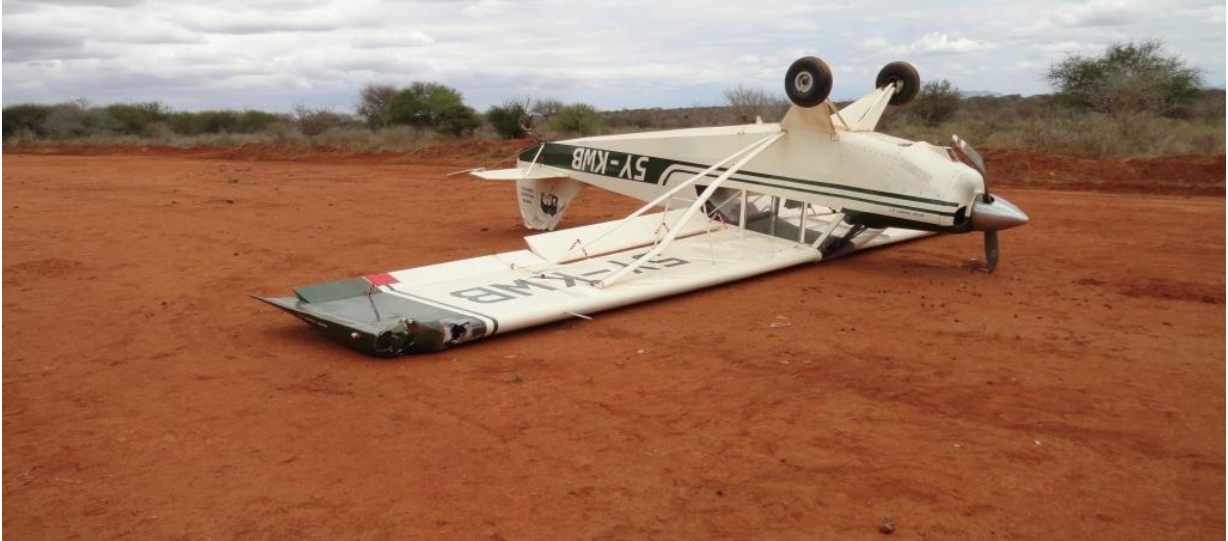
Information received indicated that the aircraft, while on its landing roll, somersaulted and came to rest on the top part of the fuselage with the underbelly facing skyward.

The aircraft had departed from Kamboyo airstrip, also within Tsavo West National Park, at approximately 0345 with the pilot as the sole occupant. He had approximately 200 litres of fuel on board with 5 hours endurance. On approach, the pilot noticed a vehicle approaching the runway. Once he committed to land the vehicle was still approaching, from the left of the runway, a point approximately halfway down the runway. This, according to the pilot, would put it on a collision path with the aircraft once it began its landing roll. Having already touched down and not being sure of the intentions of the vehicle's driver, he elected to brake heavily. At this point he was not sure whether the driver or occupants of the vehicle had seen the approaching aircraft. The vehicle stopped short of the runway, but the aircraft had already been brought to a stop. The pilot stated that he had landed on the main landing gear and the tail wheel had not made contact with the runway surface during his landing roll. Upon the heavy braking during the landing roll, just after the aircraft came to a stop, the tail section started rising and rotated 180 degrees through its nose section and the aircraft eventually came to rest on its roof, the propeller blades having impacted the ground and served as a fulcrum for the subsequent rotation of the aircraft onto its roof. The propeller spinner did not exhibit signs of contact the runway surface.
