**MINISTRY OF TRANSPORT, INFRASTRUCTURE, HOUSING  
AND URBAN DEVELOPMENT**  
**STATE DEPARTMENT OF TRANSPORT**  
**AIR ACCIDENT INVESTIGATION**

**PRELIMINARY REPORT**

OPERATOR:	Two Ten Aviation Services Ltd
AIRCRAFT TYPE/ MANUFACTURER:	Cessna T210N/ Cessna Aircraft Company
YEAR OF MANUFACTURE:	1980
AIRCRAFT REGISTRATION:	5Y-TTA
AIRCRAFT SERIAL NUMBER:	210-64017
DATE OF REGISTRATION:	9 July 2012
NUMBER AND TYPE OF ENGINE:	One Continental TSIO-520-R9B
DATE OF OCCURRENCE:	05 May 2016
TIME OF OCCURRENCE:	0708
LOCATION OF OCCURRENCE:	Wilson Airport, end of runway 14
TYPE OF FLIGHT:	Cash in transit
NUMBER OF PERSONS ON BOARD:	Four (2 crew; 2 passengers)
INJURIES:	None
NATURE OF DAMAGE:	None
CATEGORY OF OCCURRENCE:	Incident

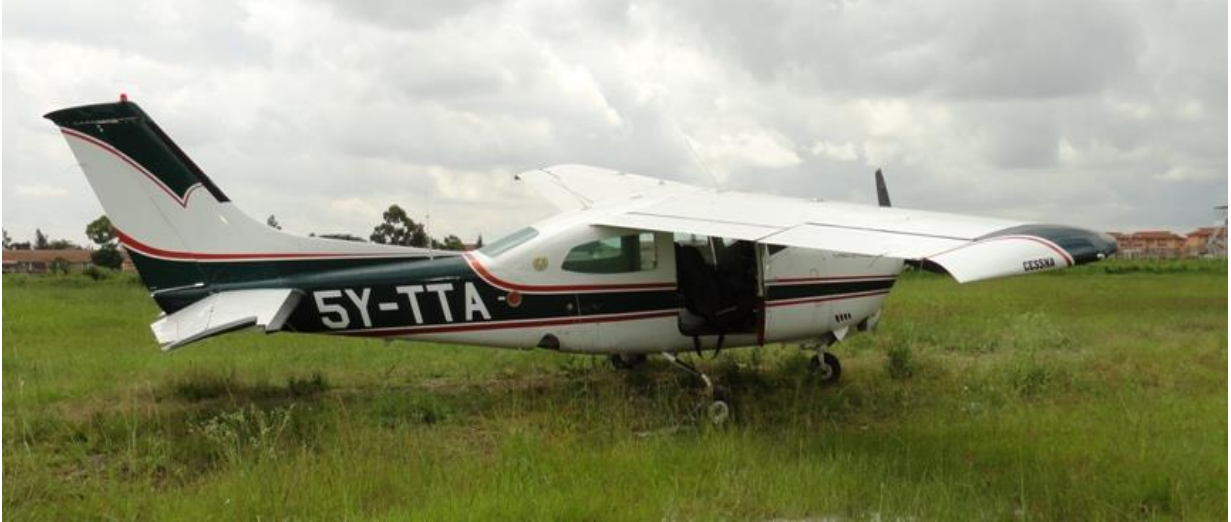
5Y-TTA after the occurrence

On the take-off roll, upon rotation, the Pilot stated that he experienced a partial loss of power and elected to abort the takeoff just after the aircraft was airborne. The aircraft came to a stop on the clearway on the extended centreline of the runway, approximately 40 metres from the end of the tarmac.
