AIR ACCIDENT INVESTIGATION

PRELIMINARY REPORT

OPERATOR:	DAC Aviation Ltd
AIRCRAFT TYPE:	Bombardier De-Havilland DHC8-202
AIRCRAFT MANUFACTURER:	Bombardier De-Havilland of Canada
YEAR OF MANUFACTURE:	1997
AIRCRAFT REGISTRATION:	5Y - WJF
AIRCRAFT SERIAL NUMBER:	456
DATE OF REGISTRATION:	18 November, 2011
TYPE OF ENGINE:	Two Pratt & Whitney 123 series
DATE OF OCCURRENCE:	06 December, 2016
TIME OF OCCURRENCE:	0725
LOCATION OF OCCURRENCE:	Wilson Airstrip (1°19'07.75"S, 36°48'52.41" E)
TYPE OF FLIGHT:	Commercial
NUMBER OF PERSONS ON BOARD:	Crew – 2
INJURIES:	None
NATURE OF DAMAGE:	Minor
CLASS OF OCCURRENCE:	Minor Incident
PIC'S FLYING EXPERIENCE:	Total 12,400 Hrs. (4,500 on type)

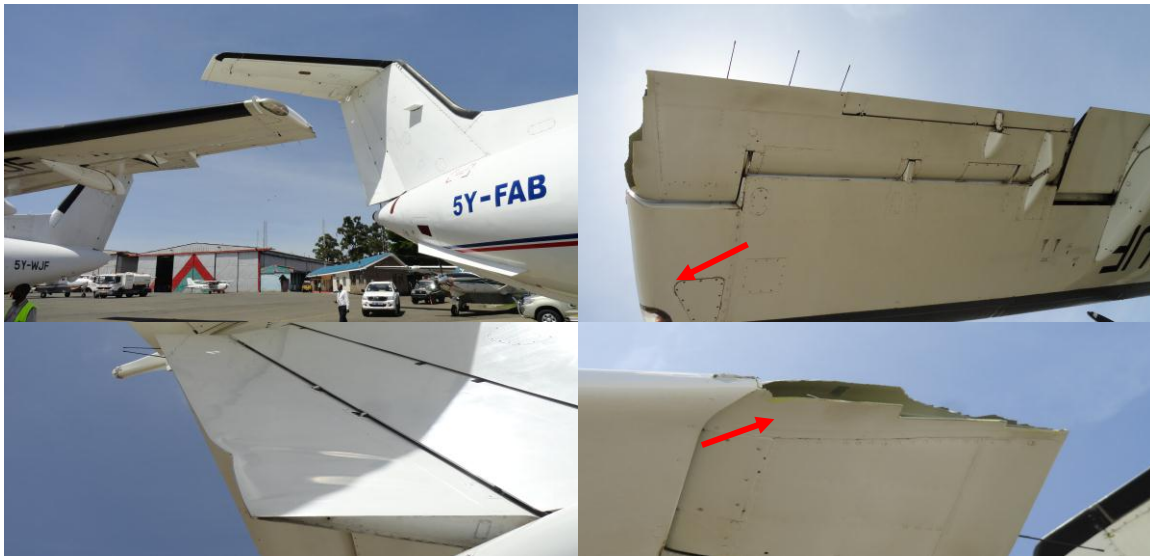
Photo: Damage after occurrence

5Y-WJF left wing tip at the aileron section clipped the lower trailing edge section of the rudder of 5Y-FAB, as it was being marshalled out of the parking bay. The lower section of the trailing edge of the rudder was bent and wrinkled to right and at about one foot long. The left aileron of 5Y-WJF was slightly damaged and a segment measuring about 50cm x 15cm was detached.
