AIR ACCIDENT INVESTIGATION

PRELIMINARY REPORT

OPERATOR:	Standard Aviation
AIRCRAFT TYPE/MANUFACTURER:	Cessna 172K
YEAR OF MANUFACTURE:	1969
AIRCRAFT REGISTRATION:	5Y-YYA
AIRCRAFT SERIAL NUMBER:	172-58798
DATE OF REGISTRATION:	09/08/2012
TYPE OF ENGINE:	ONE-LYCOMIMG 0-360-A4M
DATE OF OCCURRENCE:	07/03/2018
TIME OF OCCURRENCE:	0926
LOCATION OF OCCURRENCE:	Wilson
TYPE OF FLIGHT:	Training
NUMBER OF PERSONS ON BOARD:	1
INJURIES:	Nil
NATURE OF DAMAGE:	Slightly damaged
CATEGORY OF OCCURRENCE:	Incident
PIC'S FLYING EXPERIENCE:	120 hours

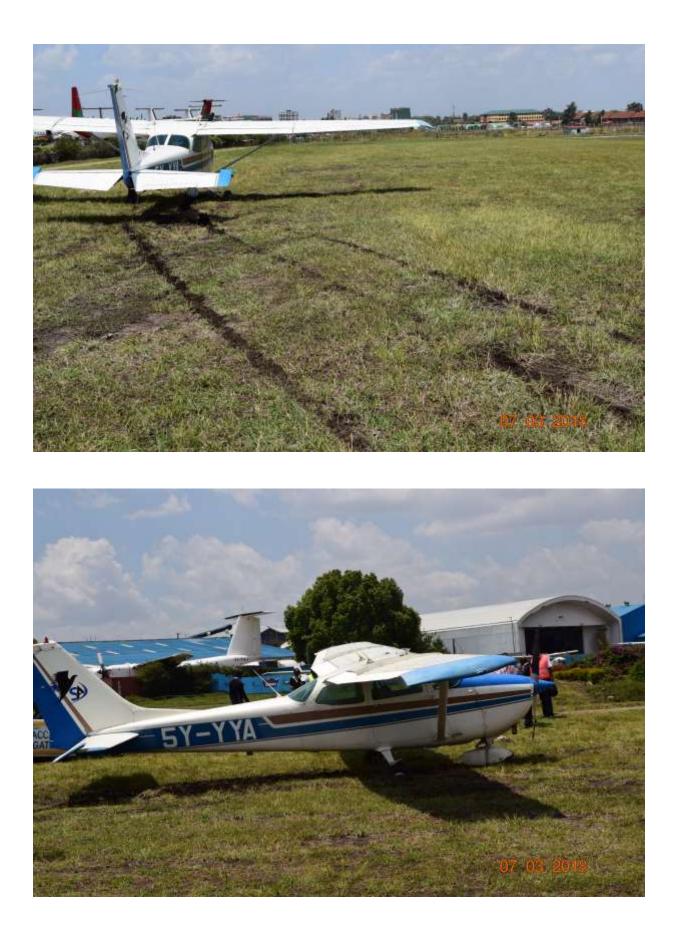
After response, it was reported that the student pilot training on flight circuits at Wilson airport experienced runway excursion after landing on runway 07. The student pilot narrated that after 45 minutes of flight training on circuits she decided to make a stop landing after experiencing heavy traffic within the circuit at Wilson. On landing, on her first touchdown, she experienced "**aircraft balloon**" but on second touchdown she managed to take control of the aircraft as she maintained the landing process. The student pilot lost control of the aircraft while trying to exit the runway via taxiway C. The aircraft veered to the left of the runway at the intersection of taxiway C and runway 07 and ploughed into the runway strip for a distance of 73m before it stopped.

Even though the propeller struck the ground and both the nose wheel and landing gear dug into the mud, there was no any other visible damage except slight bend on the right wing.
