MINISTRY OF TRANSPORT AND INFRASTRUCTURE
STATE DEPARTMENT OF TRANSPORT
AIR ACCIDENT INVESTIGATION

PRELIMINARY REPORT

OPERATOR/OWNER : Standards Aviation Limited
AIRCRAFT TYPE/ MANUFACTURER : Beech 76 Duchess/Hawker Beechcraft Corporation
YEAR OF MANUFACTURE : 1978
AIRCRAFT REGISTRATION : 5Y-YYL
AIRCRAFT SERIAL NUMBER : ME-33
DATE OF REGISTRATION : 10 April 2015
NUMBER AND TYPE OF ENGINE : Two Lycoming LO-360-AIG6D (STBD) and O-360-AIG6D (PORT)
DATE OF OCCURRENCE : 01 February 2016
TIME OF OCCURRENCE : 1423 hours
LOCATION OF OCCURRENCE : Runway 14 of Wilson Airport (1°19'14"S, 36°45'58"E)
TYPE OF FLIGHT : Training
NUMBER OF PERSONS ON BOARD : Two
INJURIES : None
NATURE OF DAMAGE : Nose section structural damage and prop strikes
CATEGORY OF OCCURRENCE : Serious incident
INSTRUCTOR'S FLYING EXPERIENCE : 2003 hours

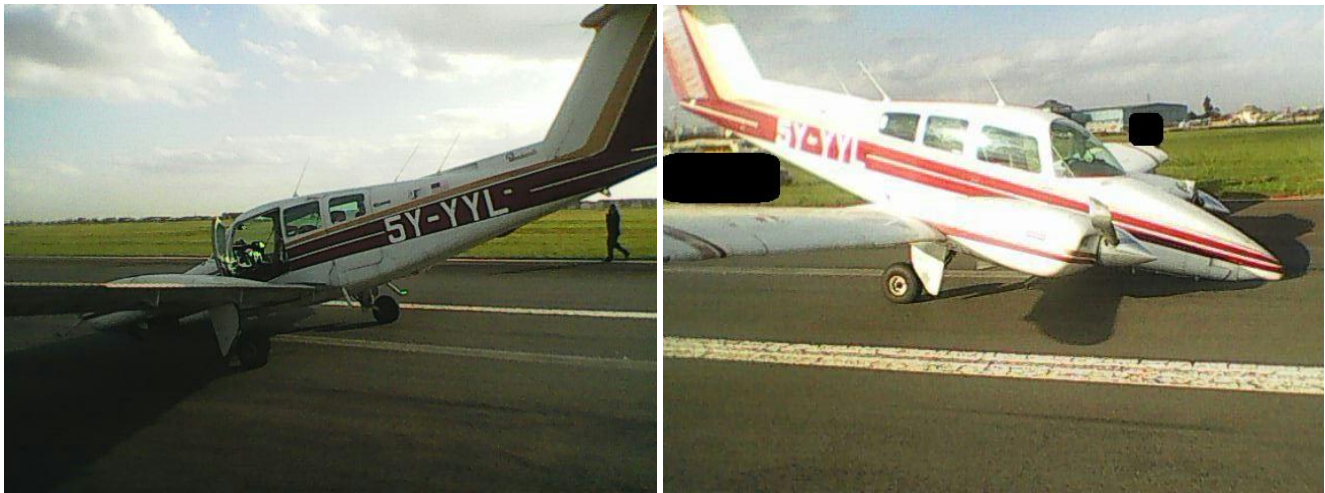
There were no reported injuries as a result of this occurrence. However, the aircraft sustained damage on the nose cone, nose gear doors, and lower skin of the nose section, nose gear retraction rod, radar antenna, windshield, propeller assembly and engines.
