AIRCRAFT ACCIDENT INVESTIGATION

REPORT OF THE SERIOUS INCIDENT INVOLVING

DHC8-300

REGISTRATION 5Y-BWG

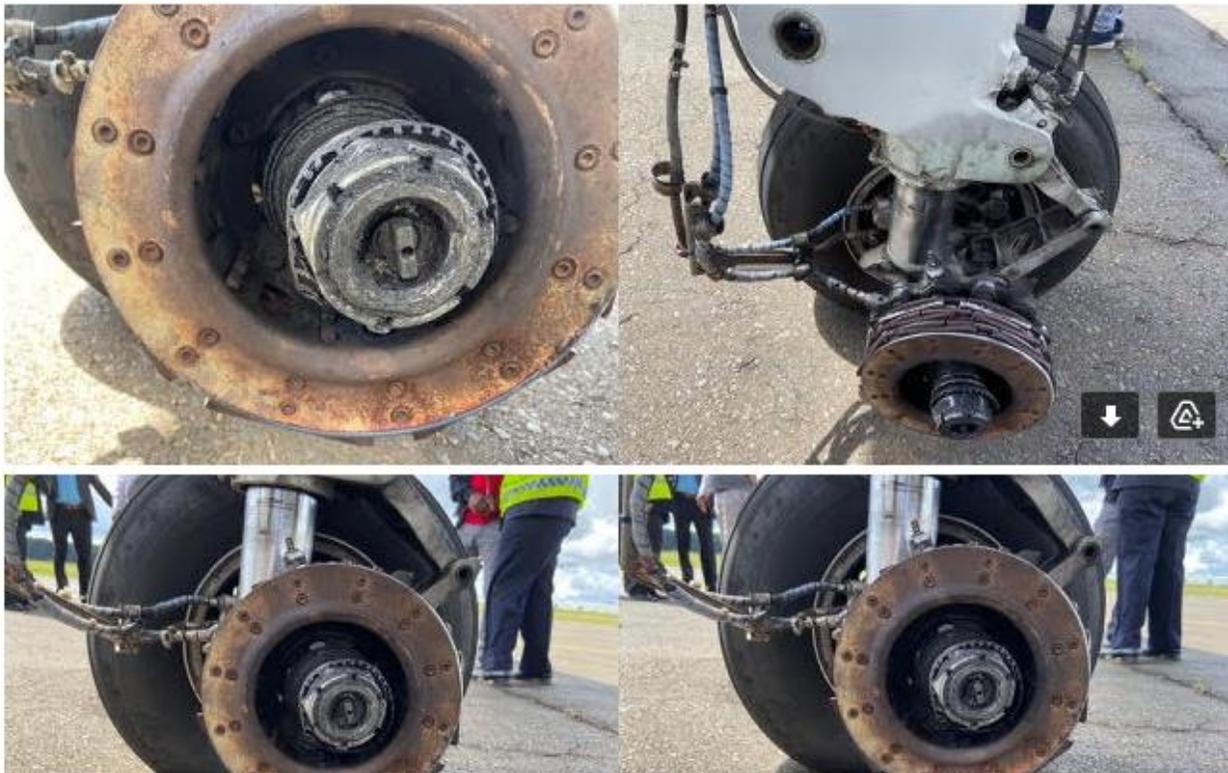
Apart from no.3 wheel assembly there was no damage to aircraft

Figure 1; Photograph showing number 3 wheel assembly

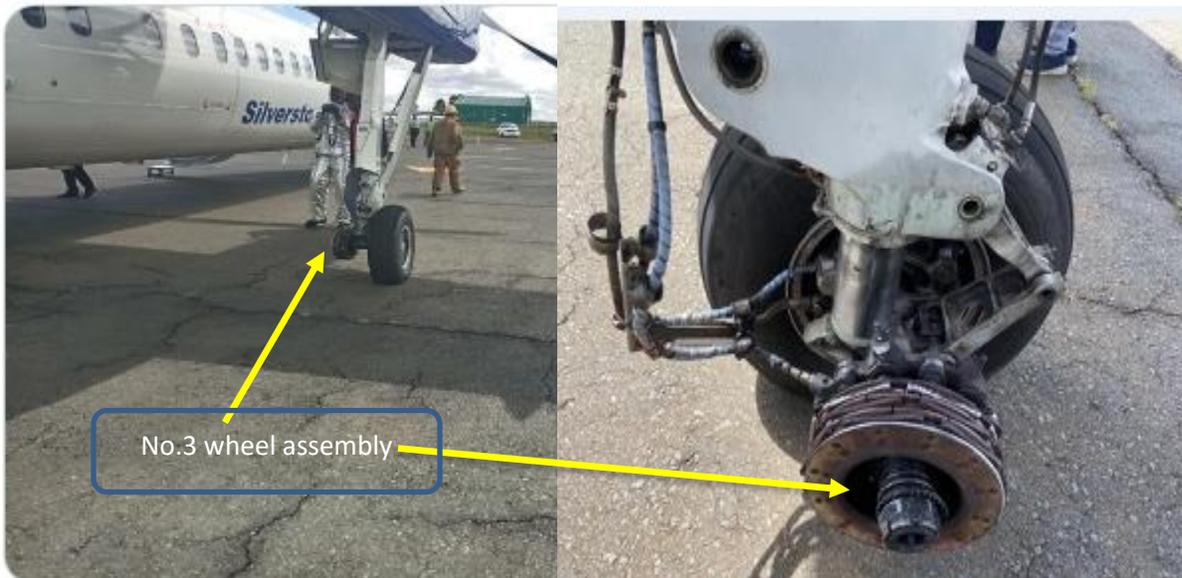
Figure 2: Photograph showing the aircraft and the number 3 wheel assembly

The number 3 wheel on the main landing gear detached from the axle and fell to the ground. The cone of the tapered rolling bearings was recovered on the axle with the rolling elements and ball

cage missing. The aircraft remained generally intact except the no. 3 wheel and parts of the assembly that was missing.

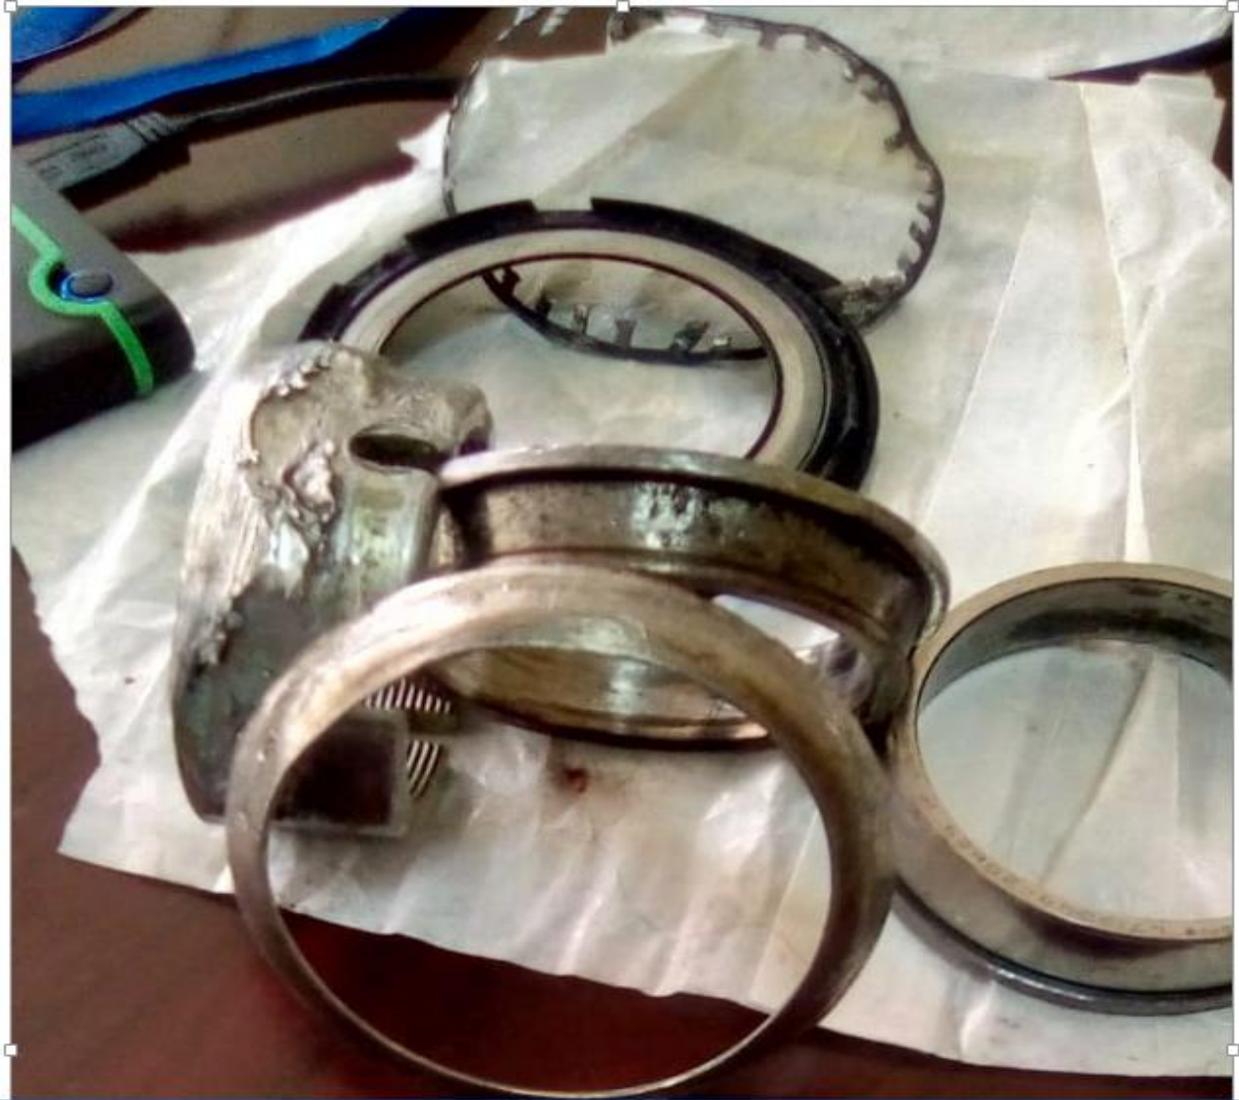
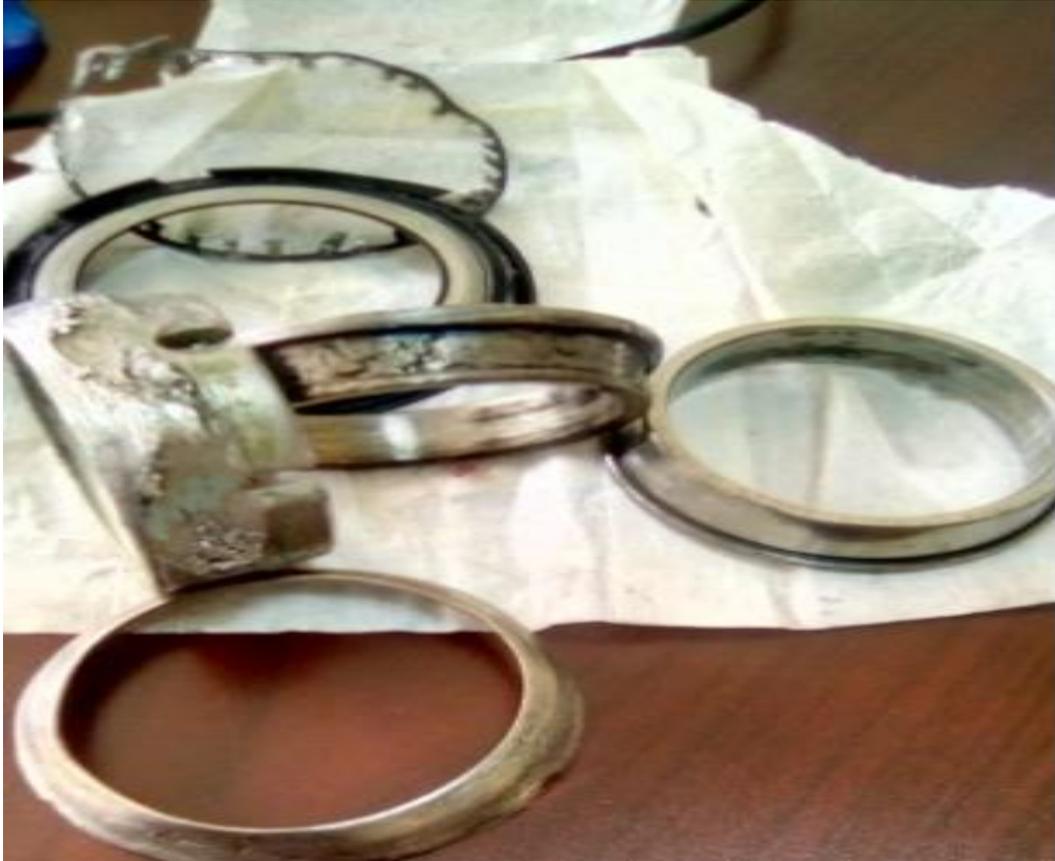
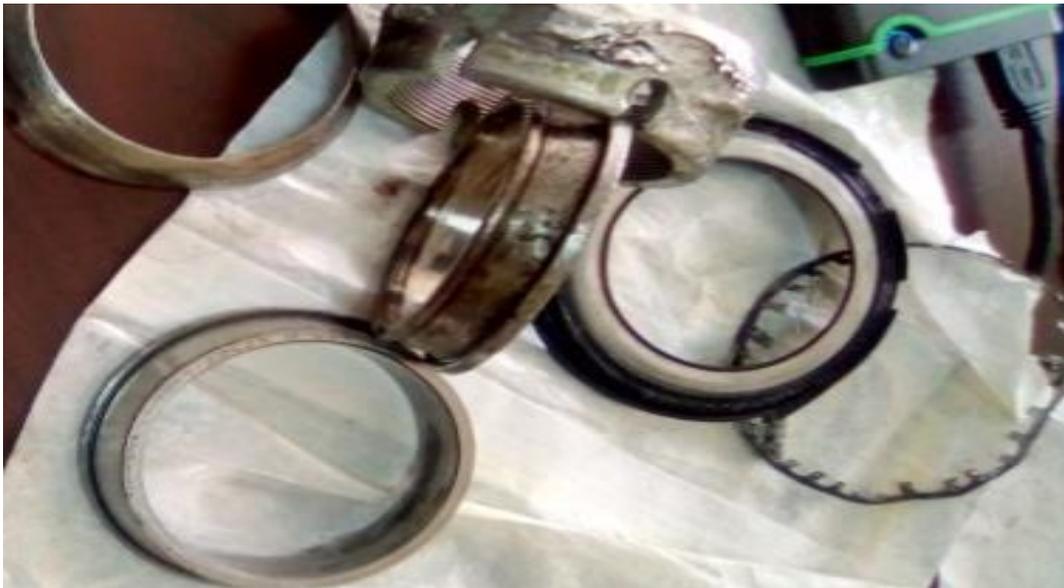
Initial inspection of the assembly found remains of the two bearings on the landing gear axle, the brake assembly was also still attached, and the axle nut and the attaching bolts were also still attached to the axle. What was missing was the wheel assembly and its wheel cup.

Figure 3: Photograph showing cone bearings on number 3 wheel assembly

The probable cause of the serious incident was likely failure of one or both bearing on the number three-wheel assembly.

4.1. Silverstone review its safety management systems on aircraft maintenance

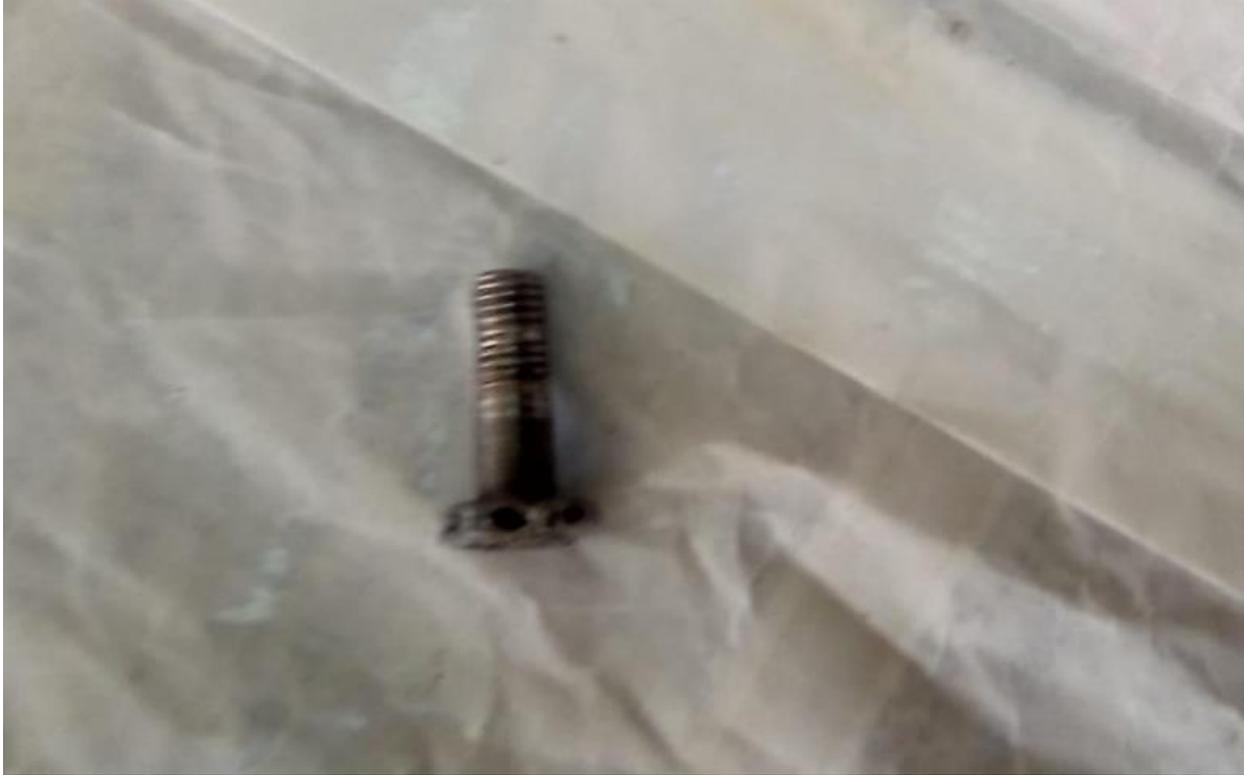
Figure 4: Photograph showing axle nut on number 3 wheel assembly.

The investigation obtained the bearing components which were presented to Collins Aerospace Engineering, the landings system manufacturer for analysis. After examination of the components, they deduced that the axle nut was not manufactured by Collins and were unable to analyze it and concluded that there was nothing to learn from it. Secondly, since the investigation had not
