AIRCRAFT ACCIDENT INVESTIGATION DEPARTMENT

INVESTIGATION REPORT 09/2021

**REPORT ON THE ACCIDENT TO THE ROBINSON R44
HELICOPTER, 5Y-MEP ON 17.10.2020**

AT ELDAMAT-MELILI, NAROK COUNTY

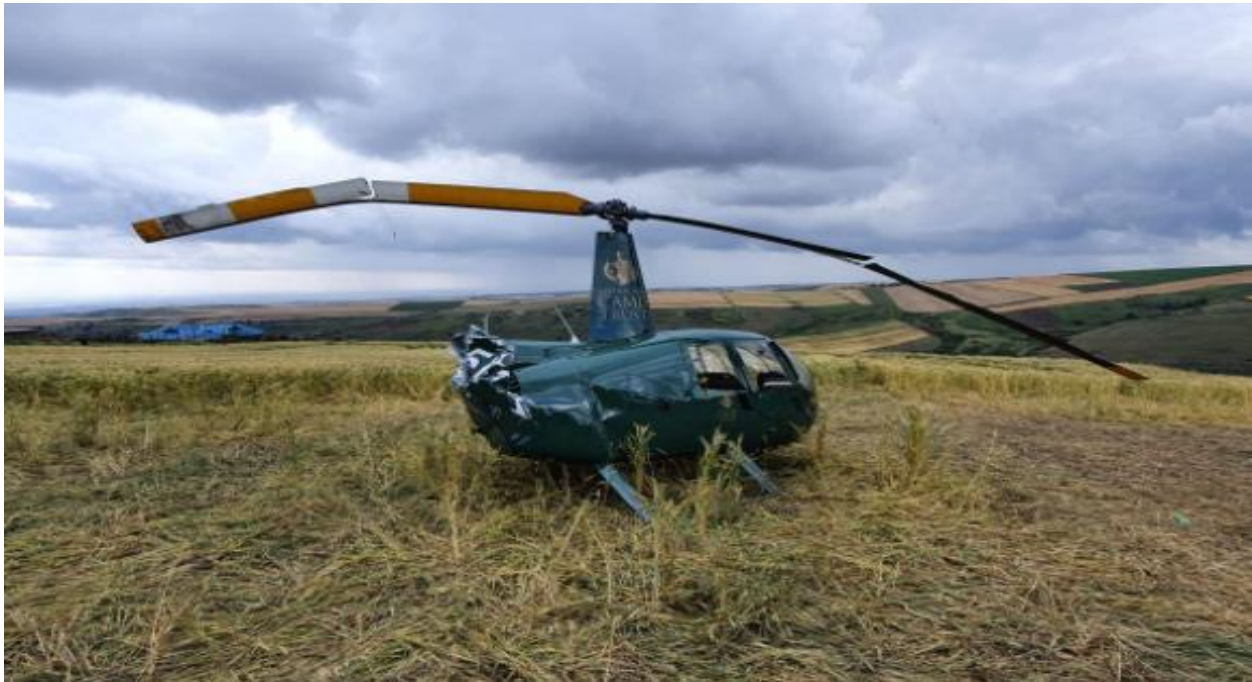
The helicopter was substantially damaged.

Figure 2: The wreckage of the helicopter

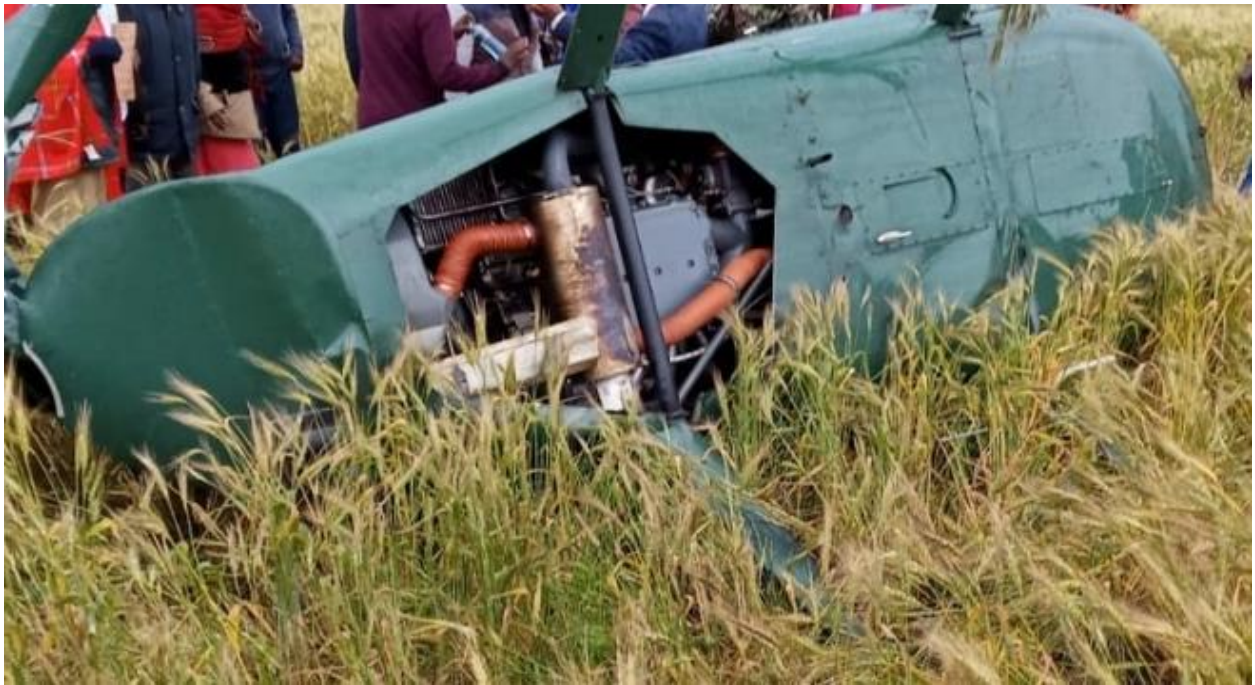
The main wreckage, consisting of the fuselage, transmission, cockpit, most of the right skid tube, a portion of the left skid tube, and the majority of both main rotor blades, came to rest within a perimeter of 20metres.

Figure 5: Helicopter Wreckage

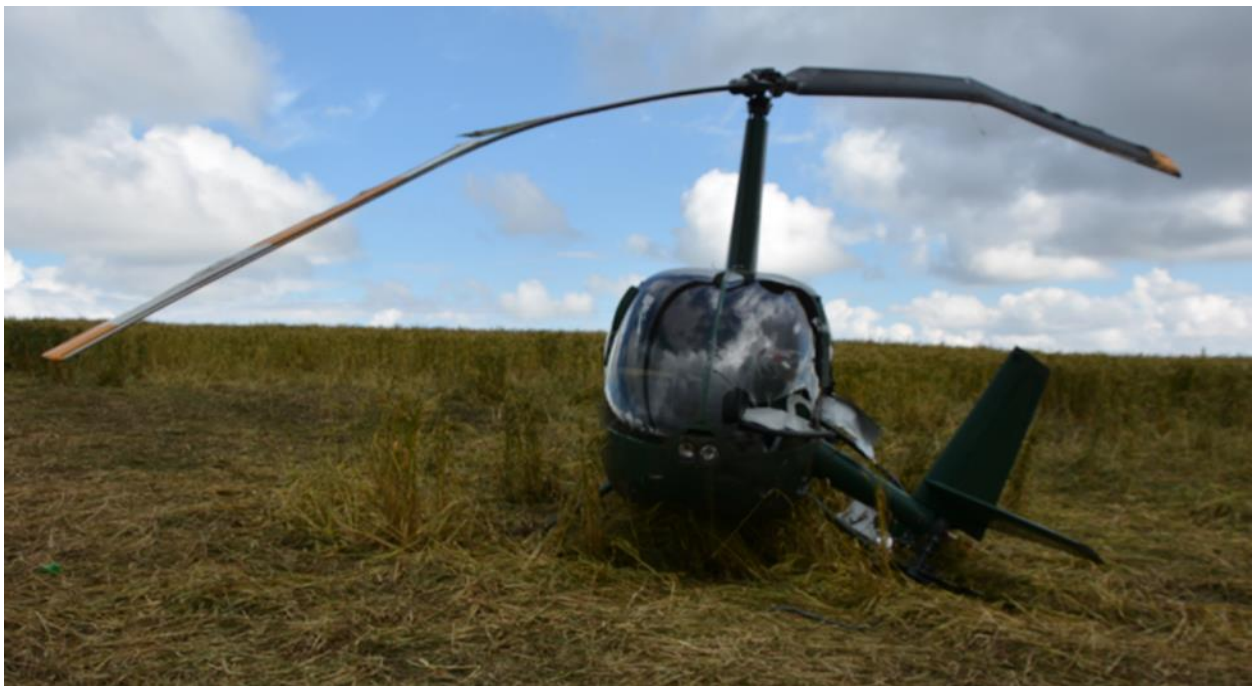
Damage to the helicopter as a result of the impact was as follows (see Figure 6,7,8,9 and 10).

- (a) The left skid was substantially damaged.
- (b) The main rotor blades remained attached to the helicopter but were significantly bent and twisted.
- (c) Both blades of the tail rotor were intact although detached from the tail boom.
- (d) The tail boom was severely fractured and detached from the main wreckage.
- (e) The main rotor blades remained attached to the helicopter but were significantly bent and twisted.
- (f) The perspex canopy was extensively damaged.

Figure 6: Helicopter Wreckage after it was tilted with the detached tail rotor on the side.

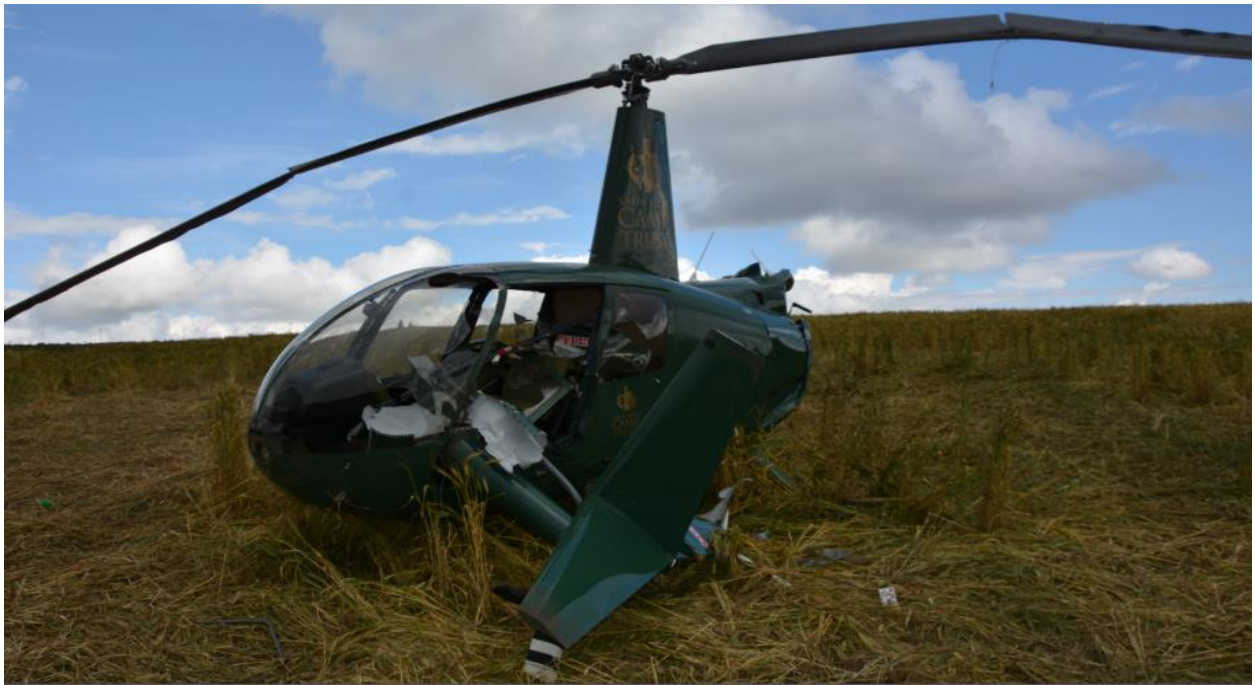
Figure 7: The side view of wreckage after it was tilted.

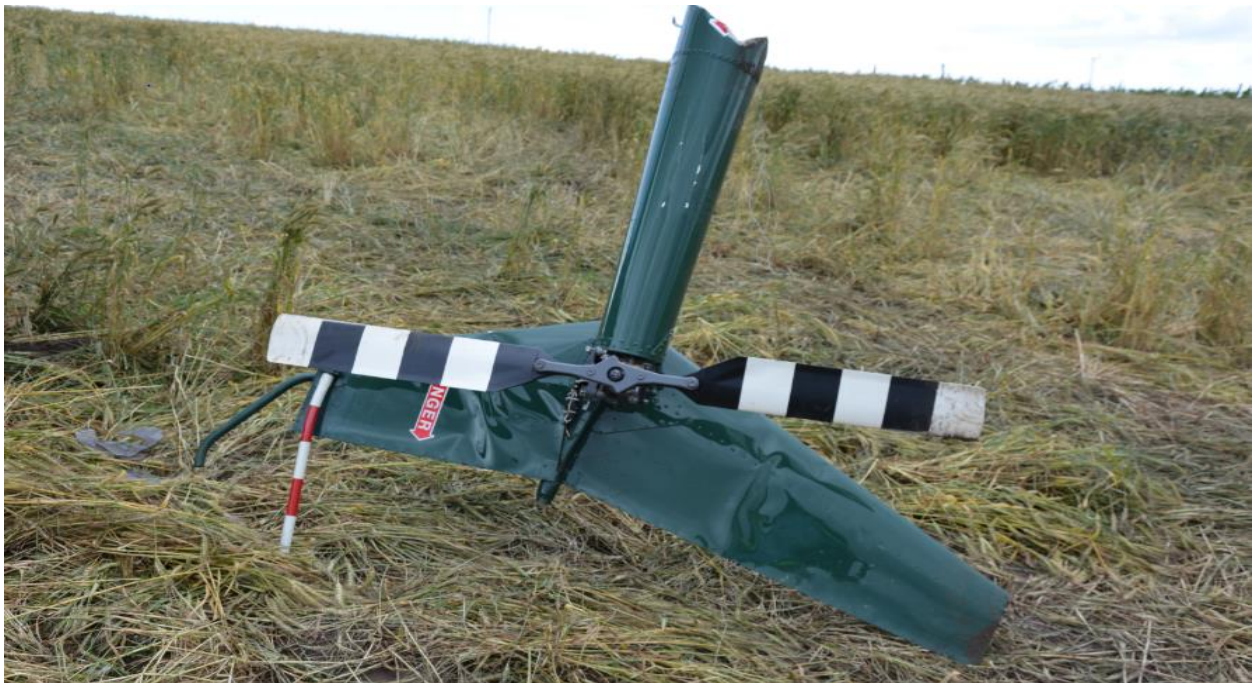
The helicopter eventually came to rest on its left side after the nose tipped over with the tail boom section detached from the main body. The tail boom was severely fractured, locally twisted, and bent to the starboard near the damper bearing of the tail rotor drive shaft. The left skid was substantially damaged. The main rotor blades remained attached to the helicopter but were significantly bent and twisted. Both blades of the tail rotor were severed.

Figure 8: Damaged tail rotor assembly

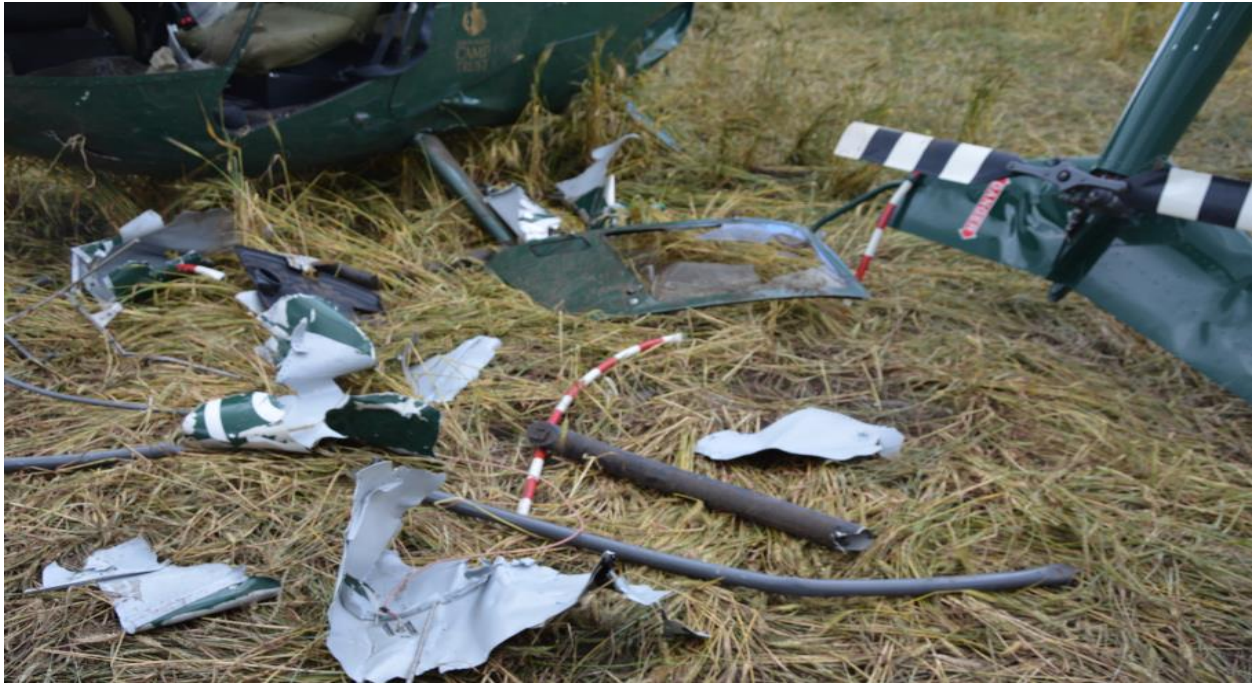
Figure 9: Helicopter damaged components

Deformation of the left-hand lower frame of the fuselage. Because the left-hand lower frame of the fuselage is attached to the skids, it is considered highly probable that the upward force applied to the skid during the touchdown caused compressive deformation in the frame.
