AIRCRAFT ACCIDENT INVESTIGATION DEPARTMENT

INVESTIGATION REPORT 05/03/22

**INVESTIGATION REPORT OF A SERIOUS INCIDENT INVOLVING
A CESSNA C-152N AIRCRAFT REGISTRATION 5Y-BWM ON 07
MARCH 2022 AT NYARIBO AIRSTRIP, NYERI COUNTY**

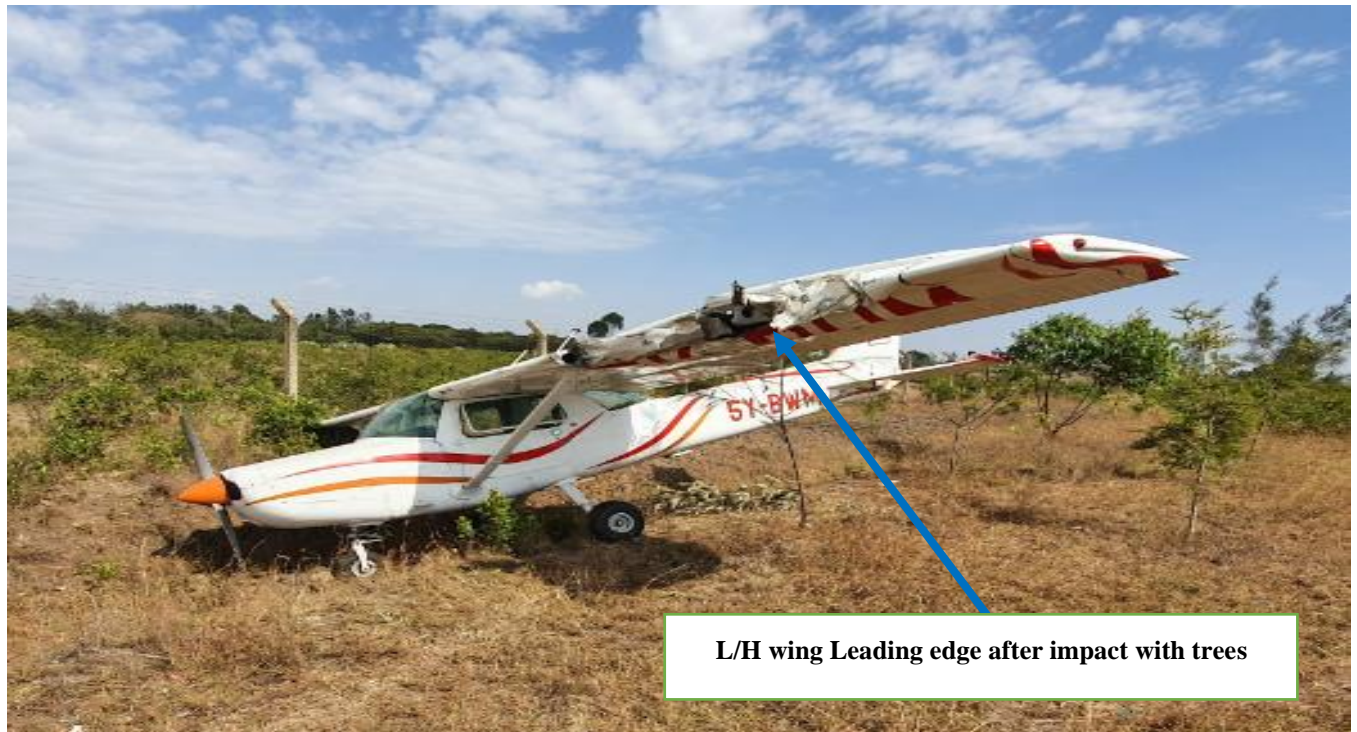
Figure 1: The aircraft in a grassy area within the confines of the Aerodrome

The aircraft sustained damage along the outer length of the left-hand wing leading edge, the tip of the right-wing and the propeller blades.

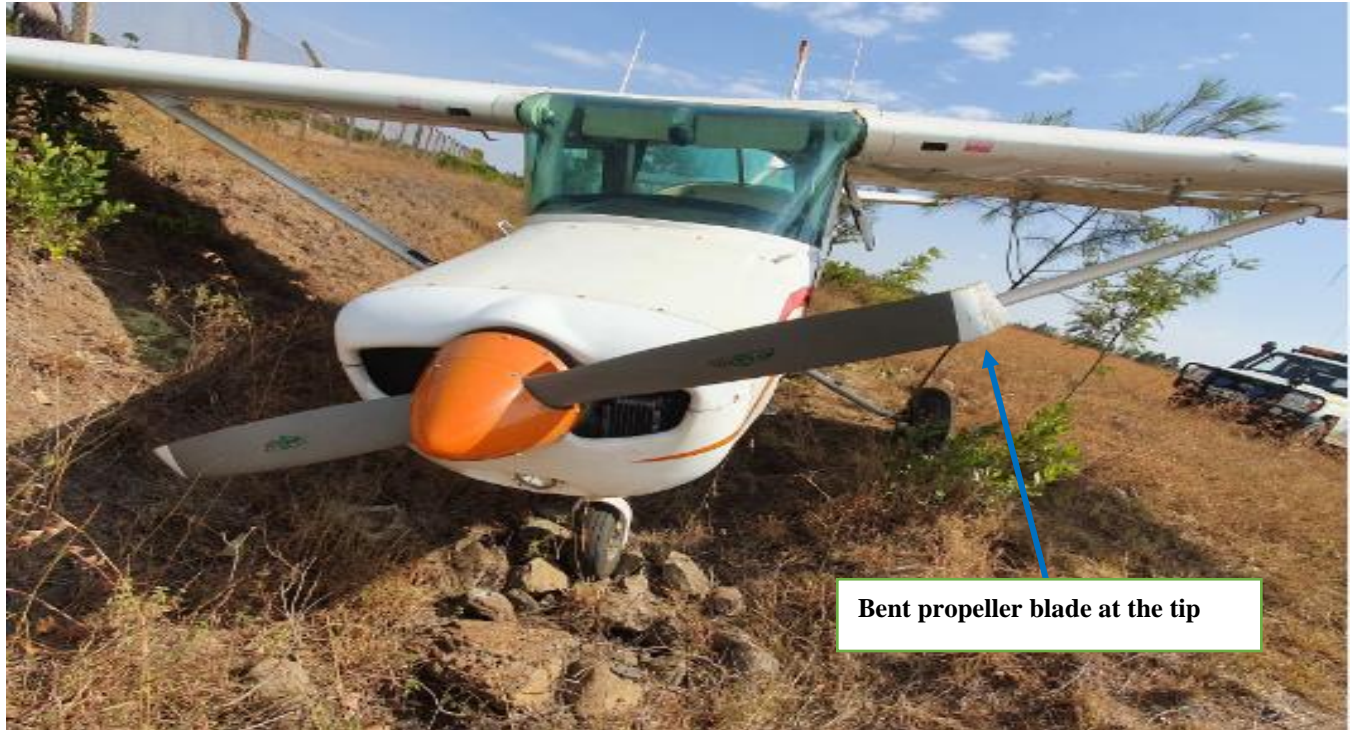
The aircraft came to a final stop about 29 meters to the left of the runway. It was largely intact. The right-wing came into contact with the ground at its tip damaging it within that area while the left-wing struck trees damaging the leading edge along its outer length and the propeller blades struck the ground at the tips.

Figure 4: The front section of the aircraft after the final stop

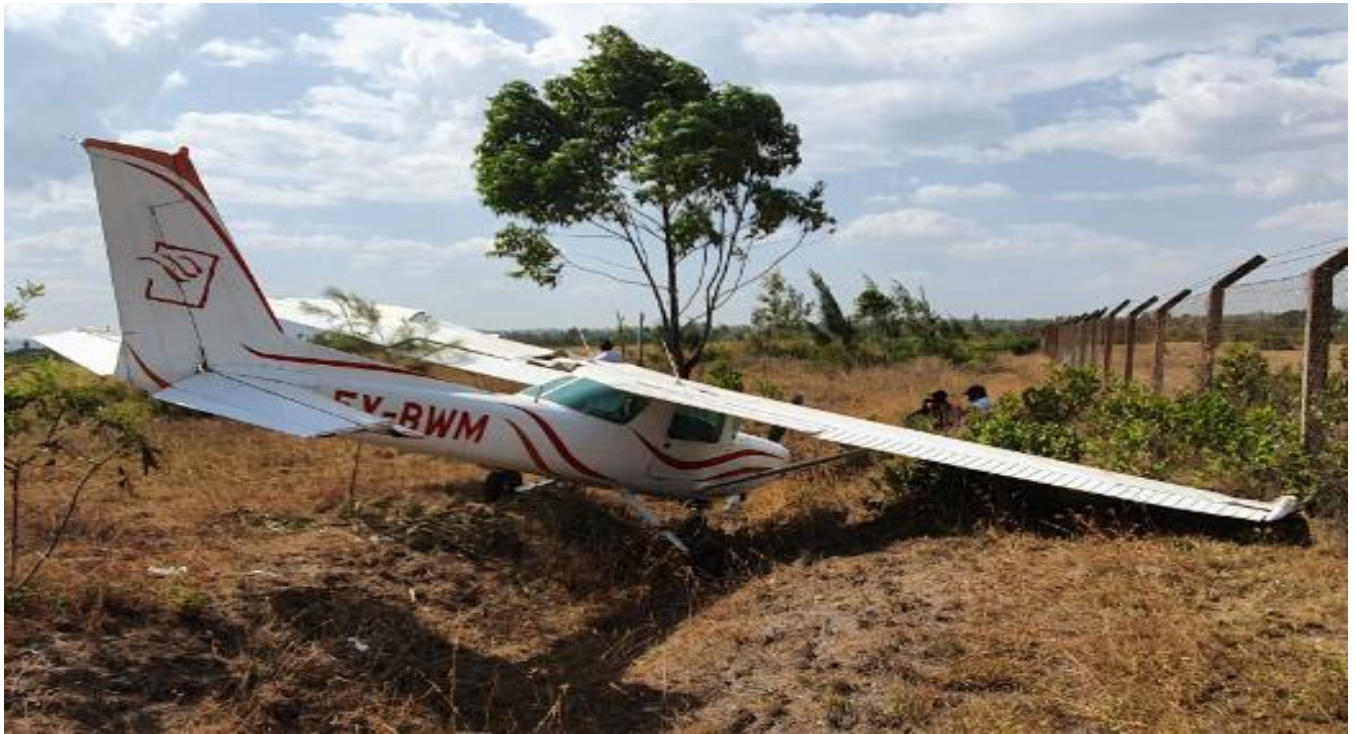
Figure 5: The occurrence aircraft viewed from the rear.

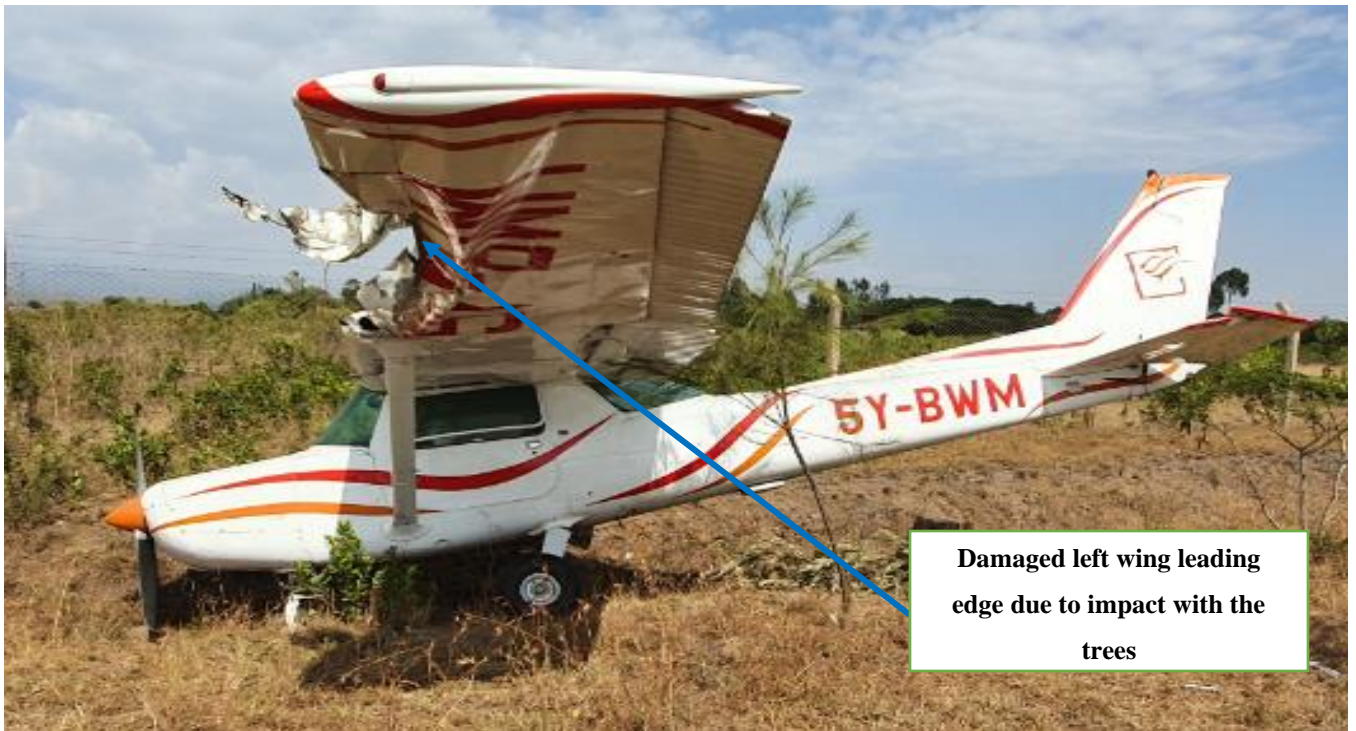
Damaged left wing leading edge due to impact with the trees

Figure 6: The damage to the left-wing

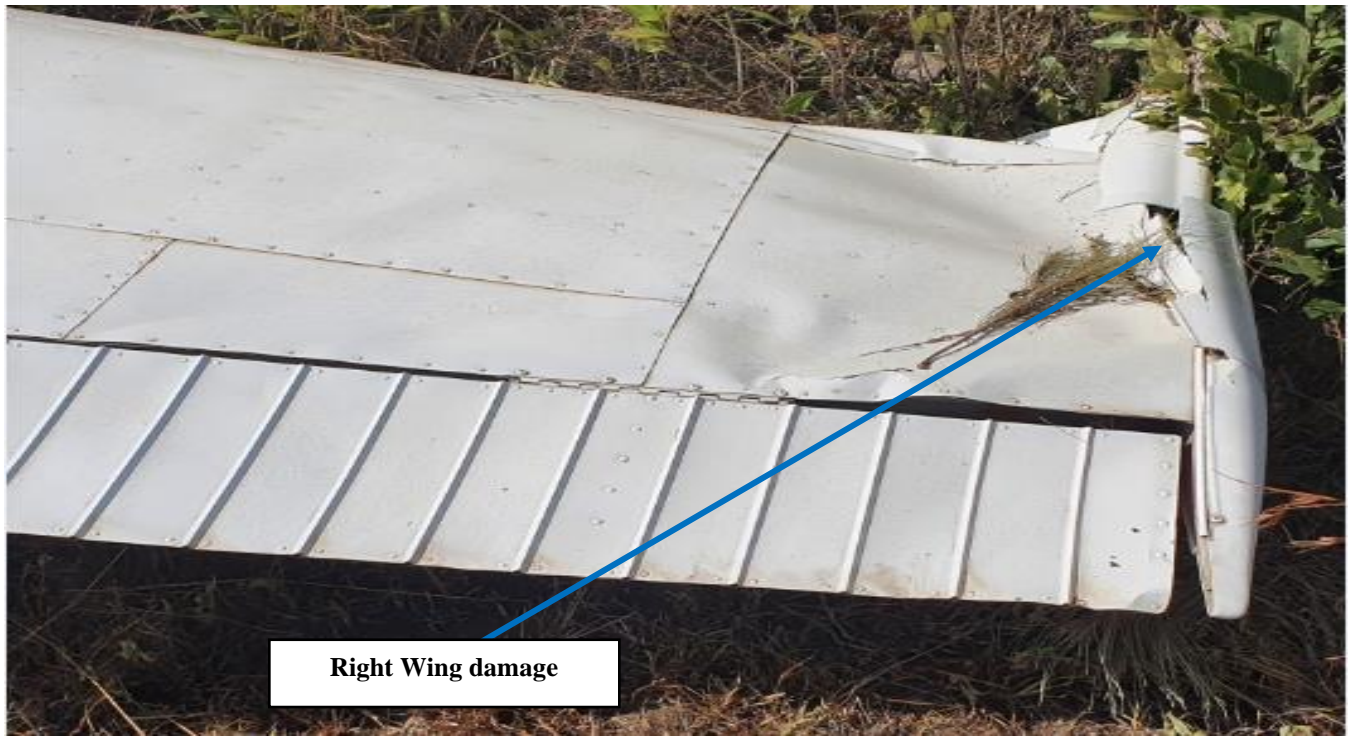
Figure 7: Right-wing outboard damage.

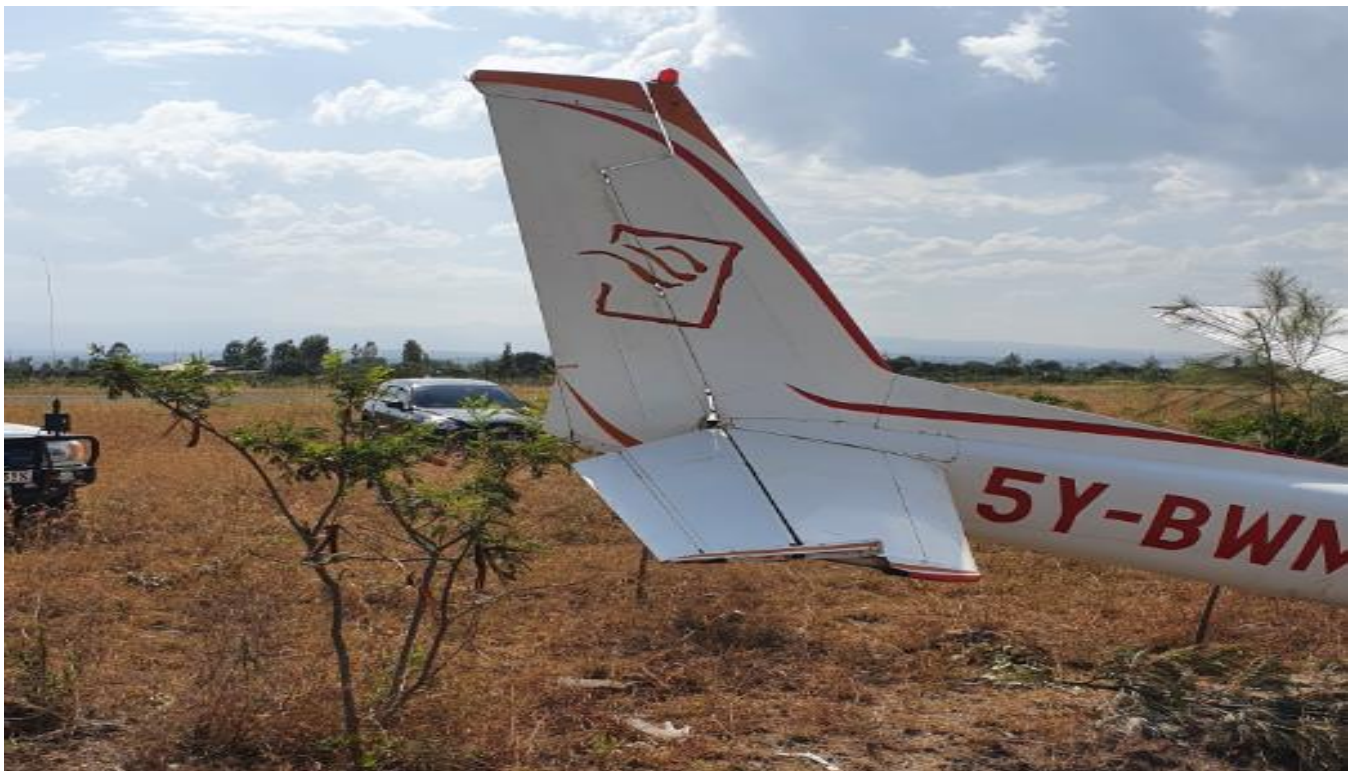
Figure 8: The Empennage section after the Incident
