MINISTRY OF ROADS AND TRANSPORT  
STATE DEPARTMENT FOR TRANSPORT  
**AIRCRAFT ACCIDENT INVESTIGATION DEPARTMENT**

INVESTIGATION REPORT No. **01/01/2021**

INVESTIGATION REPORT OF AN OCCURRENCE INVOLVING AN  
CESSNA 172M, REGISTRATION 5Y-NNJ ON 03 JANUARY 2021  
AT WILSON AIRPORT IN NAIROBI

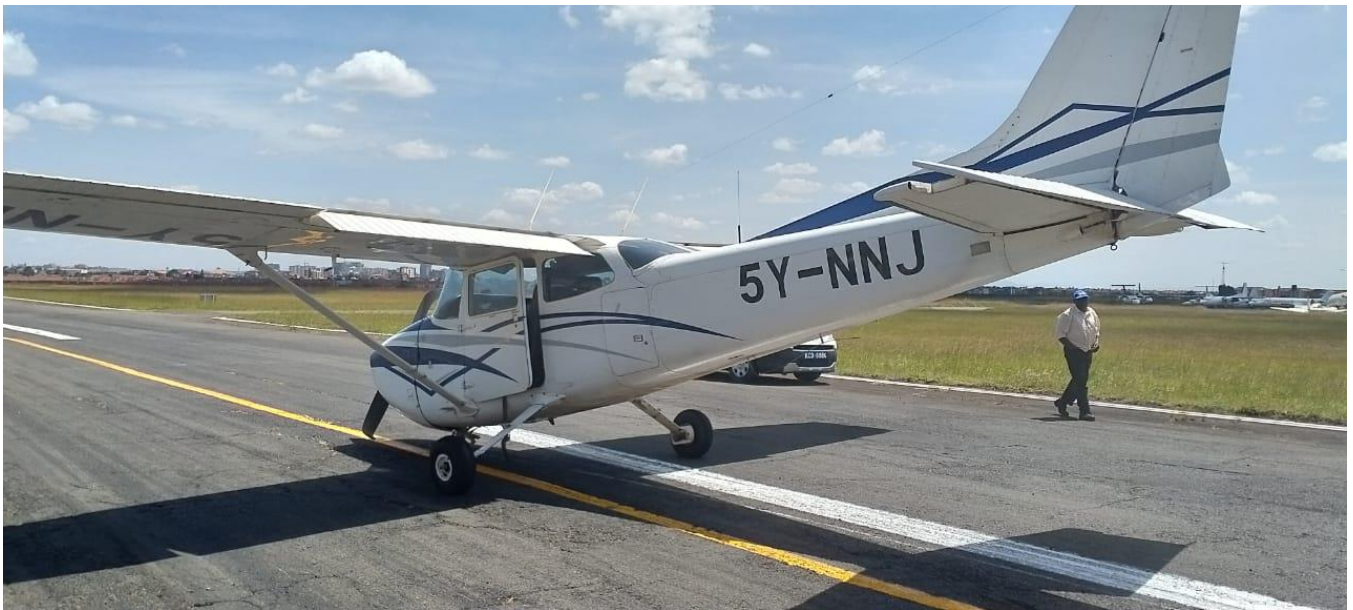
**FIGURE No. 1** – A photo of the aircraft in a nose down position on Runway 07.

3.1.12 The aircraft stopped on the runway in a nose down position.

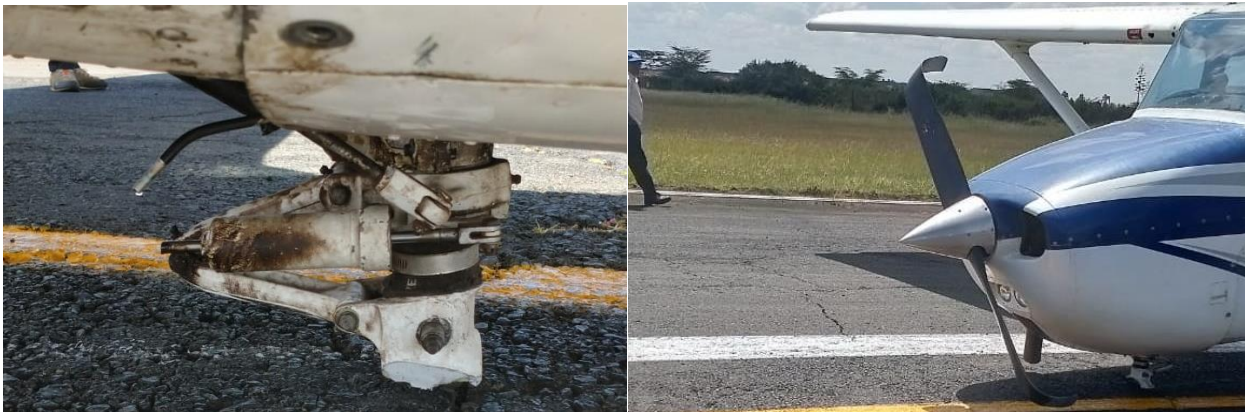
The nose wheel assembly and wheel fork were found detached from the nose landing gear. There was grinding damage on the broken nose gear strut. Both propeller blades exhibited impact damage and the blade tips were bent rearwards. The engine remained intact and secured to the aircraft structure.

*FIGURE No. 2 and 3 – Photos depicting extent of damage to the propeller and nose landing gear wheel.*

The ground marks were consistent with the damage to the aircraft. The first slash mark was located near the runway centerline marking. Slash marks were consistent with the propeller striking the runway surface. From examination of the propeller blades, the backward bending indicated forward aircraft speed, whereas bending of more than one blade indicated that the engine was still running at the time of impact.

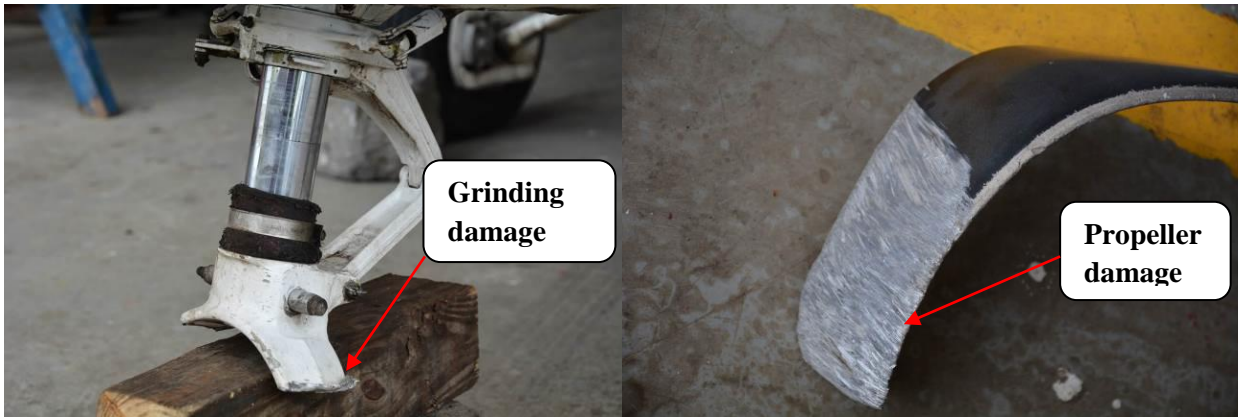
*FIGURE No. 4 and 5 – Photo depicting damage of nose landing gear and propeller.*

Inspection of the fracture surfaces of the nose wheel fork were consistent. There was no pre-existing failure, and the fracture of the nose wheel fork was due to overload. Examination of the detached nose wheel assembly revealed a cut exhibited on the nose tire and a rubber transfer mark on the nose wheel assembly. The cut and transfer mark indicated that the aircraft had experienced a hard nose landing, in which the tire was compressed and/or folded over and made contact with the nose wheel assembly.

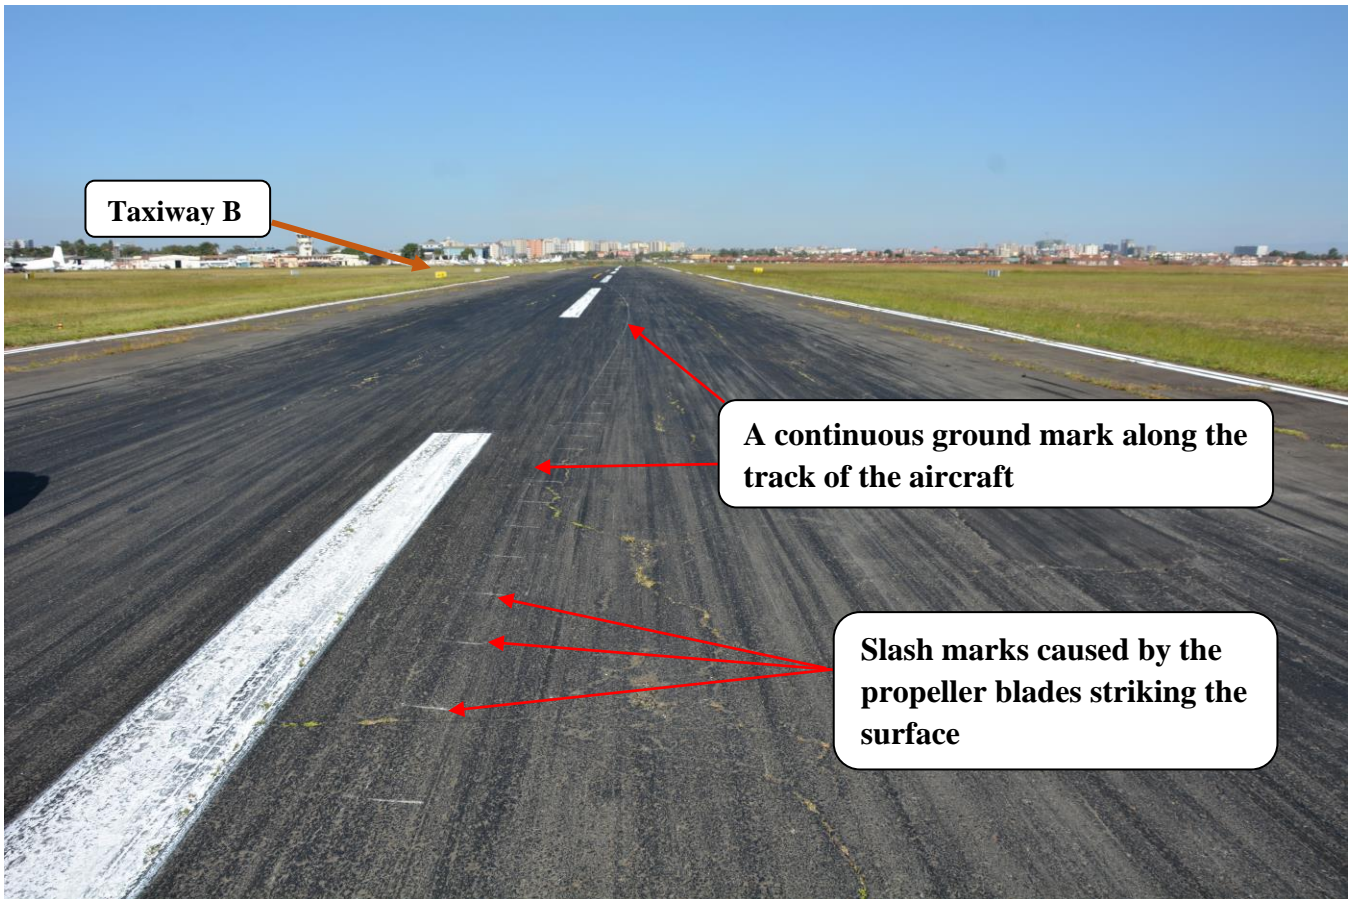
*FIGURE No. 6 – Ground marks*

The broken nose gear strut left an impact point and a continuous ground mark along the track of the aircraft on the runway pavement surface. Slash marks caused by the propeller blades striking the surface were also found. The distance between most of the marks was 30cm.

The main body of the aircraft remained intact, except that the nose wheel assembly and nose wheel fork were detached and found on the runway. An impact point was located on Runway 07. Right after the impact point, a gouge mark was found while the remaining ground mark was a scratch mark continuing to the final position of the aircraft. Propeller blades slash marks were found along the track of the aircraft. Most of the spaces between the slash marks measured 30cm. The aircraft moved forward for approximately 210 m and finally stopped slightly the left of the runway centerline. No tire mark was found.

- The track of the aircraft could be traced by a ground mark continuing from the impact point to the final stop position. The first segment of the ground mark was a gouge mark while the remaining was a scratch mark. The gouge mark revealed that the broken nose gear was pressing on the runway surface. The gouge mark was subsequently lightened to scratch mark, showing that a reduction in force exerted by the nose gear on the surface, partially shared by the main landing gears.

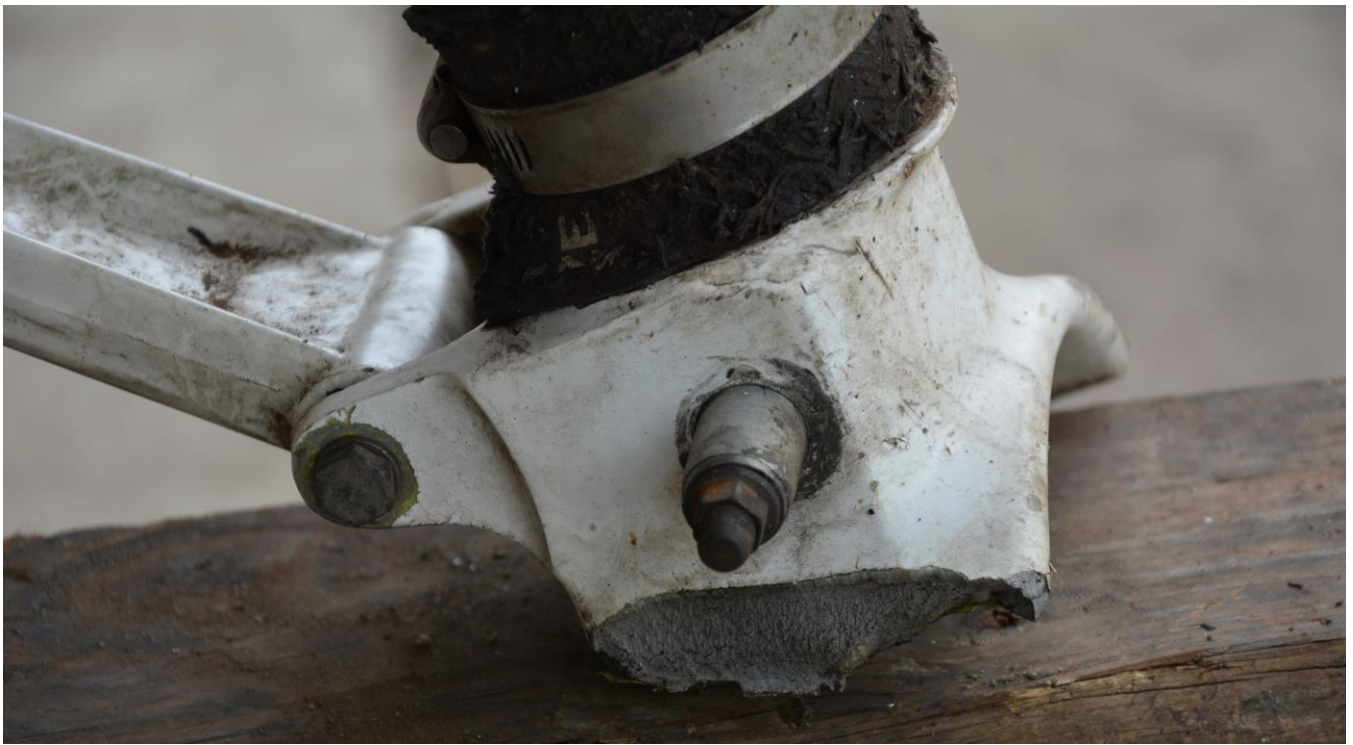
Inspection of the fractured surfaces indicated that there was no pre-existing failure on the nose wheel fork and the failure was due to overload.

*FIGURE No. 7 – Broken nose gear fork*

3.1.11 The detachment of the nose landing gear wheel assembly and fork was due to overload during the hard nose landing.
