MINISTRY OF ROADS AND TRANSPORT
STATE DEPARTMENT FOR TRANSPORT
AIRCRAFT ACCIDENT INVESTIGATION DEPARTMENT

**INVESTIGATION REPORT OF AN OCCURRENCE INVOLVING A
CESSNA 180A, REGISTRATION 5Y-FOO ON 17 APRIL 2021 AT
MAGADI IN KAJIADO COUNTY**

AIRCRAFT ACCIDENT INVESTIGATION

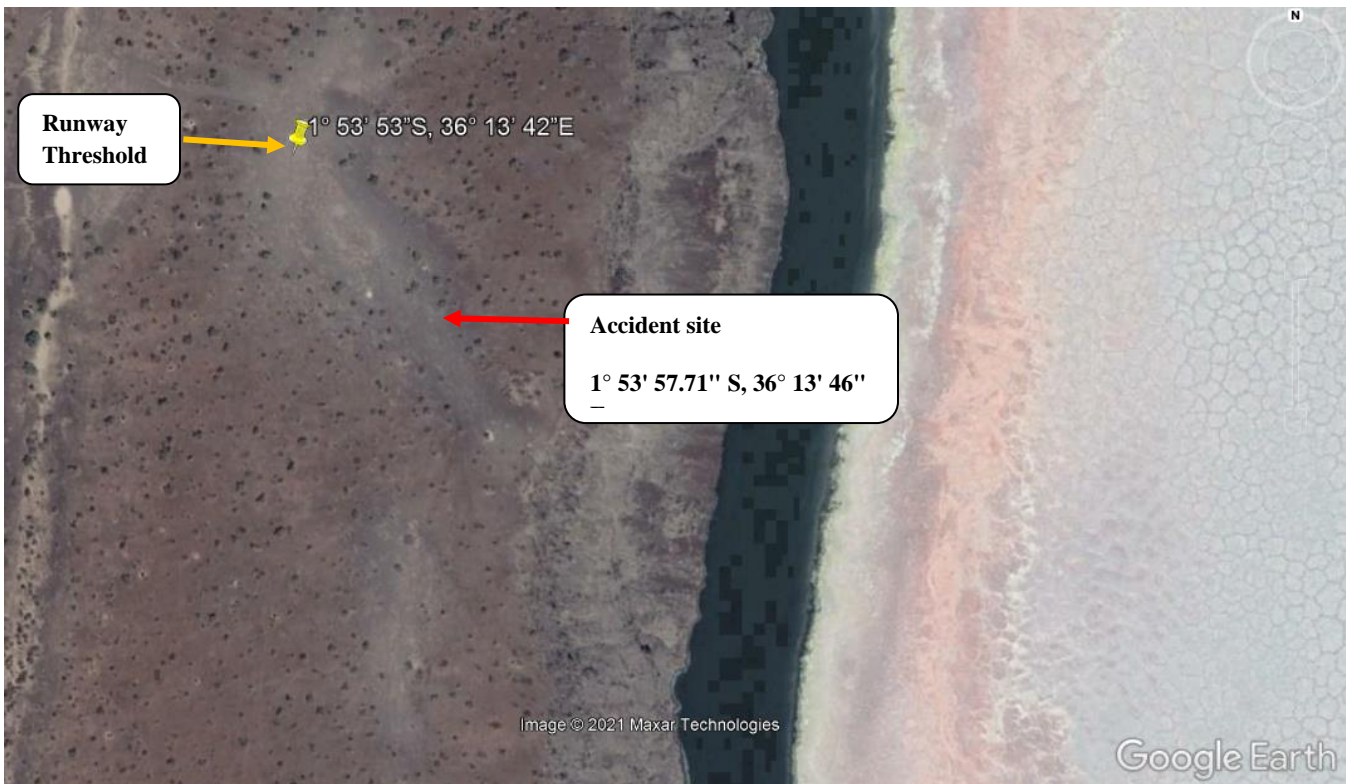
FIGURE No. 2 – Aerial view of the accident site (source: Google earth with AAID annotations)

The distance between the threshold and the location of the struck tree was 150 metres and the location between the tree and where the aircraft came to rest was 52 metres.

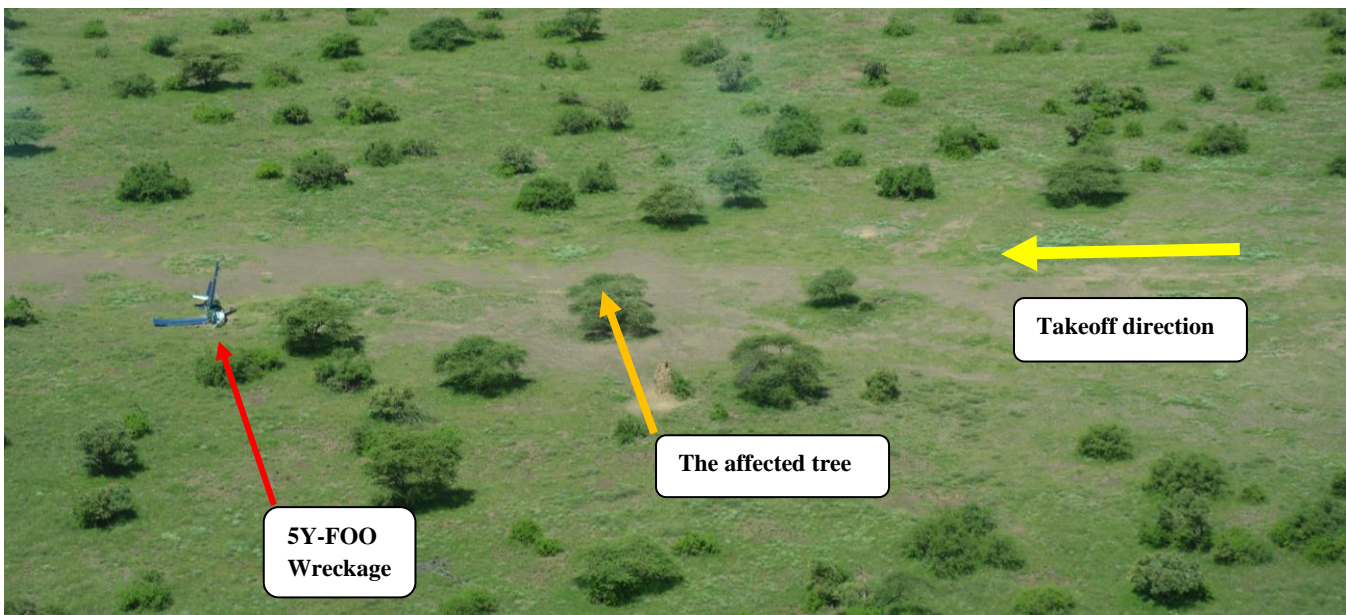
FIGURE No. 3– Aerial photo of final position of the accident aircraft

The main body of the aircraft came to rest largely intact facing 90° to the left of the intended direction of flight. The aircraft rested on its right side with the left wing facing up. The right wing broke off its root, the horizontal stabilizer broke off at the midsection and the propeller blades were damaged. The right main landing gear wheel detached from its hub and there was further damage to the left wing tip and its fairing.

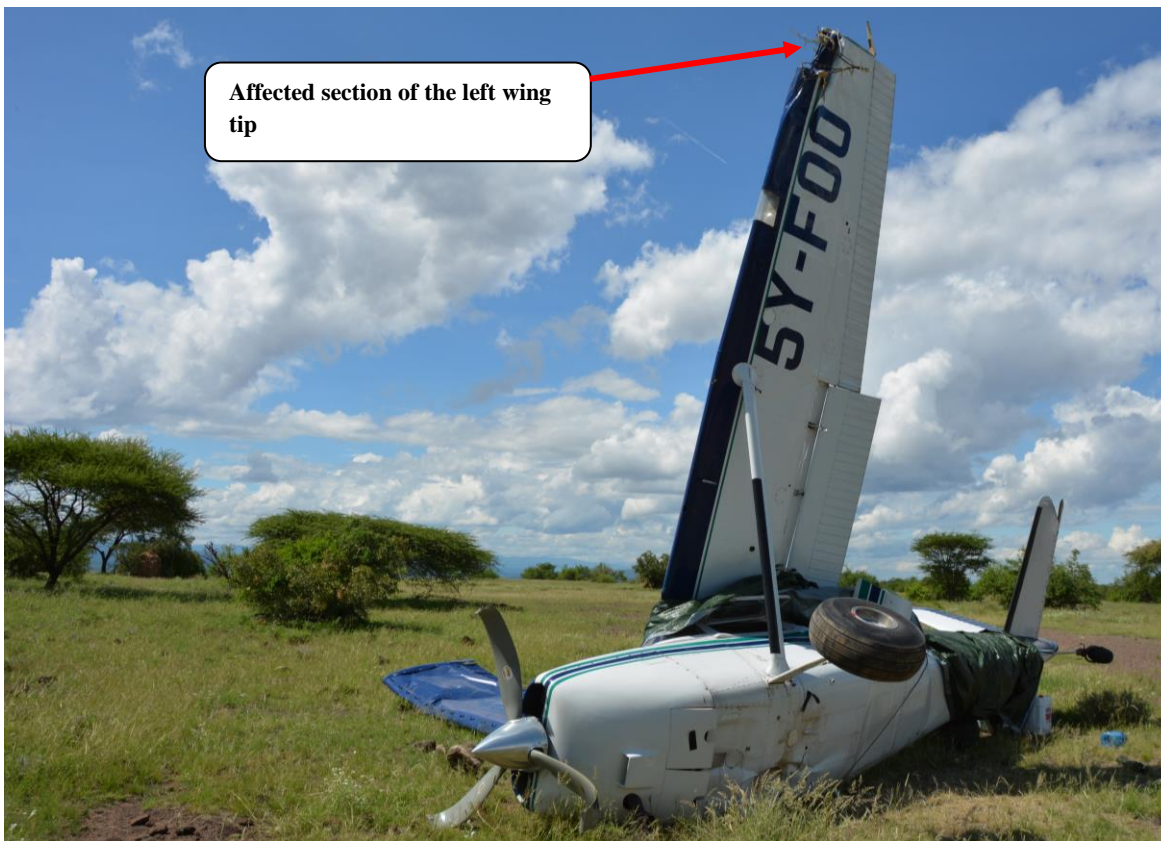
FIGURE No. 4 – A photo of 5Y-FOO accident site

On takeoff run, at 150m past the runway threshold, the left-wing tip struck a tree. This resulted in the aircraft veering off the runway to the left and subsequently ground looped, coming to a stop on its right side with the left wing facing up and the aircraft facing 90 degrees to the left of intended direction of travel. The right wing broke off its root.

Affected section of the left wing tip

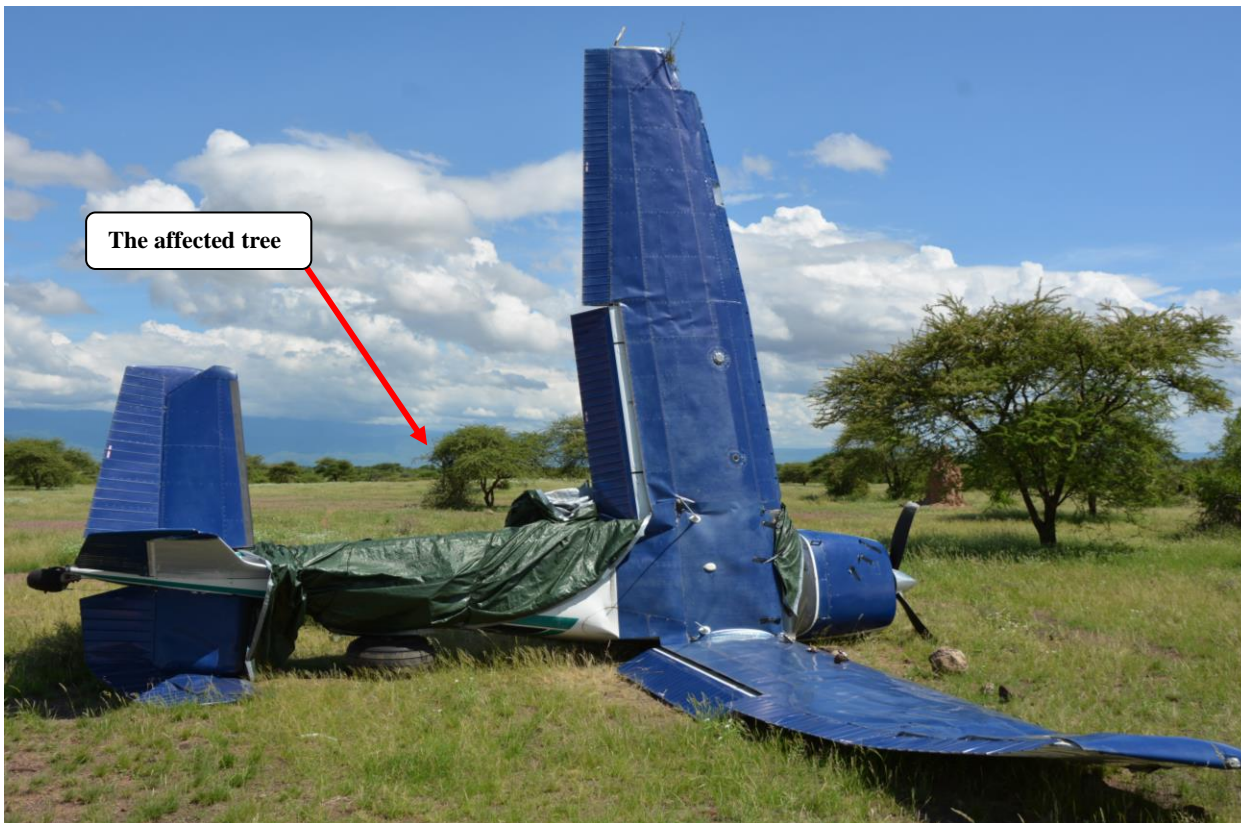
FIGURE No. 5 – A photo of 5Y-FOO accident site with the affected tree in the background

The affected tree

On takeoff run, the pilot deviated to the left and the aircraft's left wing tip struck a tree leading to loss of directional control on ground leading to the accident.

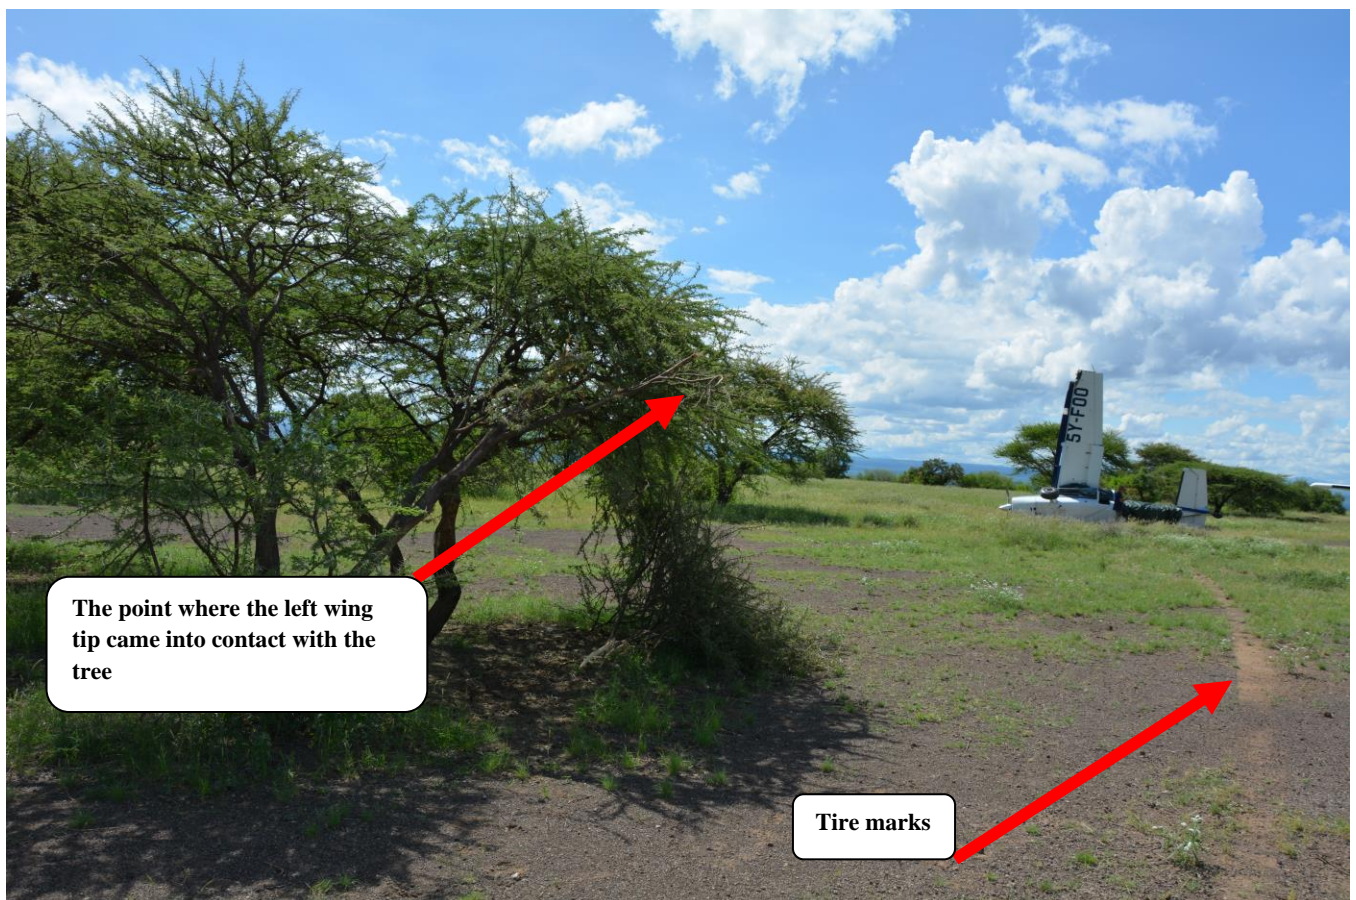
FIGURE No. 6 – A photo of 5Y-FOO, the affected tree and tire marks

From examining the aircraft damage and tire marks aforesaid, it was determined that the aircraft never left the ground prior to the accident.

The track of the aircraft could be traced by a tire marks continuing from the runway threshold to the final stop position. The first segment of the tire marks from the threshold to about 140 metres was faint while the remaining was more profound. The second segment of the tire marks revealed that the wheels were pressing deep on the runway surface.
