INVESTIGATION REPORT

**PRELIMINARY INVESTIGATION REPORT OF AN OCCURRENCE
INVOLVING AN CESSNA 206, REGISTRATION 5Y-CJM ON 10
NOVEMBER 2020 AT BEATON'S AIRSTRIP IN MAASAI MARA**

OPERATOR	:	Prime Aviation Ltd
AIRCRAFT TYPE	:	Cessna TU 206 G
MANUFACTURER	:	Textron Aviation Inc.
AIRCRAFT REGISTRATION	:	5Y-CJM
AIRCRAFT SERIAL NUMBER	:	AU206-05048
DATE OF REGISTRATION	:	09 April 2014
NUMBER AND TYPE OF ENGINE	:	One, TSI0-520-M
DATE OF OCCURRENCE	:	10 November 2020
LAST POINT OF DEPARTURE	:	Beaton's airstrip
POINT OF INTENDED LANDING	:	Tigoni Airstrip, Limuru
TIME OF OCCURRENCE	:	1205 (1505)
LOCATION OF OCCURRENCE	:	Beaton's airstrip, Maasai Mara
TYPE OF FLIGHT	:	Commercial (Non-Scheduled)
NUMBER OF PERSONS ON BOARD	:	04
INJURIES	:	None
NATURE OF DAMAGE	:	Minor
CLASS OF OCCURRENCE	:	Serious Incident
PILOT IN COMMAND	:	CPL holder
PIC FLYING EXPERIENCE	:	2,763.2 hours

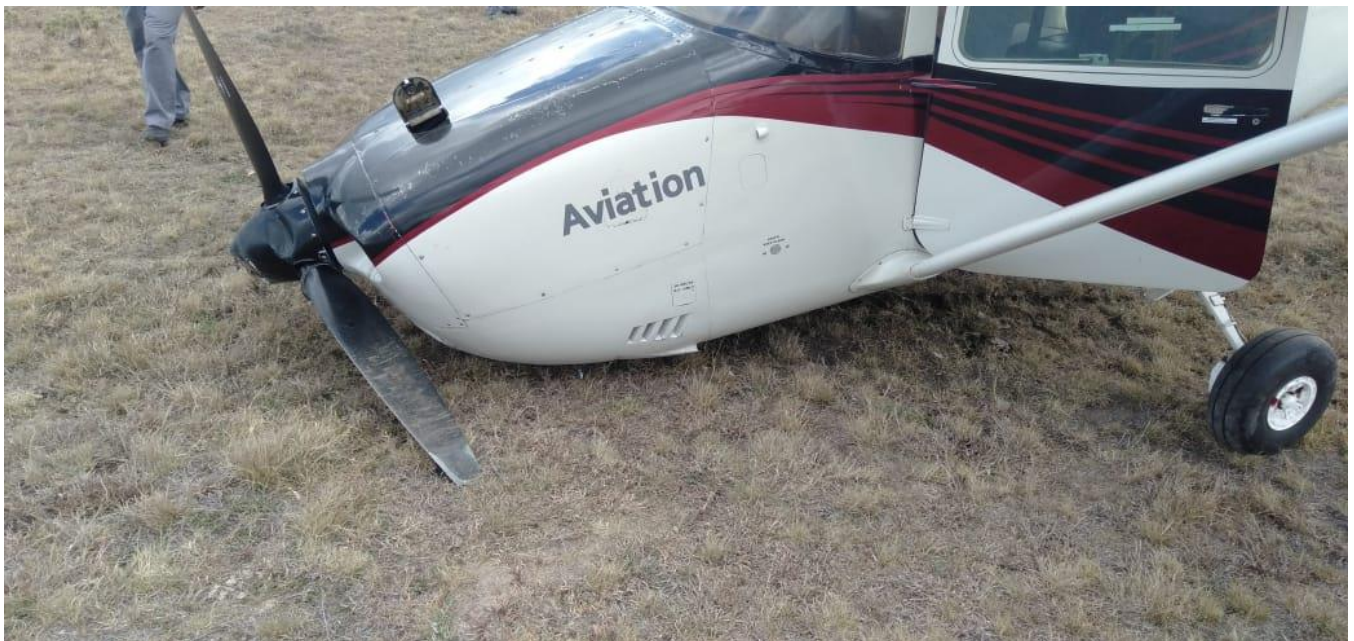
Upon inspection, the engine oil filler cap access was found unlatched. The cap is closed securely by a latching mechanism that requires one to twist a tab 90° and fold it down.

FIGURE No. 1 – A photo of the front section of the aircraft

Latching the oil reservoir cap after checking and adding oil is a requirement. The pilot did not latch the engine oil filler cap after checking and replenishing oil.

AAID determined the probable cause of the occurrence as the pilot's failure to adhere to the pre-flight inspection checklist of the aircraft resulting in the unsecured engine oil filler cap not being detected, and the engine venting significant oil during operation.

The Prime Aviation Ltd to ensure implementation of its Standard Operating Procedures to mitigate the consequences of an unsecured engine oil filler cap.

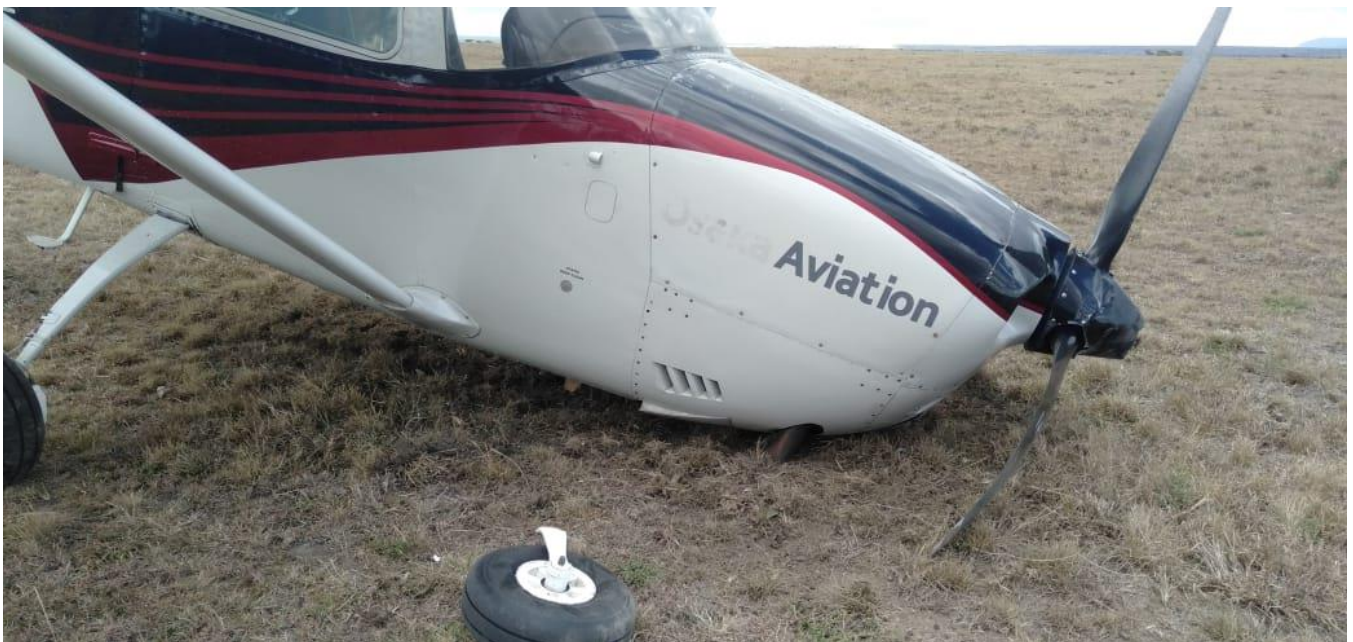
The aircraft sustained minor damage. It came to rest with the nose wheel struck off from its assembly and two propeller blades bent along their length. The propeller spinner was also damaged.

FIGURE No. 2 – A photo depicting extent of damage to the propeller and nose landing gear wheel.

The aircraft overran the runway, struck a stone with the nose landing gear and came to rest with the propeller striking the ground. The nose wheel assembly broke off. The propeller spinner was damaged. The rest of the aircraft remained intact.
