AIRCRAFT ACCIDENT INVESTIGATION DEPARTMENT

A SERIOUS INCIDENT TO THE AIRCRAFT 5Y- CFG,

AT MAGADI AIRSTRIP, KAJIADO COUNTY

PRELIMINARY SERIOUS INCIDENT REPORT SUMMARY

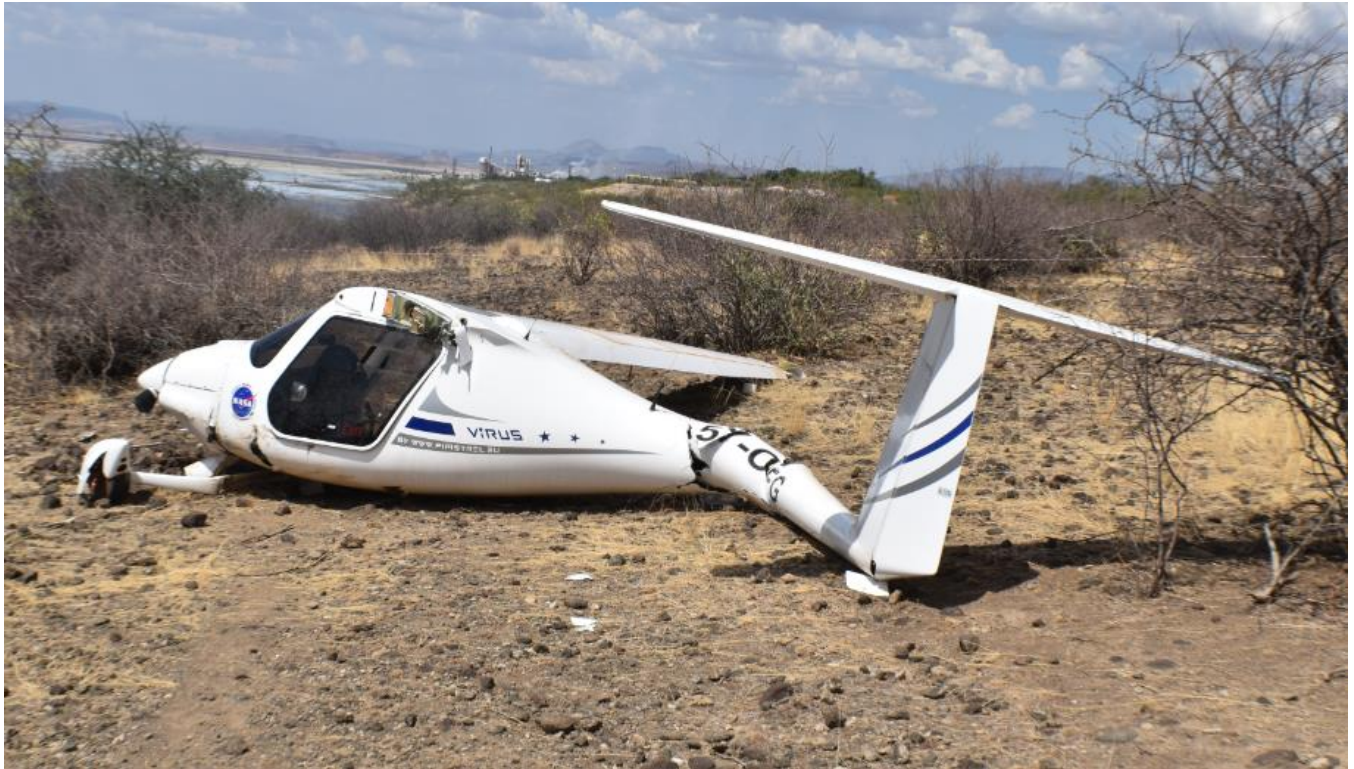
Figure 1: The accident Aircraft viewed from the LH side.

The aircraft impacted the terrain about 2.3kilometres east of the Magadi airstrip. As shown in Figures 1 & 2, the main wreckage, which included fuselage, engine, and the right-wing came to rest on the rugged terrain. The left-wing had separated from the fuselage and was located adjacent to the main wreckage. The empennage broke but was still attached to the fuselage. The forward

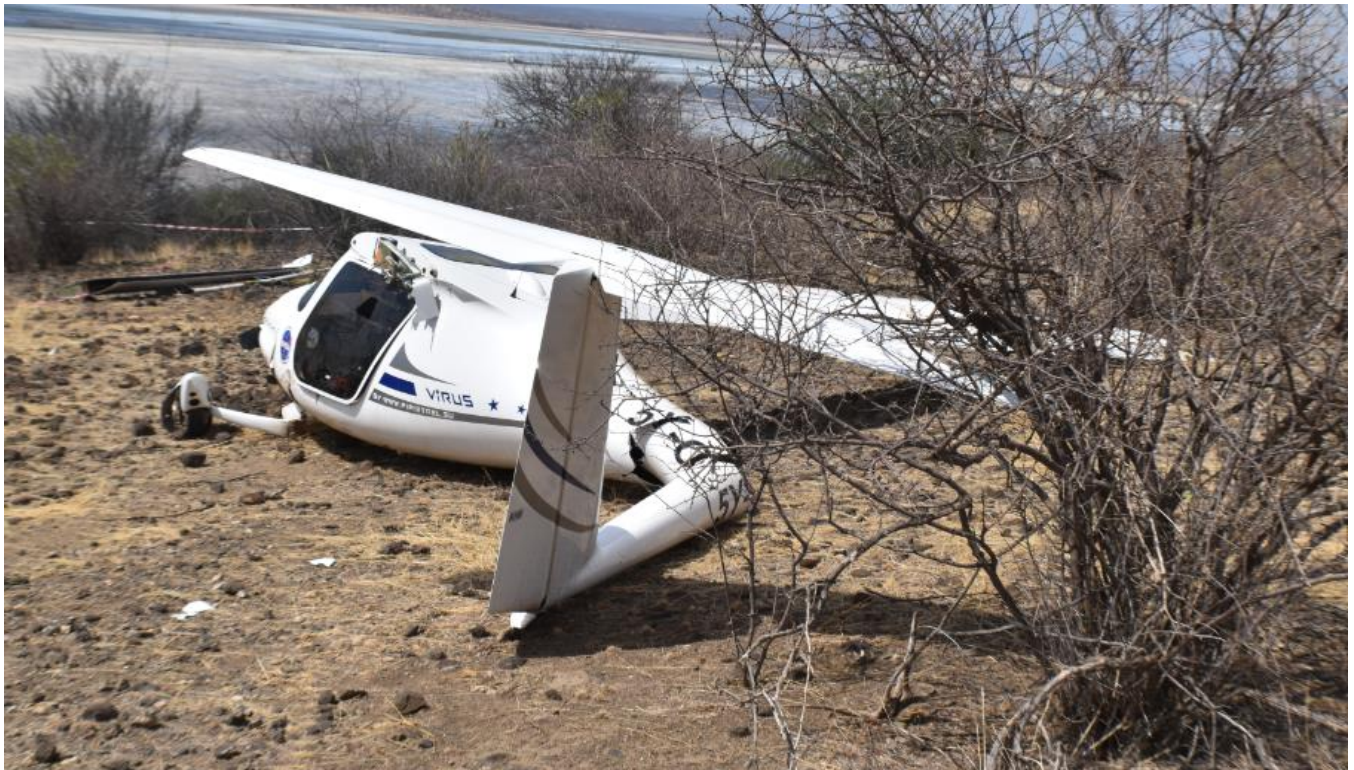
Figure 2: The accident Aircraft after viewed from the AFT side

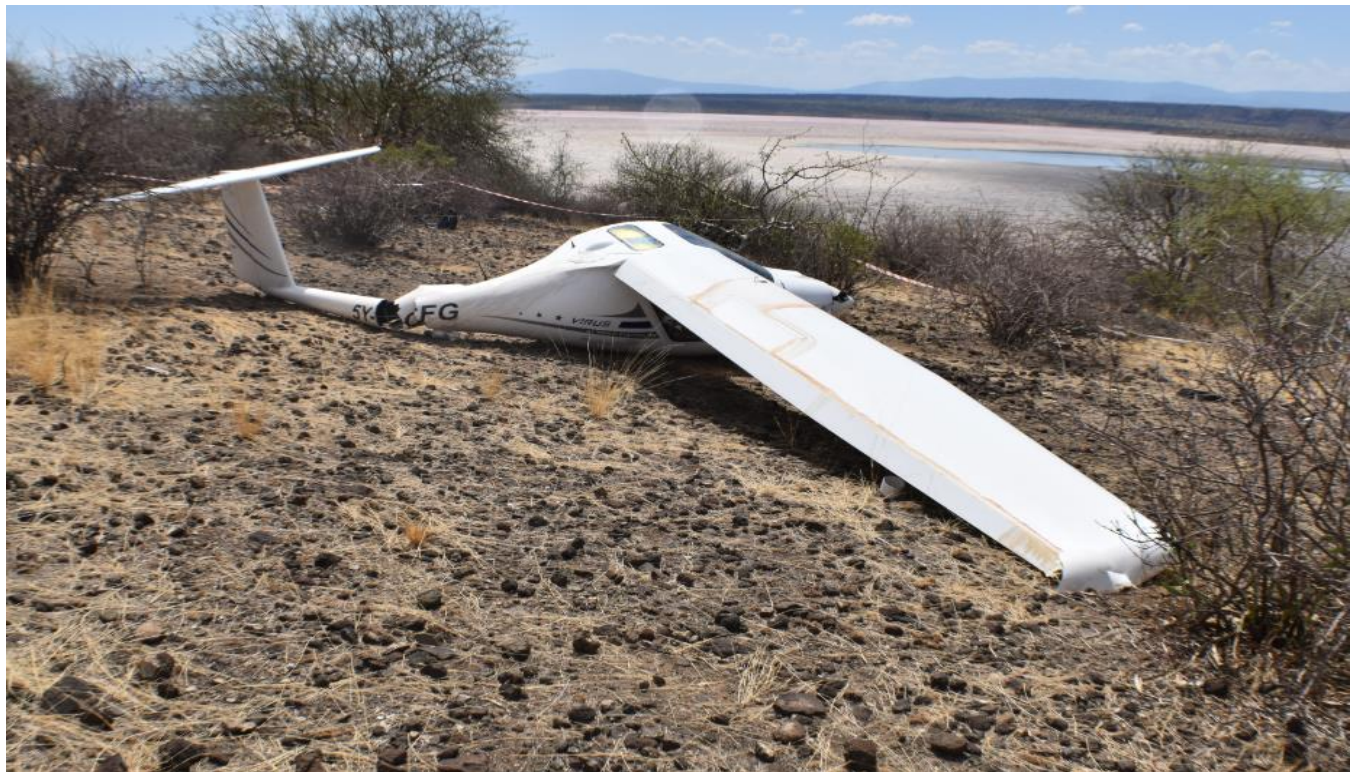
Figure 4: Section of the RH wing showing the fuel spillage

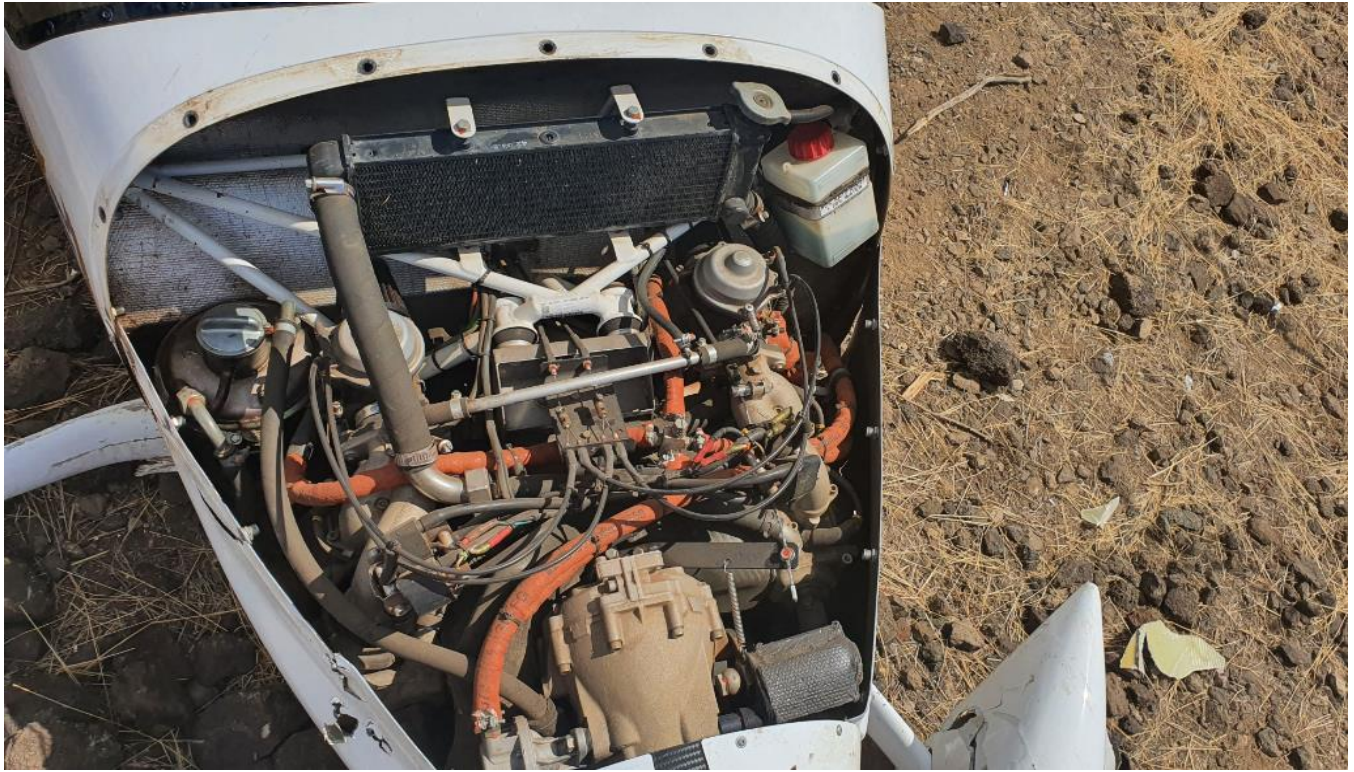
Figure 5: The Engine section with the cowling opened.

A post-accident examination of the engine was conducted by AAID Investigators did not reveal any anomalies related to the cylinders, crankshaft, or valve train

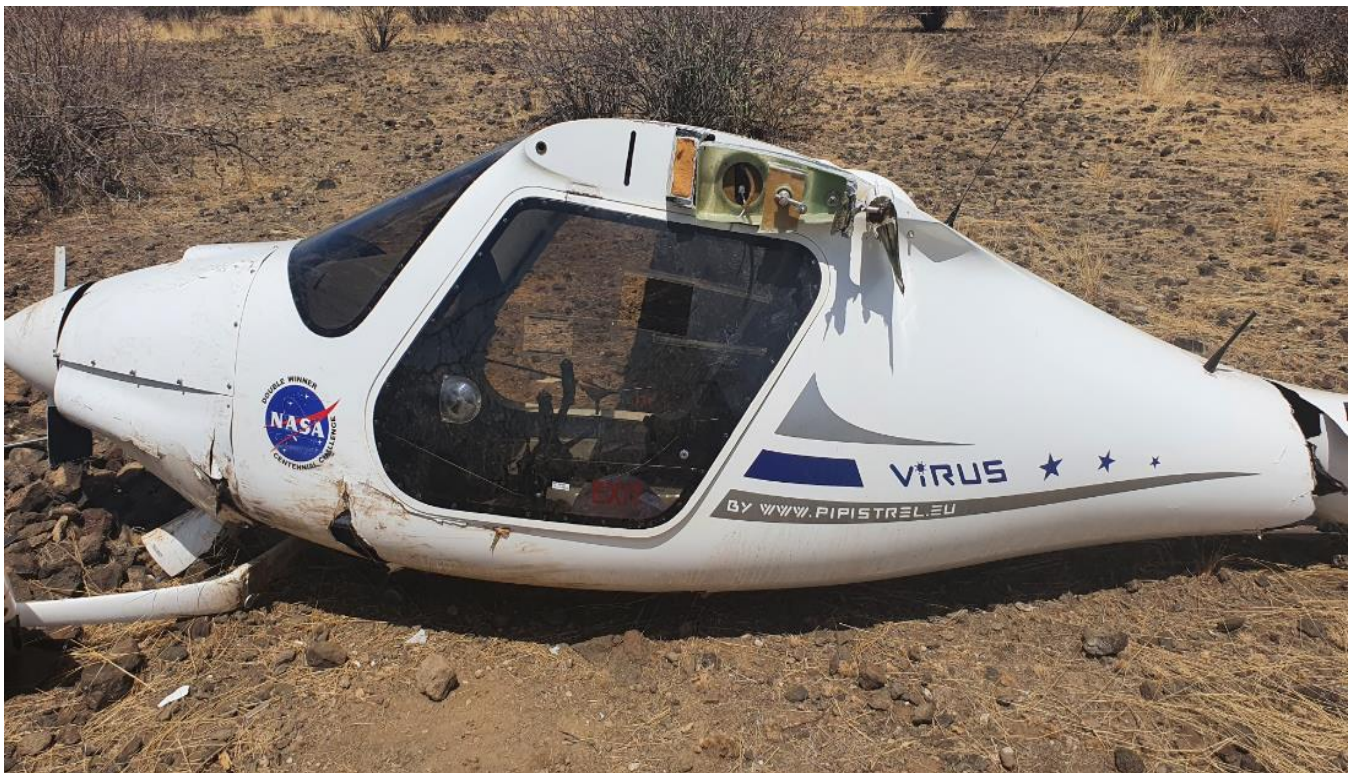
Figure 6: LH of the accident aircraft with the wing detached

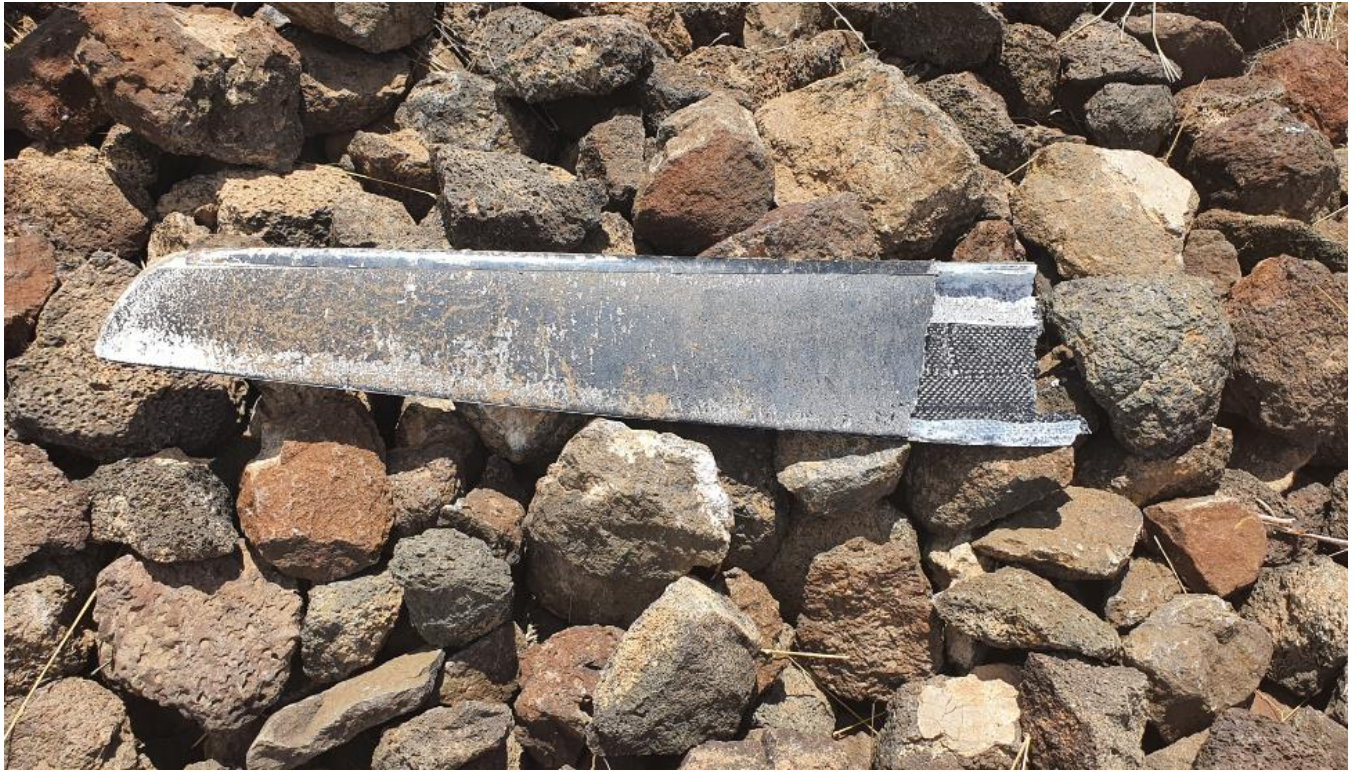
Figure 7: Broken Propeller blade

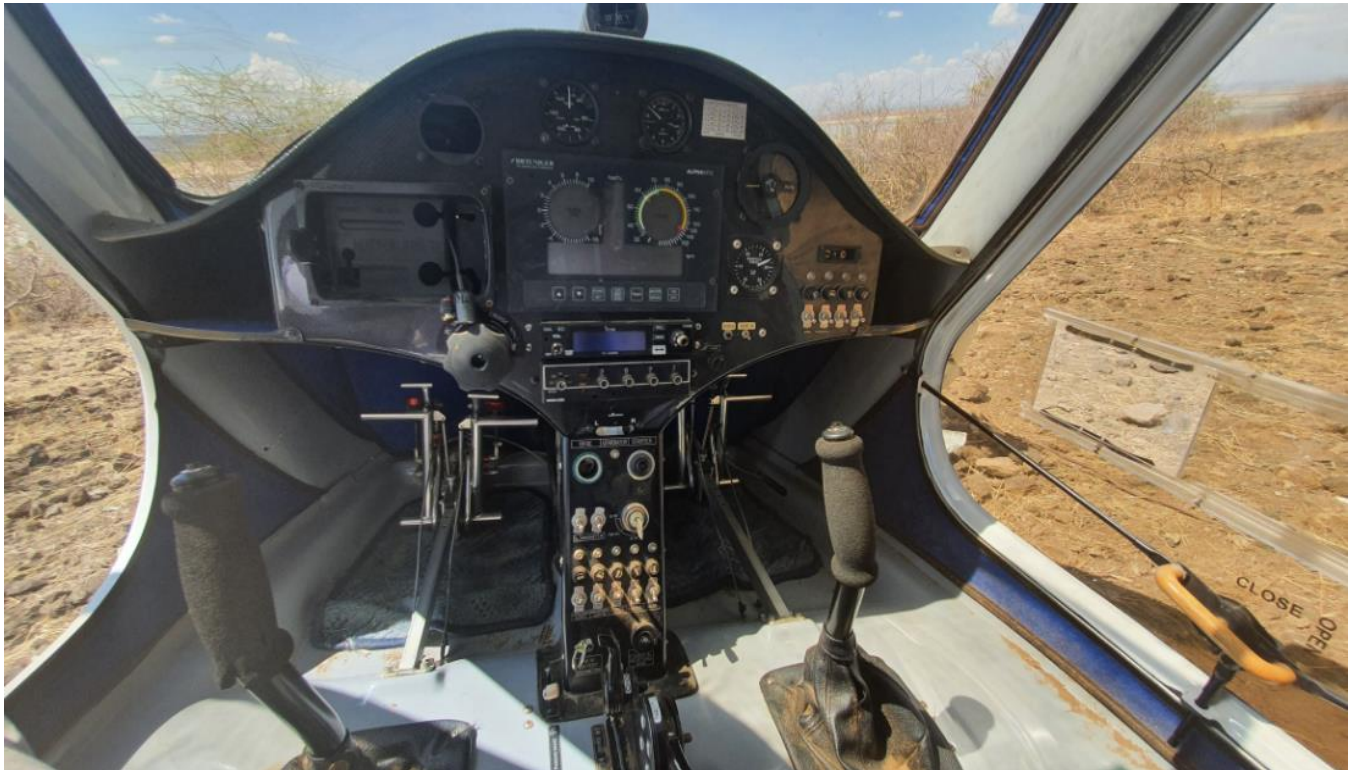
Figure 8: Section of the Cockpit

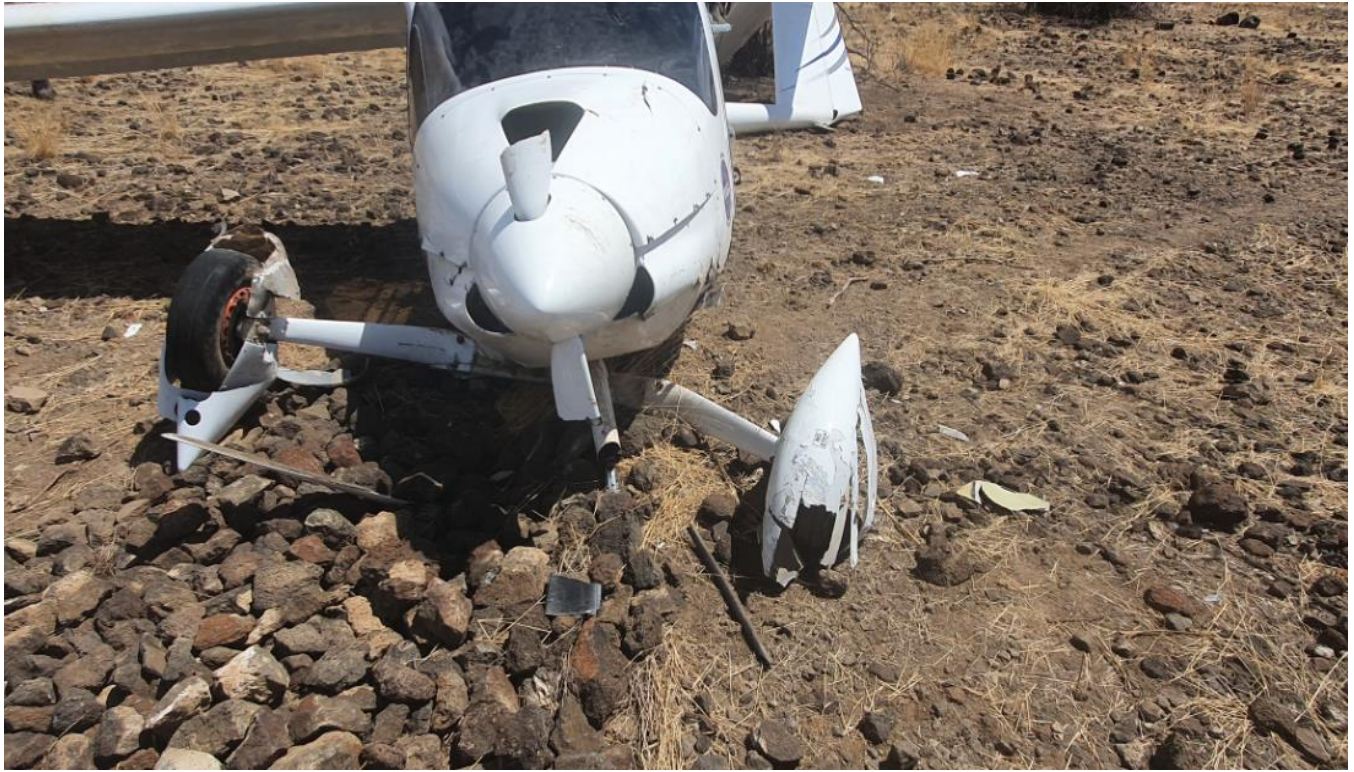
Figure 9: Front Section of the accident aircraft

portion of the fuselage was largely intact, with the cockpit doors intact. Both the propeller blades broke mid-span and were located within the wreckage radius (See Figure 9). The left and right-wing flaperons remained attached to the wing. The rudder and elevators remained attached to the empennage. Flight continuity was confirmed at the rudder and elevators. Discontinuities in the remainder of the flight control system appeared consistent with separations due to the impact sequence
