AIRCRAFT ACCIDENT INVESTIGATION DEPARTMENT

PRELIMINARY INVESTIGATION REPORT

**A SERIOUS INCIDENT TO THE AIRCRAFT 5Y- MMG, CESSNA 172 RG
ON 01 NOVEMBER 2021 AT LAMU MANDA AIRSTRIP, LAMU
COUNTY**

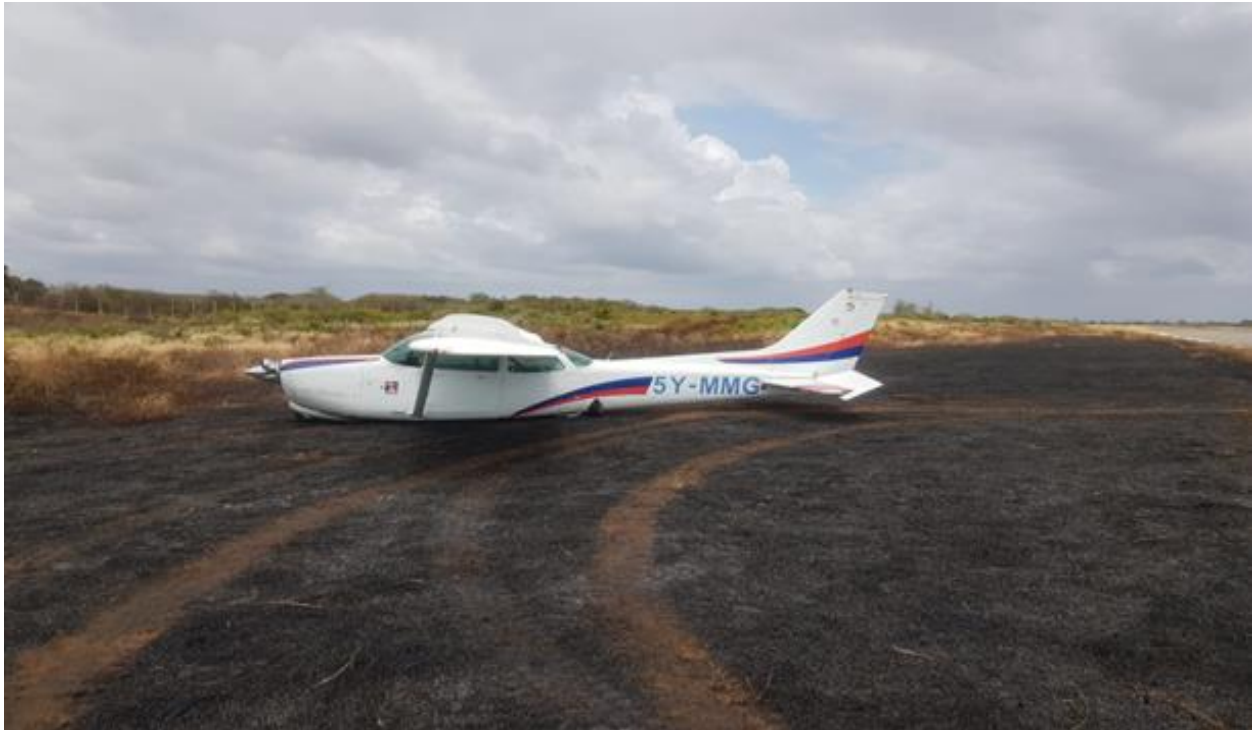
The aircraft sustained minor damage to its belly and the propeller.

Figure 1: The Aircraft after landing on its belly

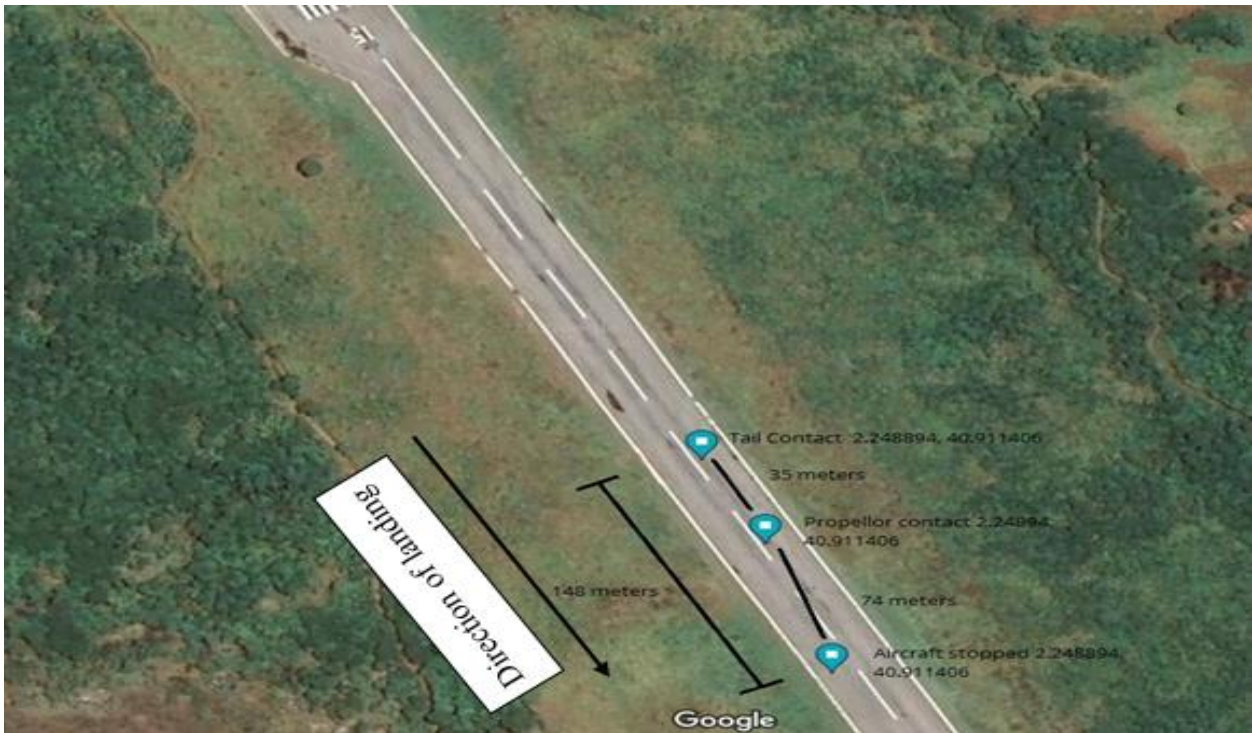
Figure 2: Aerial view of the first and the last point of contact

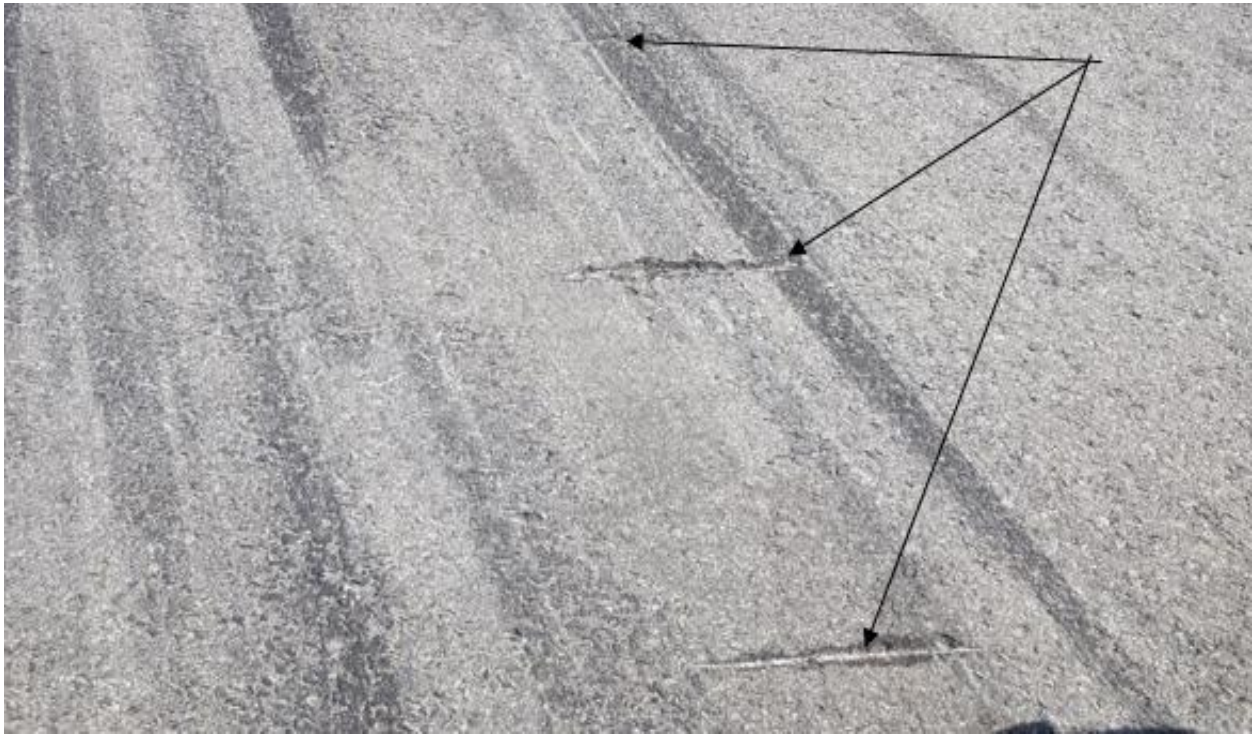
Figure 3: Slash marks caused by the propeller blades striking the runway surface

The aircraft came into contact with the runway surface as shown in in Fig. 7. Slash marks caused by the propeller blades striking the runway surface are visible. The touchdown was about 240 m from the threshold of RWY 15. The distance between the first point of touchdown to the final stop was 109 meters. On touchdown, the outer skin on the bottom of the fuselage was damaged. A small piece of debris was found on the runway.

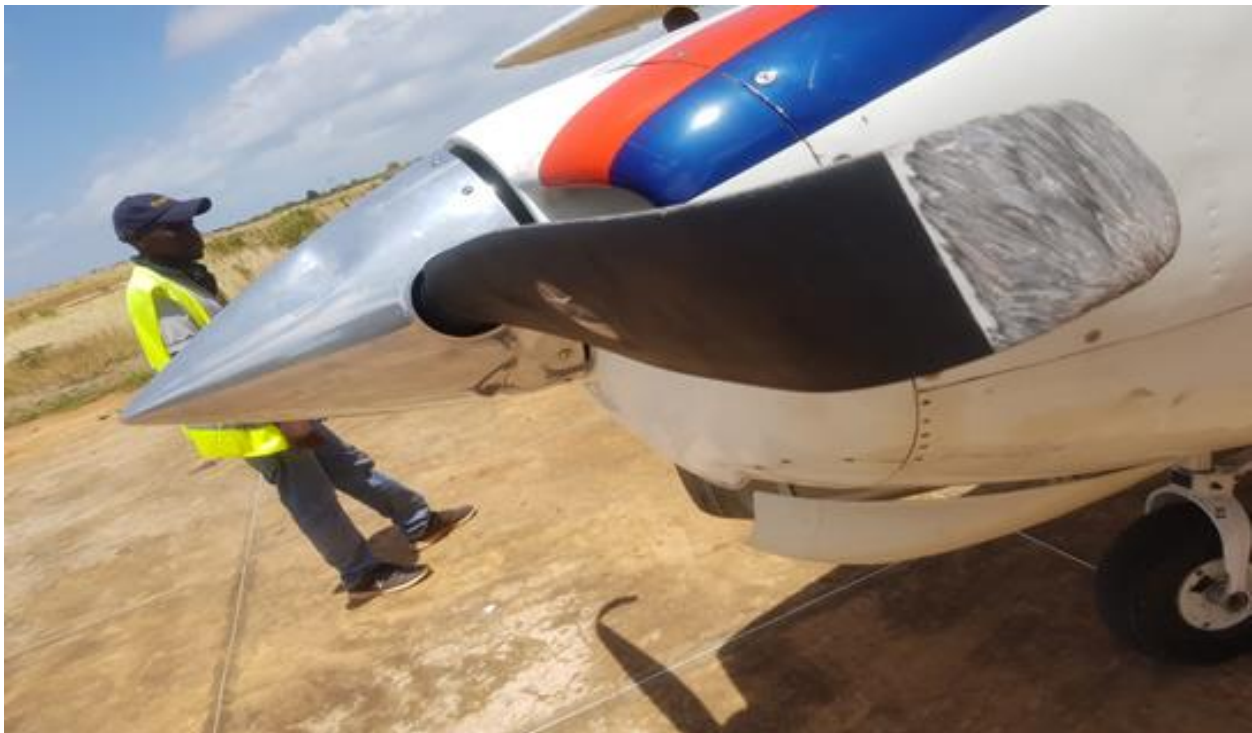
The aircraft sustained minor grinding damage to the belly, both propeller blades exhibited impact damage and the blade tips were bent rearwards. There was a minor dent to the spinner. The outer skin on the bottom of the fuselage was damaged.

Figure 4: Damage to the propeller

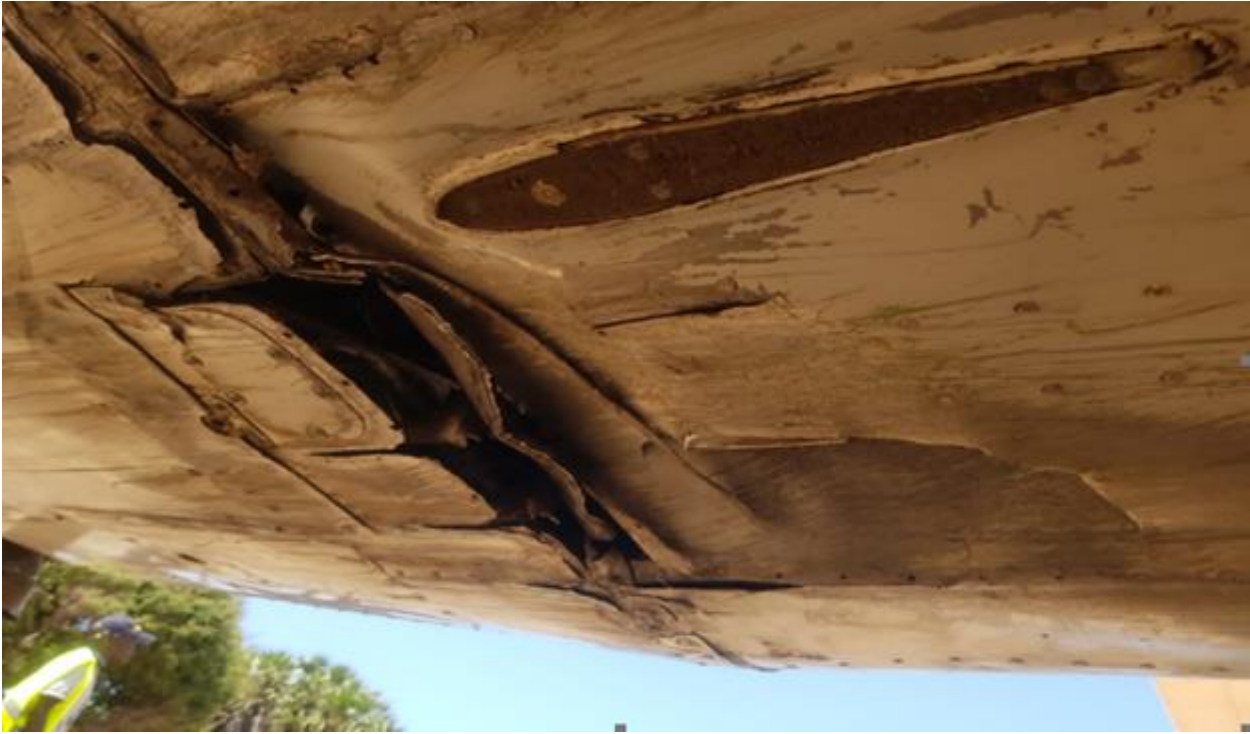
Figure 5: The damage to the belly of the aircraft

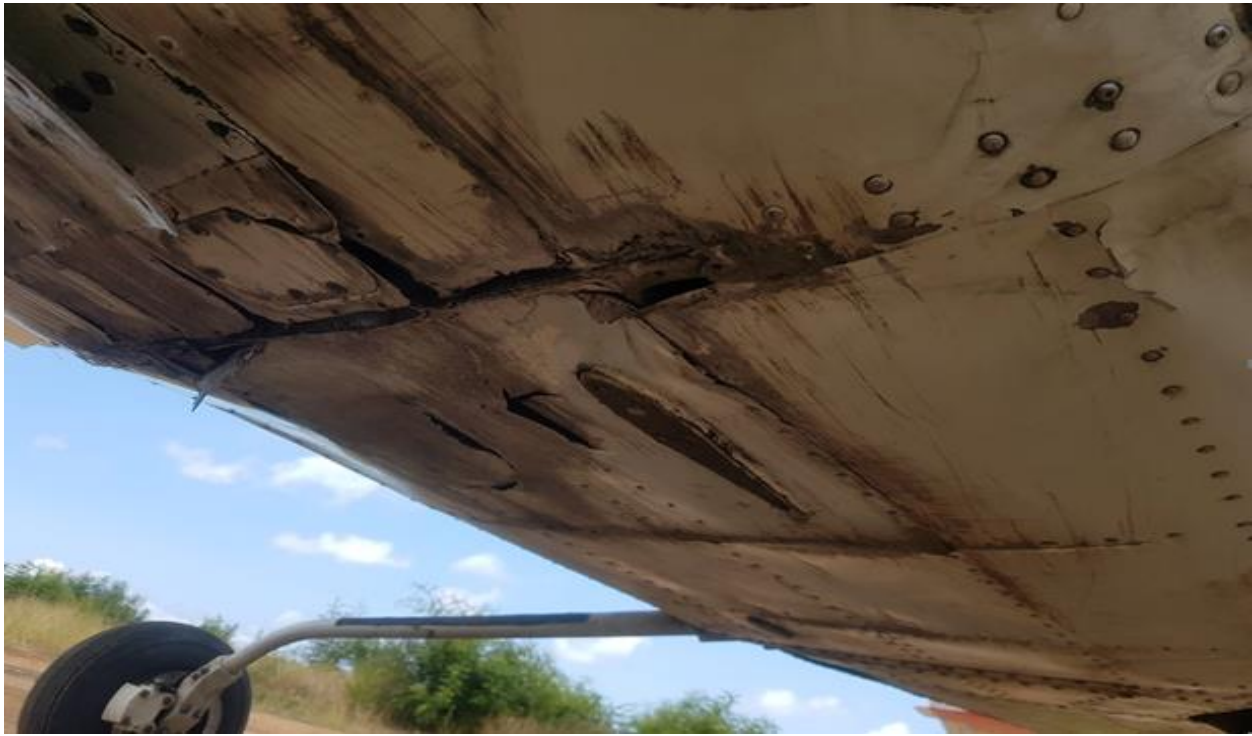
Figure 6: Damage to the outer skin on the bottom of the fuselage

- The landing procedures, where the landing gear should be selected “down” was not performed.
- The gear up touch-down led to propeller strike and damage to the outer skin on the bottom of the fuselage.

The probable cause of the occurrence was the pilot's failure to adhere to pre-landing checklist procedures leading to gear up landing resulting in propeller strike and damage to the outer skin on the bottom of the fuselage.
