MINISTRY OF TRANSPORT AND INFRASTRUCTURE
STATE DEPARTMENT OF TRANSPORT
AIR ACCIDENT INVESTIGATION

PRELIMINARY REPORT

AIRCRAFT TYPE/ MANUFACTURER: BOEING (STEARMAN) B-75-PT17.

AIRCRAFT REGISTRATION: N999WY

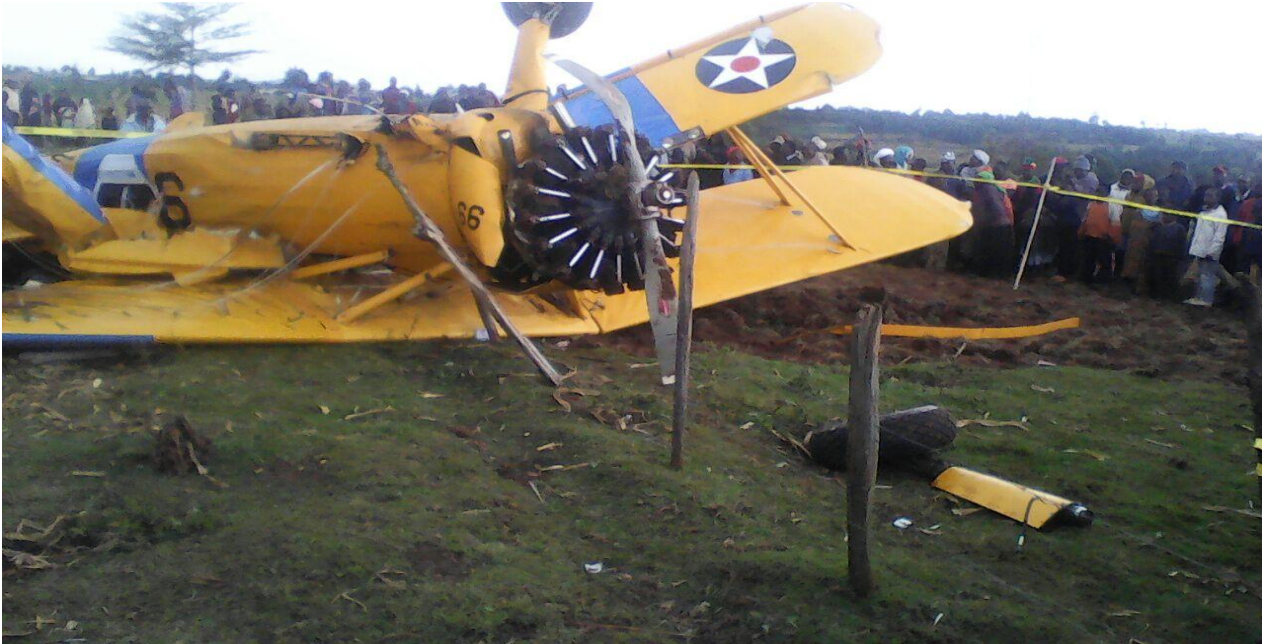
Picture: N999WY lying inverted after the occurrence

The aircraft landed in a soft field which had a barbed wire fence at one end. The aircraft crashed into the fence which brought the aircraft to an instant stop and the aircraft flipped upside down. The aircraft sustained damage on the undercarriage, engine, wings and the hull. There was no post-crash fire.
