**AIR ACCIDENT INVESTIGATION
PRELIMINARY REPORT**

OPERATOR : Yellow Wings Air Services Limited

AIRCRAFT TYPE : Cessna 206

AIRCRAFT REGISTRATION : 5Y-CHR

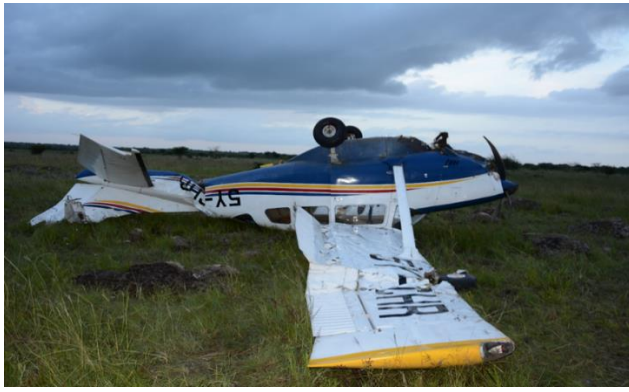
Photo 1: The C206, 5Y-CHR accident site; Photo 2: The detached nose landing gear

Preliminary onsite investigation reveals that the aircraft flipped over when the nose landing gear hit a depression in the terrain.
