AIRCRAFT ACCIDENT INVESTIGATION DEPARTMENT

PRELIMINARY INVESTIGATION REPORT

**ACCIDENT TO THE AIRCRAFT 5Y-PSM, BELL 407GXP ON
30.05.2021 AT KUDHO PRIMARY SCHOOL, SIAYA COUNTY**

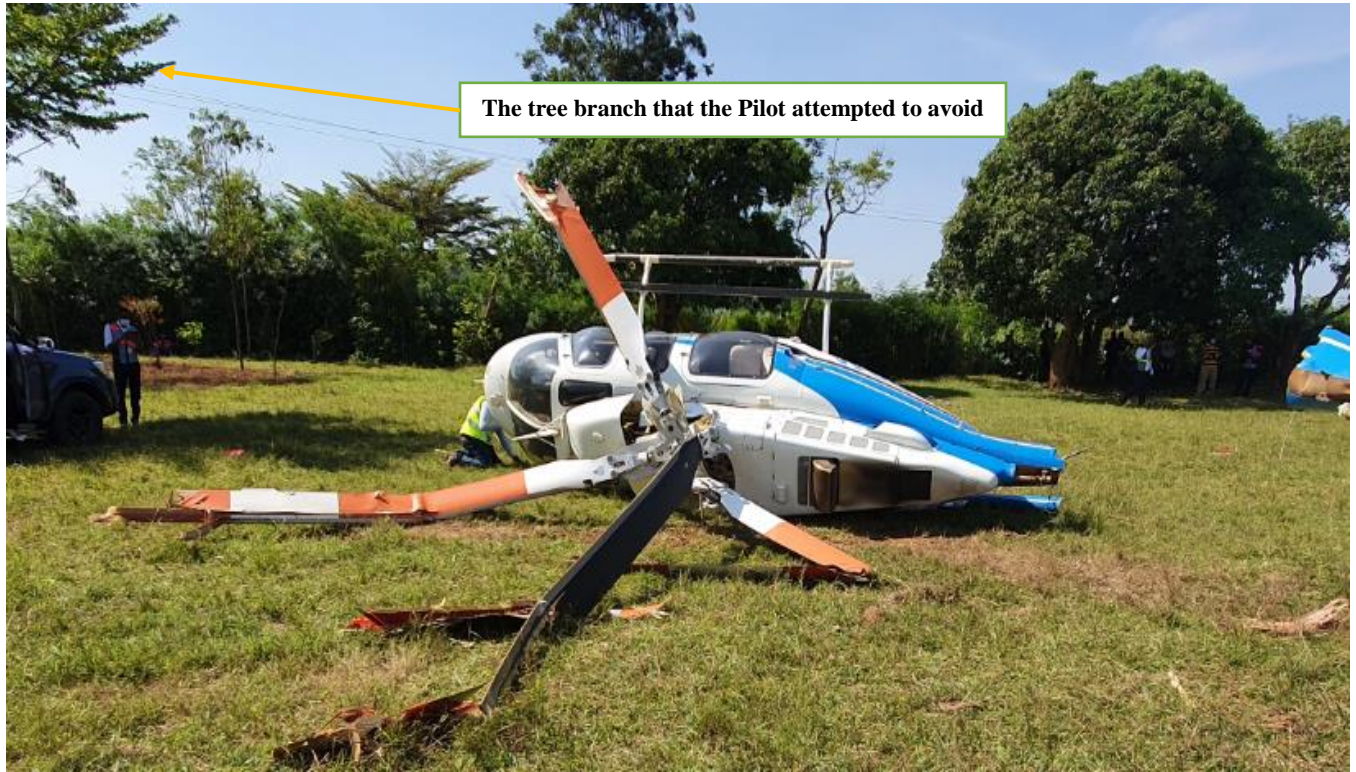
Figure 2: The Helicopter wreckage in the field at Kudho Primary School

During takeoff at 1304 (1604) with one passenger on board, with intentions of repositioning to Yala airstrip where the four passengers were to board after completing the official events with the President. The helicopter rolled over and collided with terrain in an attempt to hover taxi to the left to clear off the nearby trees (fig 2). The pilot and the passenger were extricated from the wreckage with minor injuries.

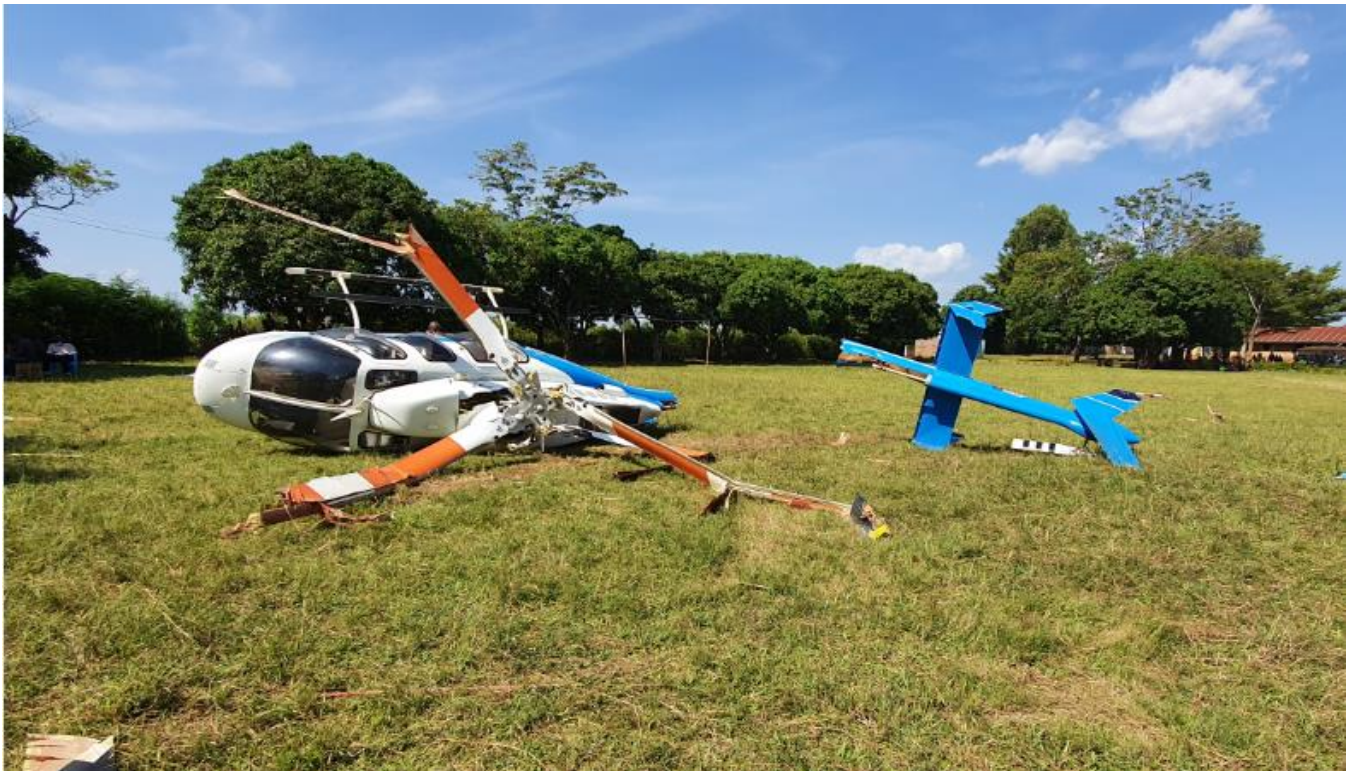
Figure 3: The Helicopter wreckage in the field at Kudho Primary School

The aircraft was substantially damaged by impact forces.

The main wreckage included the helicopter frame assembly, skin, fairing assembly of both sides, shell assembly of the lower cabin, aft cabin, cowlings, firewalls, longerons, roof beams and panels were found resting to the left.

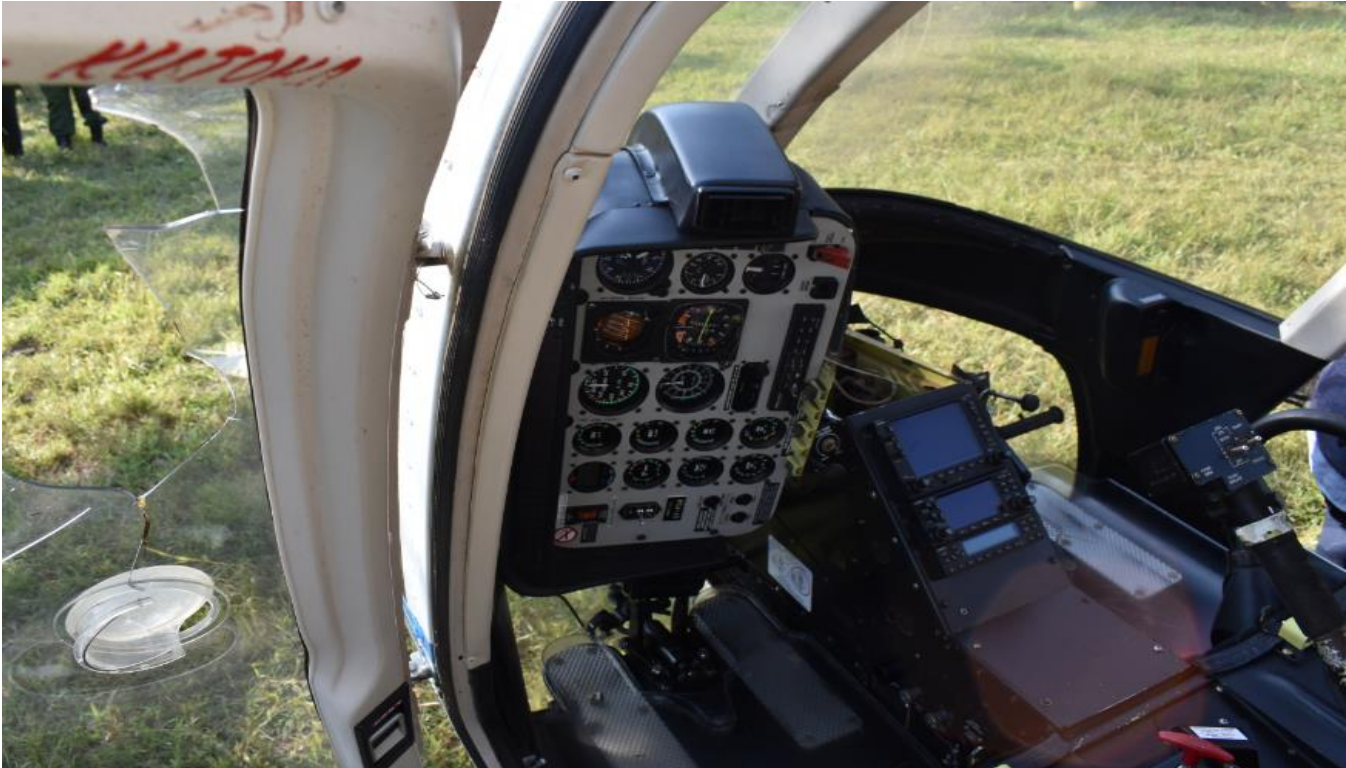
Figure 4: The Helicopter control panel after the accident

The LH cockpit side door and cabin door were found cracked (fig 4) and partially crushed with door hinges distorted. Examination of the site revealed two depressions in the ground consistent in size and shape with the helicopter's landing gear skids and main rotor blades.

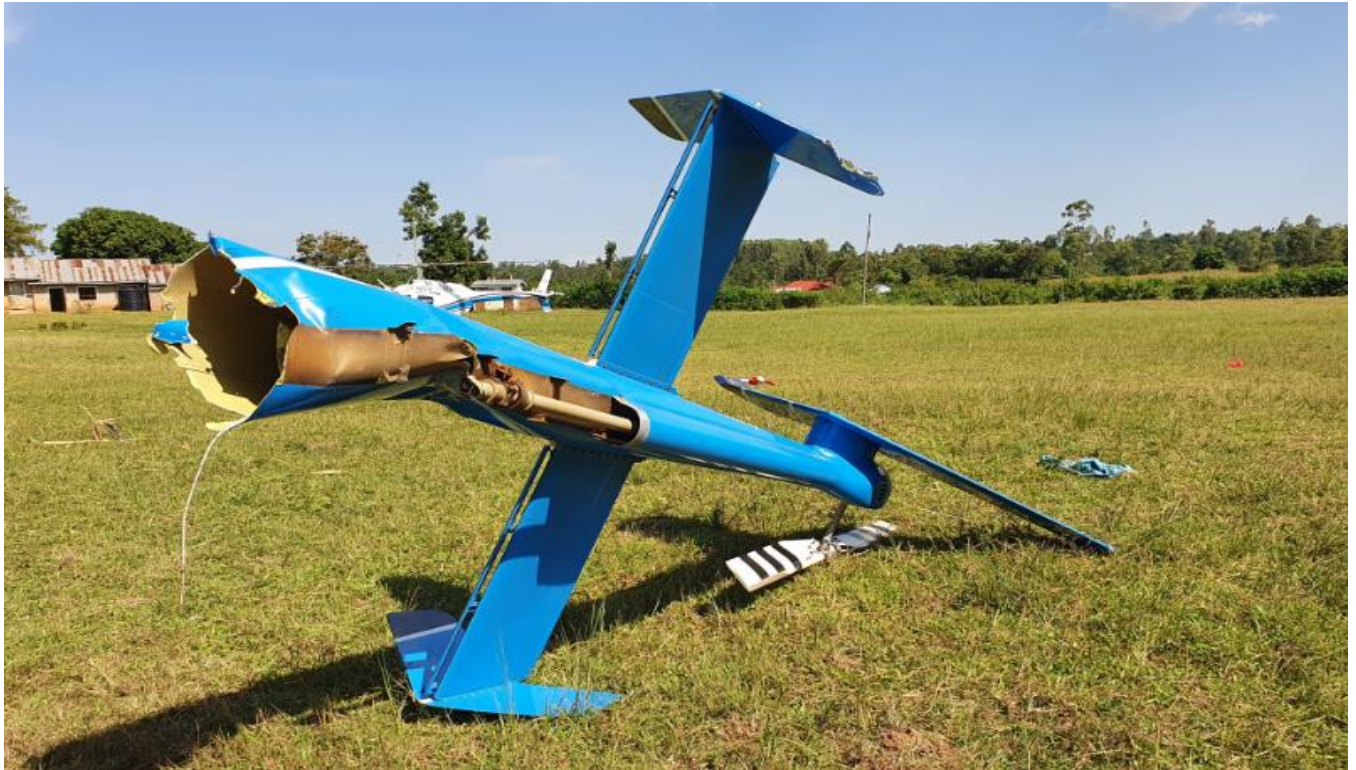
Figure 6: The tail boom after the accident

A separated section of the tail boom, severed near its mid-section, the empennage, tail rotor driveshaft sections, and tail rotor blade debris were to the north of the main wreckage and were generally intact with the crosshead, pitch change links, and the tail rotor gearbox connector shaft. All the four main rotor blades remained attached to the rotor hub but broke off at the midspan from the tip leaving evidence of the twisted fiber material and longitudinal crack.
