MINISTRY OF TRANSPORT, INFRASTRUCTURE, HOUSING,  
URBAN DEVELOPMENT AND PUBLIC WORKS  
STATE DEPARTMENT FOR TRANSPORT  
**AIRCRAFT ACCIDENT INVESTIGATION DEPARTMENT**

INVESTIGATION REPORT No. 01/08/2021

PRELIMINARY INVESTIGATION REPORT OF AN OCCURRENCE  
INVOLVING A DHC-2 BEAVER MK1 VIKING AIRCRAFT  
REGISTRATION 5Y-BCL ON 12 JULY 2021 AT KOSOVO AREA  
OF NDABIBI NAIVASHA IN NAKURU COUNTY

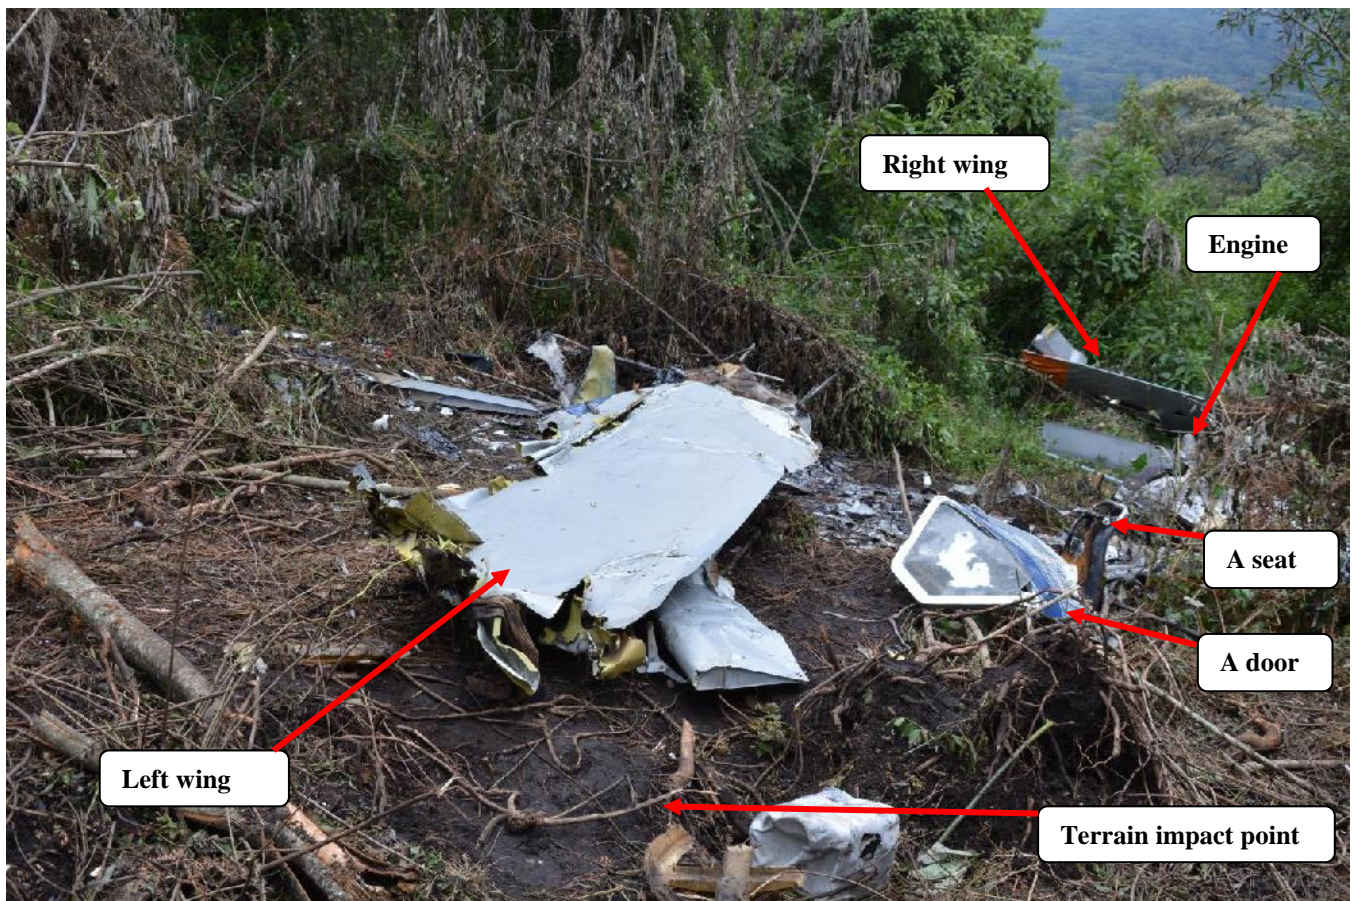
*FIGURE No. 2 - Accident site (Terrain impact point)*

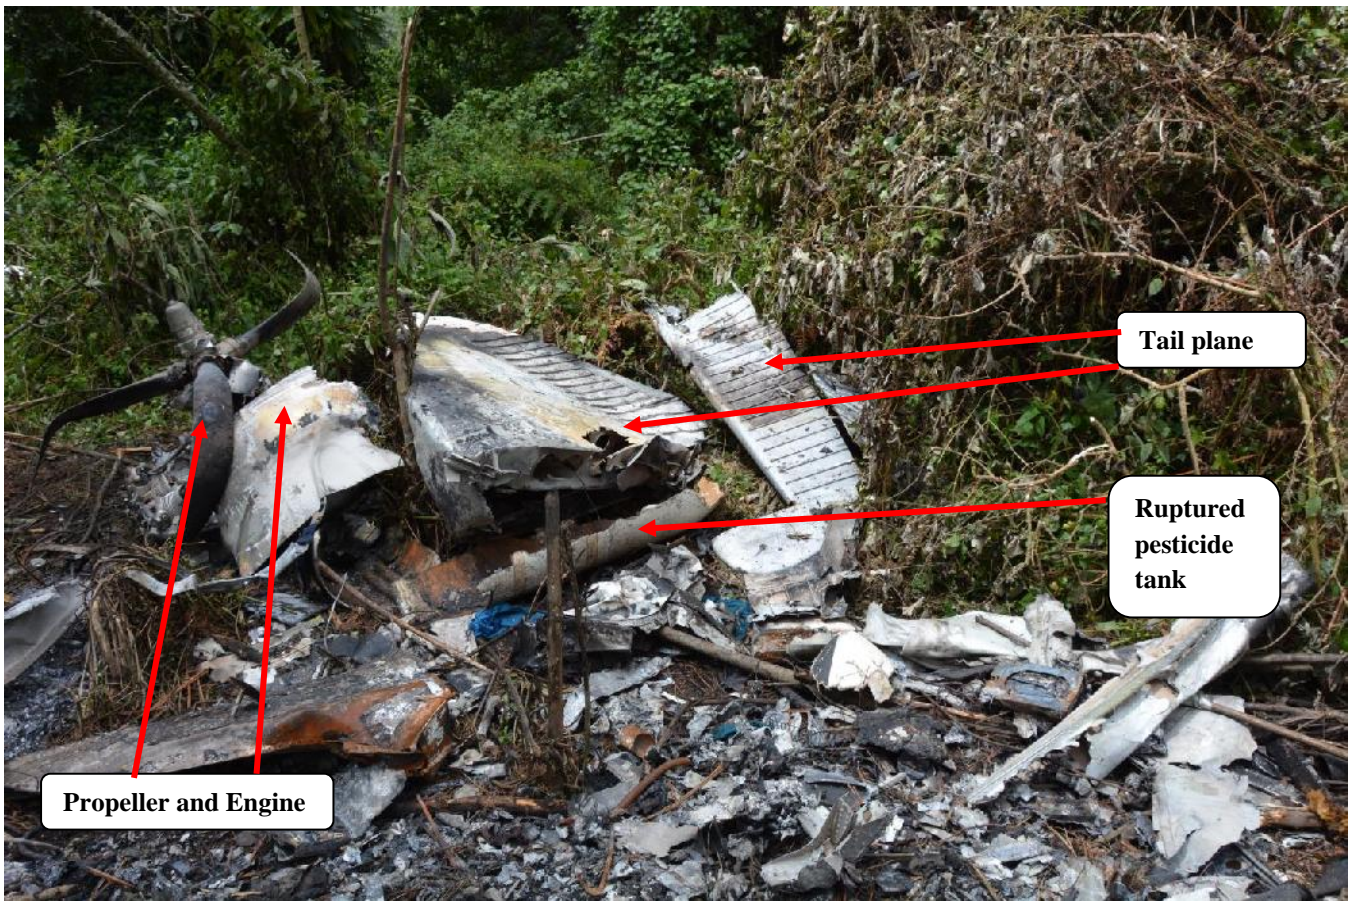
*FIGURE No. 3 - Accident site (engine, propeller and tail plane)*

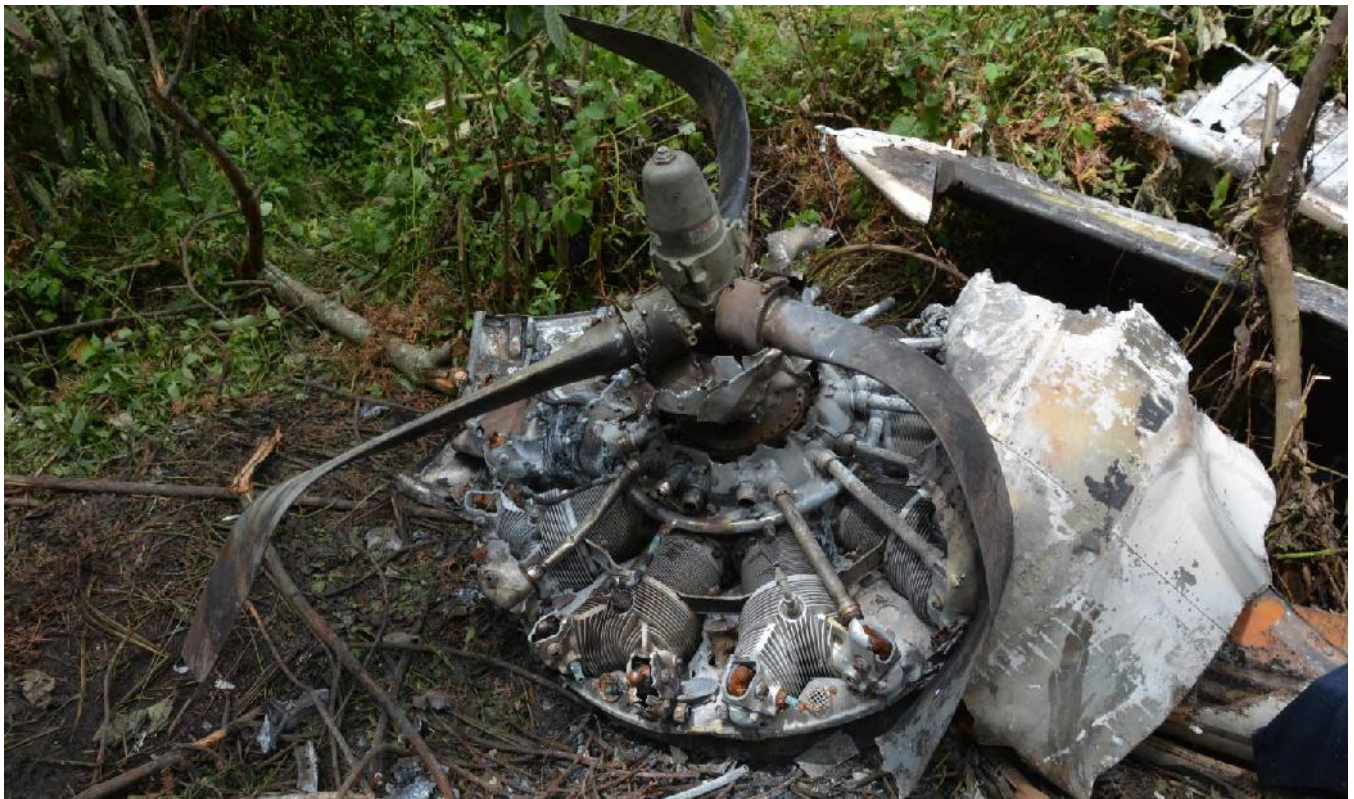
*FIGURE No. 4 - Accident site (A closer view of engine, propeller and part of the tail plane)*

The aircraft was destroyed by impact forces and largely consumed by the ensuing fire.

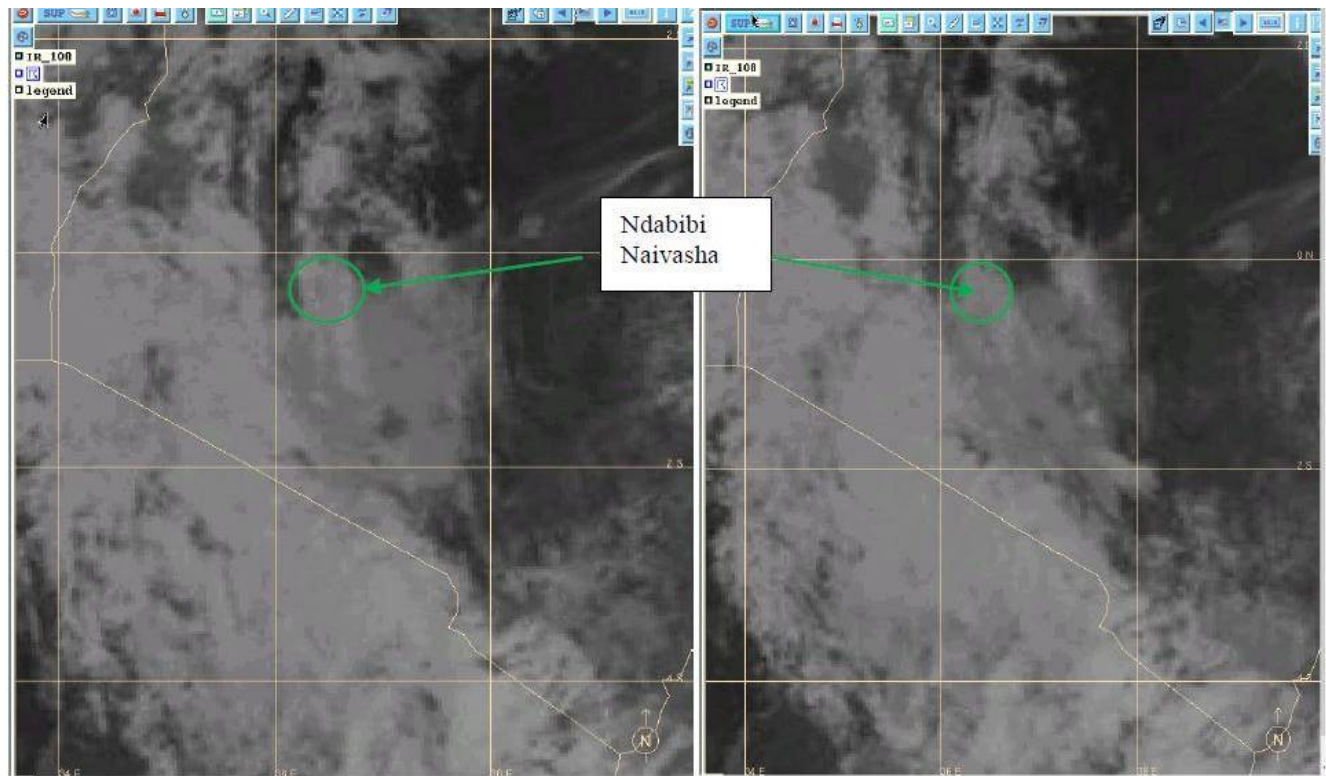
**FIGURE No. 6 – Satellite information: MSG Satellite imageries on 12 July 2021 at 1000 (1300) and 1100 (1400) left and right panels respectively courtesy of the Kenya Meteorological Department**

The prevailing weather conditions report as issued by the Kenya Meteorological Department indicated that at the time of the accident, the area in the vicinity of the accident site had near overcast cloudy conditions. The cloud cover was 6 oktas out of 8 oktas, covering the entire sky with surface winds of 8 knots with no rainfall and few Cumulo Nimbus (CB) clouds at 1,500 ft from the surface.

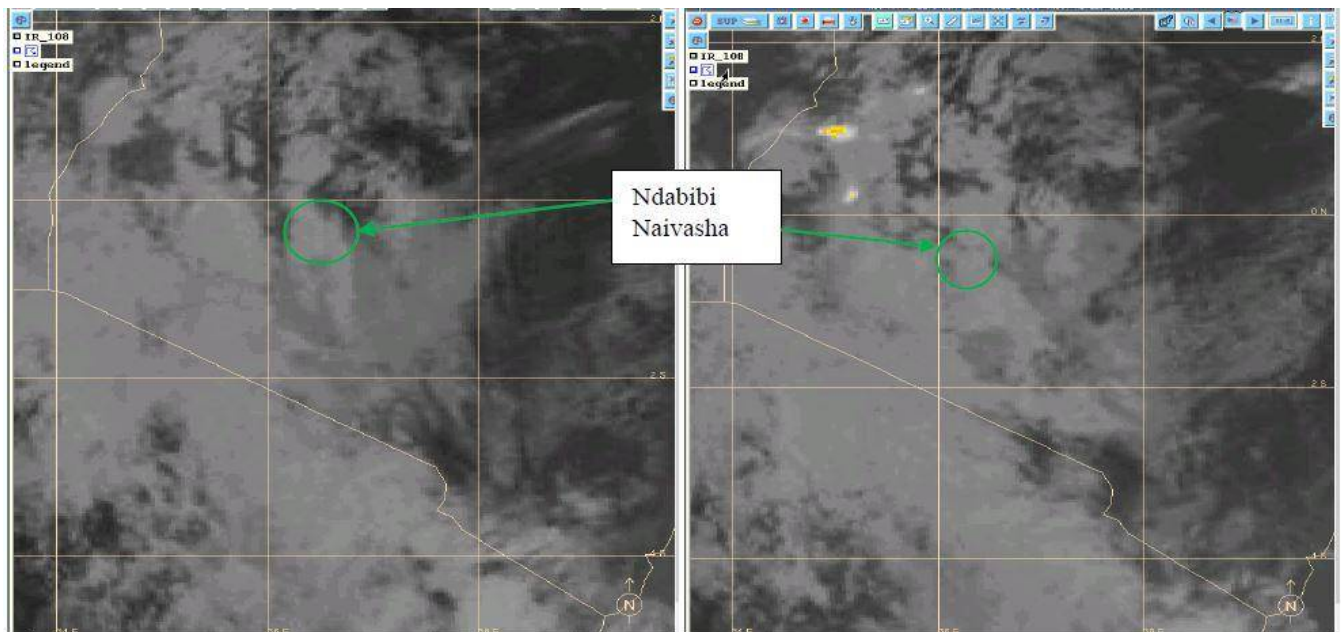
**FIGURE 7 – Satellite information: MSG Satellite imageries on 12 July 2021 at 1200 (1500) and 1300 (1600) left and right panels respectively courtesy of the Kenya Meteorological Department**

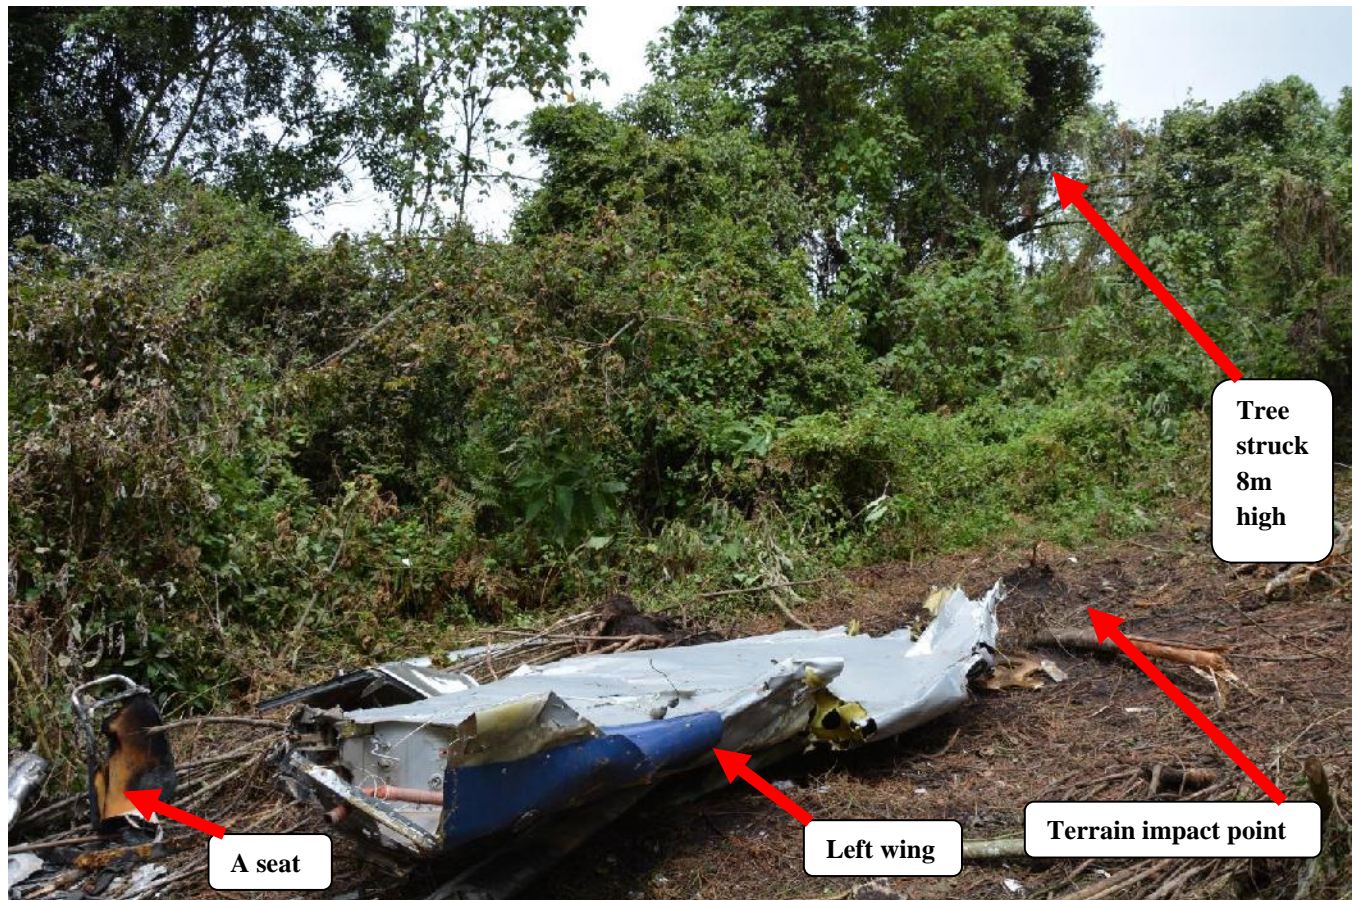
**FIGURE No. 8 - Accident site (the direction of travel is towards the reader)**

The aircraft struck a tree at a height of 8m leaving behind a part of the pesticide tank and moved forward 27m to impact the ground where the left wing was located. At a further 1.1m, the burnt engine and the

propeller were found dislodged from the fuselage. The propeller blades were bent and exhibited rotational damage. The cockpit, all instruments and the fuselage were consumed by fire. The tail plane was burnt and at a further 9m, the right wing was located. Its pesticide tank was damaged. Two sets were recovered burnt and damaged. The entire crash site area measured 18m long by 9m wide.

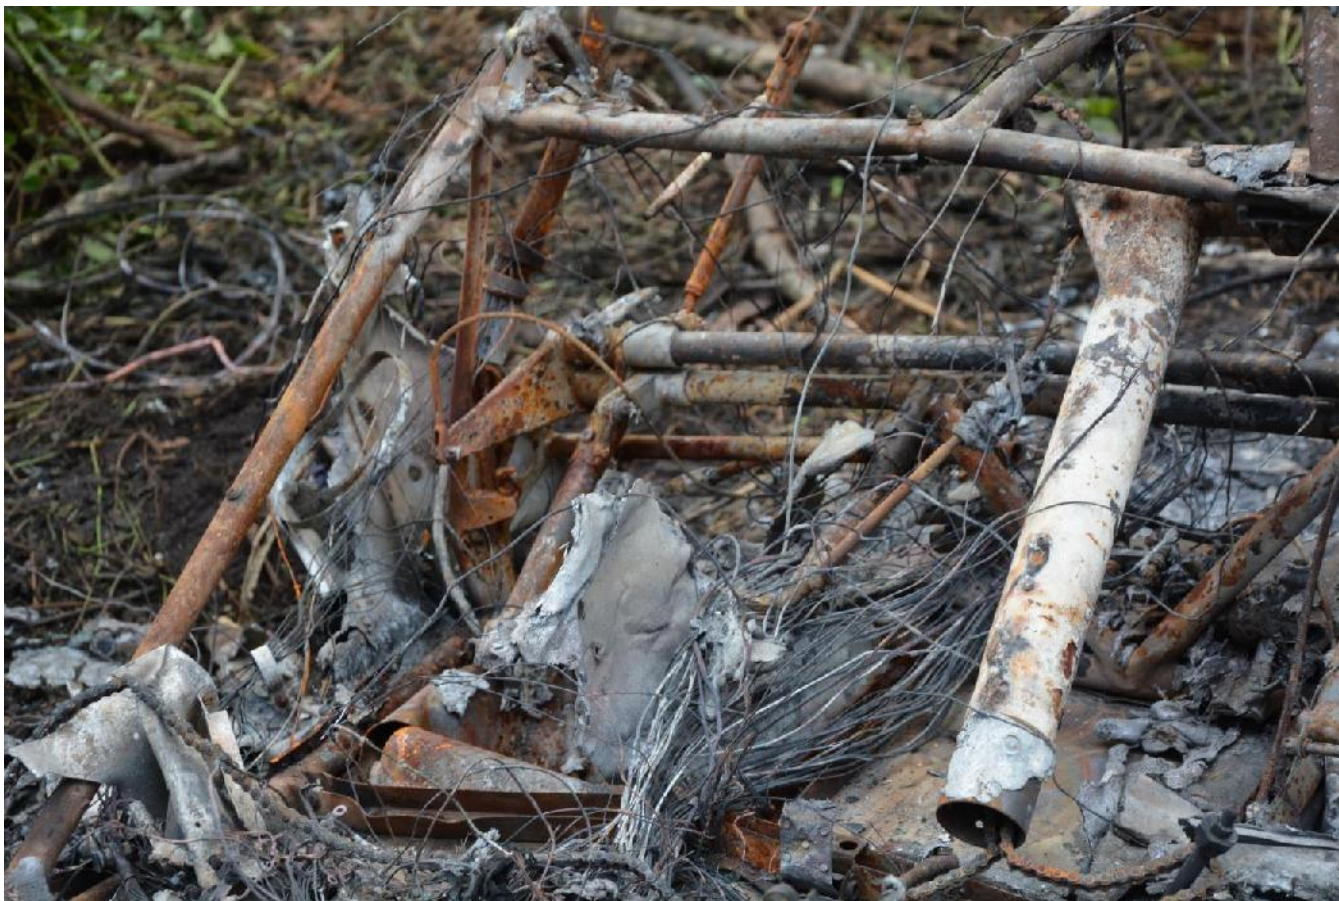
*FIGURE No. 4 - Accident site (the cockpit)*
