AIRCRAFT ACCIDENT INVESTIGATION

PRELIMINARY AIRCRAFT ACCIDENT REPORT TO

CESSNA 208B

REGISTRATION 5Y-JKN

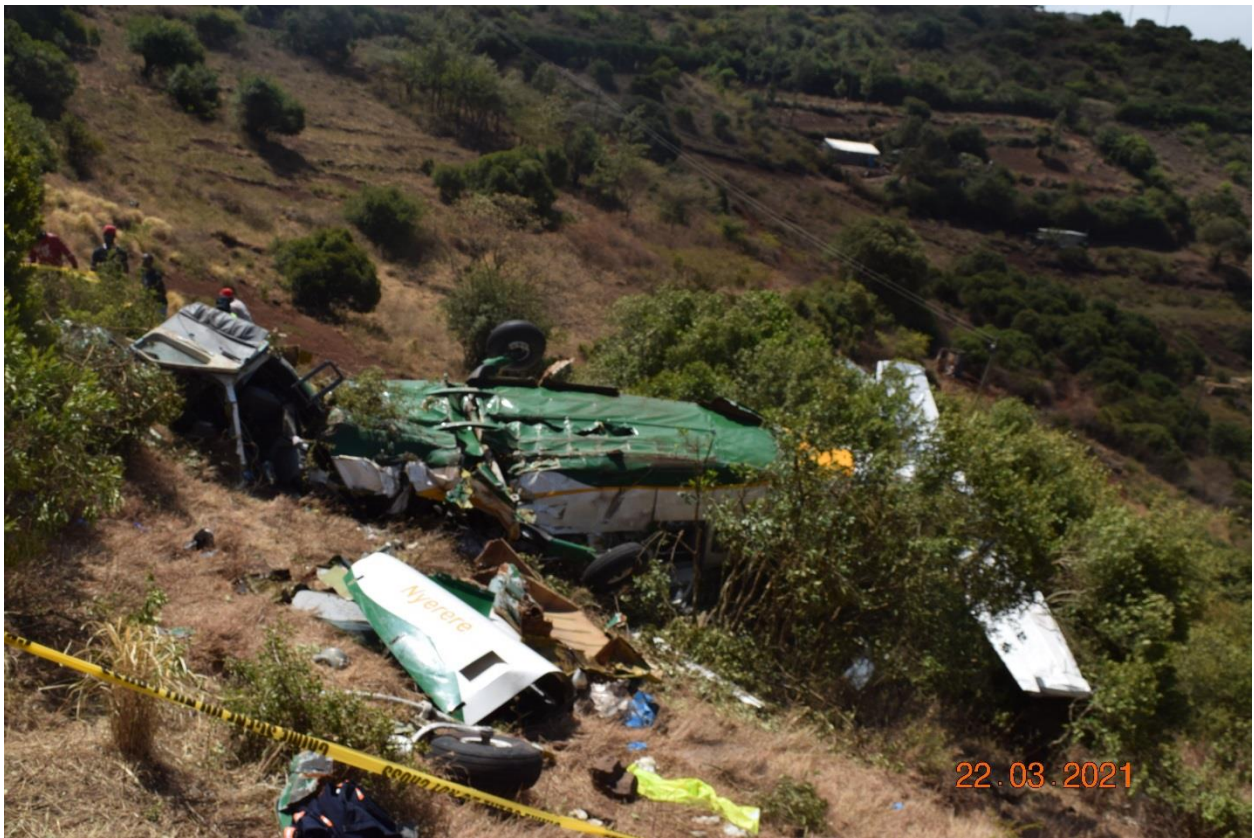
Figure 1: Photograph of the accident aircraft at the accident site

direction. It left a trail of aircraft parts along its path before it came to rest. The nose-wheel and its assembly separated and fell off and was found next to the house 110m from its first point of impact. There was no fire after impact but all the occupants received fatal injuries.

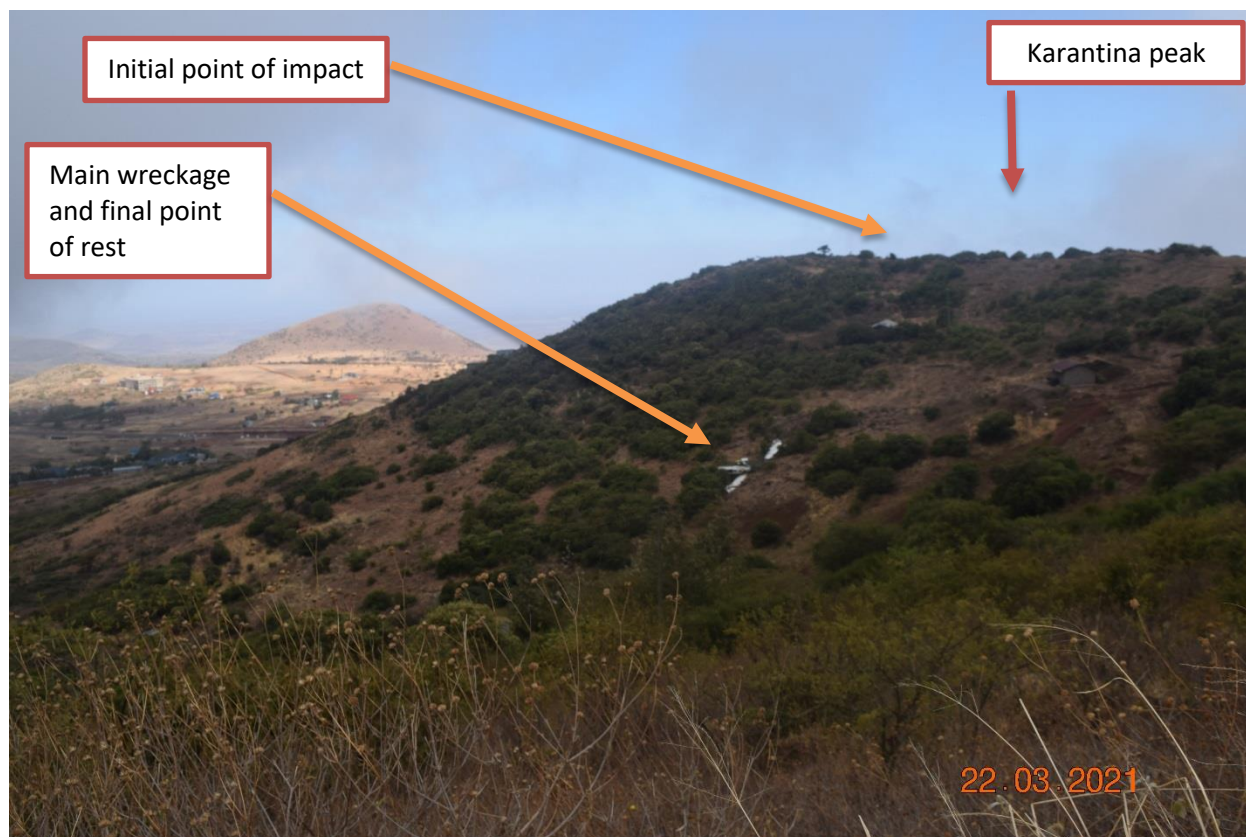
Figure 5: Photograph showing the first point of impact and final wreckage position

The aircraft impacted the hill top with its nose wheel and landing gear after which the nose wheel collapsed and separated. The fuselage also contacted the ground and some parts peeled-off. An iron box containing aircraft oil lubricants, mechanic rags, locking wire and water was found at the first point of impact. A bag containing personal effects for the first officer was also found at the first point of impact. The right wing broke off and separated from the main fuselage but remained near the main wreckage (7m) away. The propeller and its assembly separated and was not accounted for except a single piece of the propeller blade was collected along the path. The nose wheel landing gear was found next to a house along the wreckage flight path.

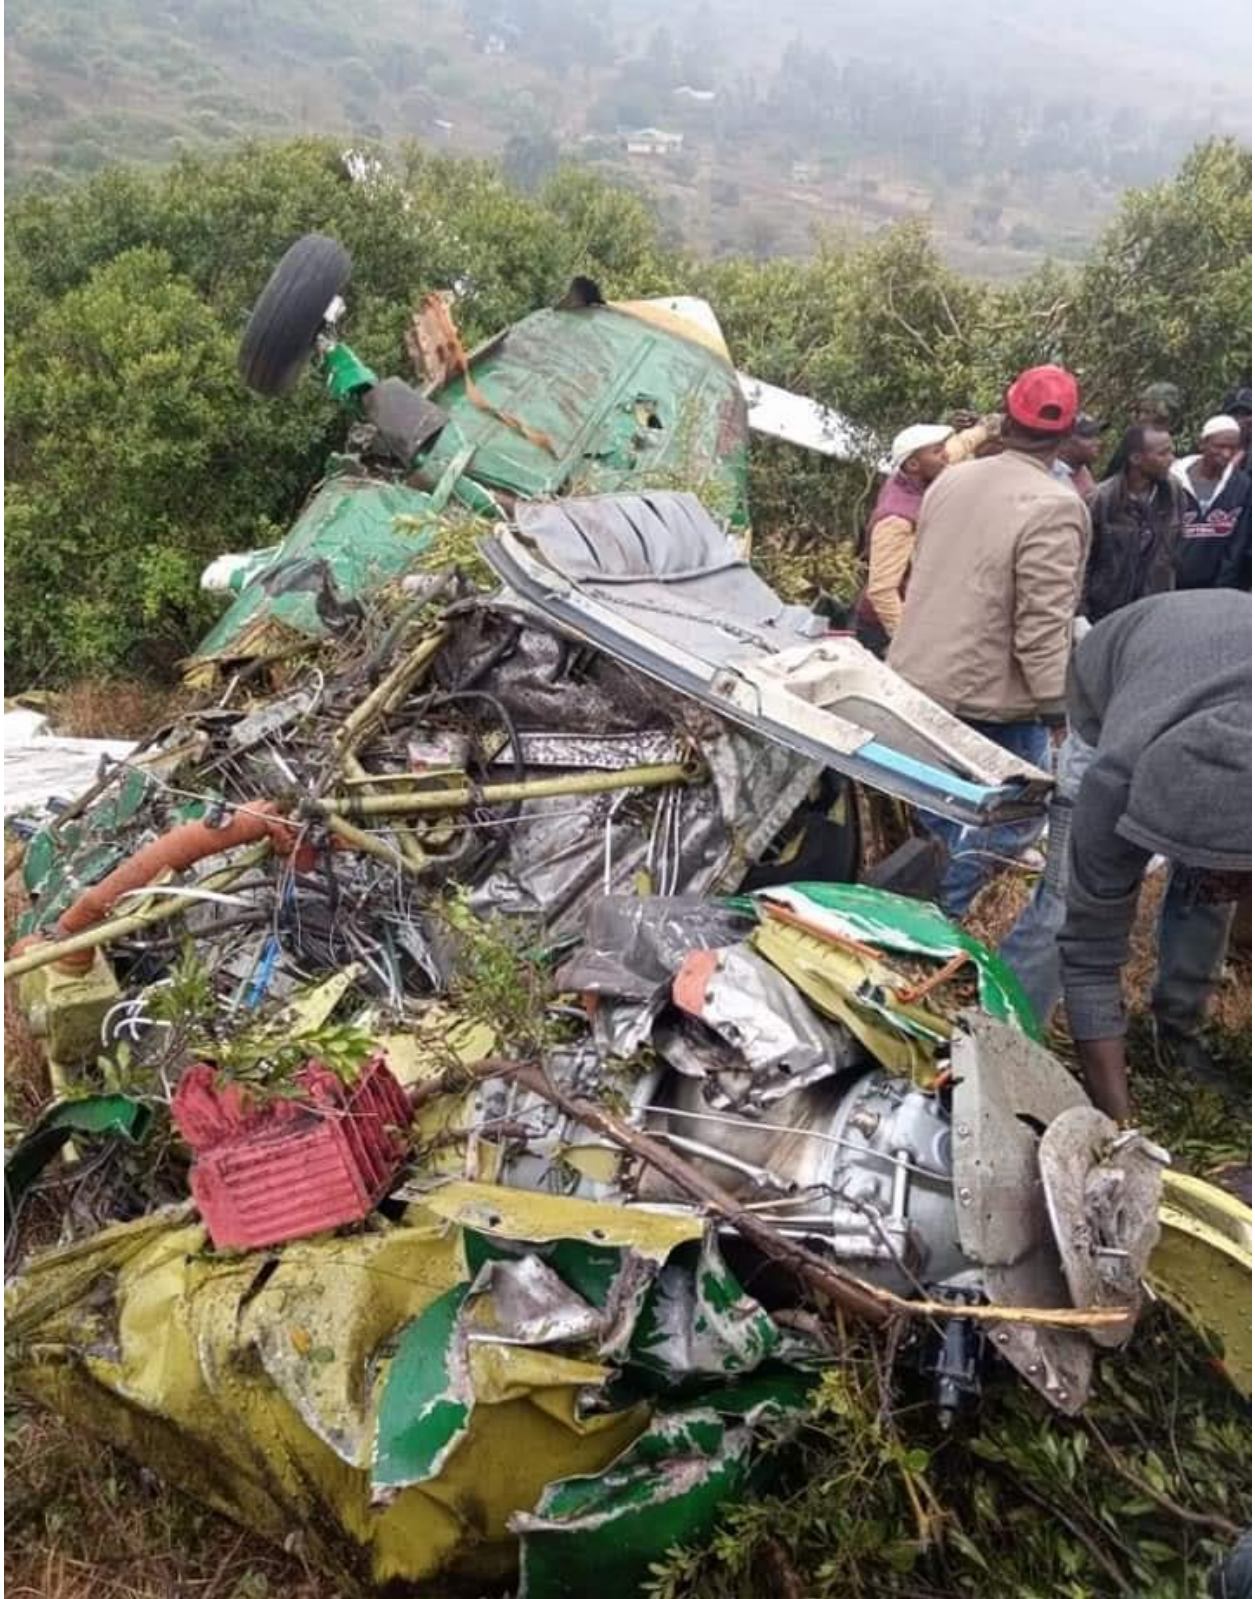
Figure 6: Photograph showing the wreckage of the accident aircraft
