AIRCRAFT ACCIDENT INVESTIGATION DEPARTMENT

PRELIMINARY ACCIDENT REPORT TO

ROBINSON R44 HELICOPTER, 5Y-MEP

ELDAMAT-MELILI, NAROK COUNTY

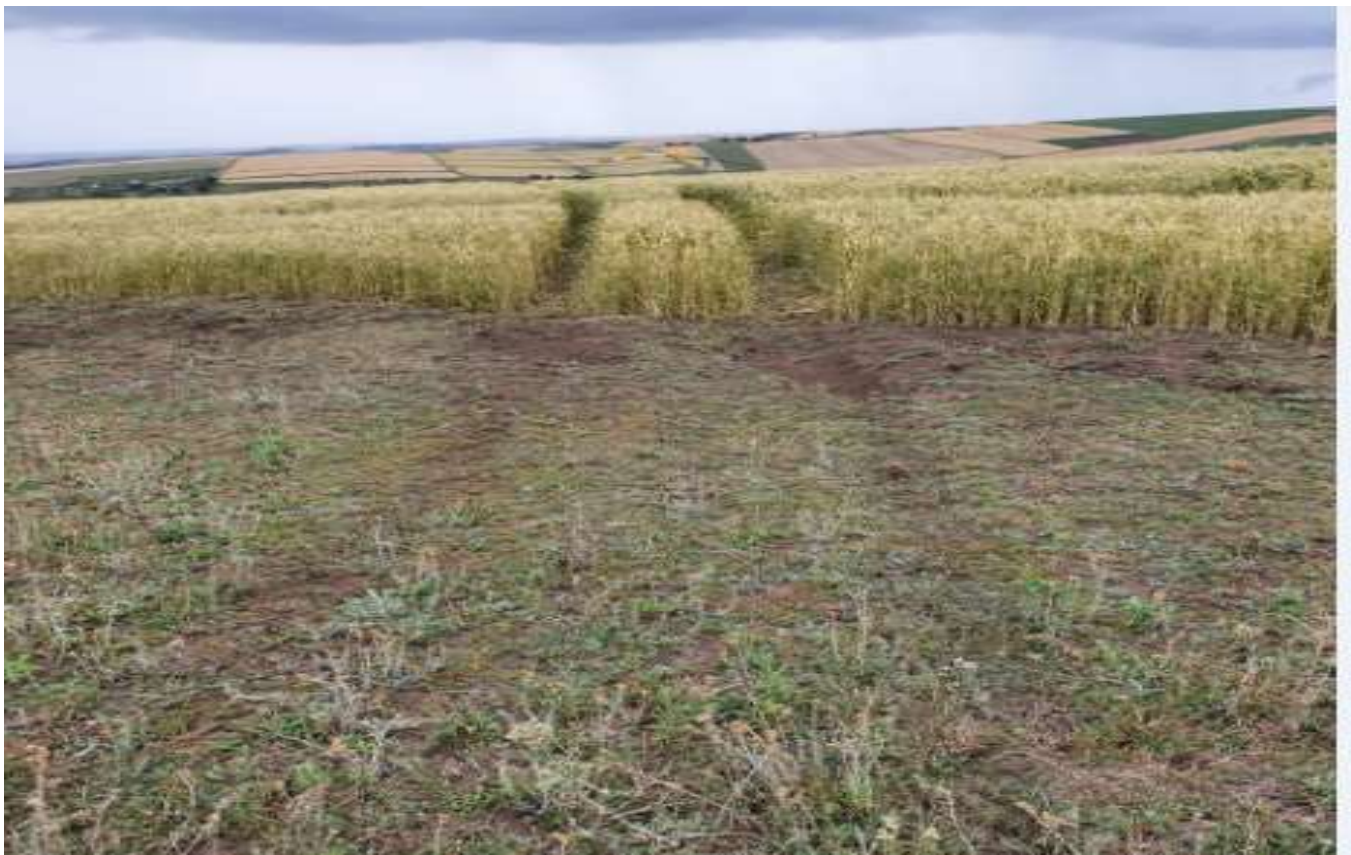
The helicopter lifted off at 1315 (1615) from a wheat-filled area at Melili for Olenkipejus village (see Figure 1). Onboard were the pilot, the governor, and his security guard. The Governor occupied the left front seat while his guard occupied the left rear one.

Figure 1: The Wheatfield area

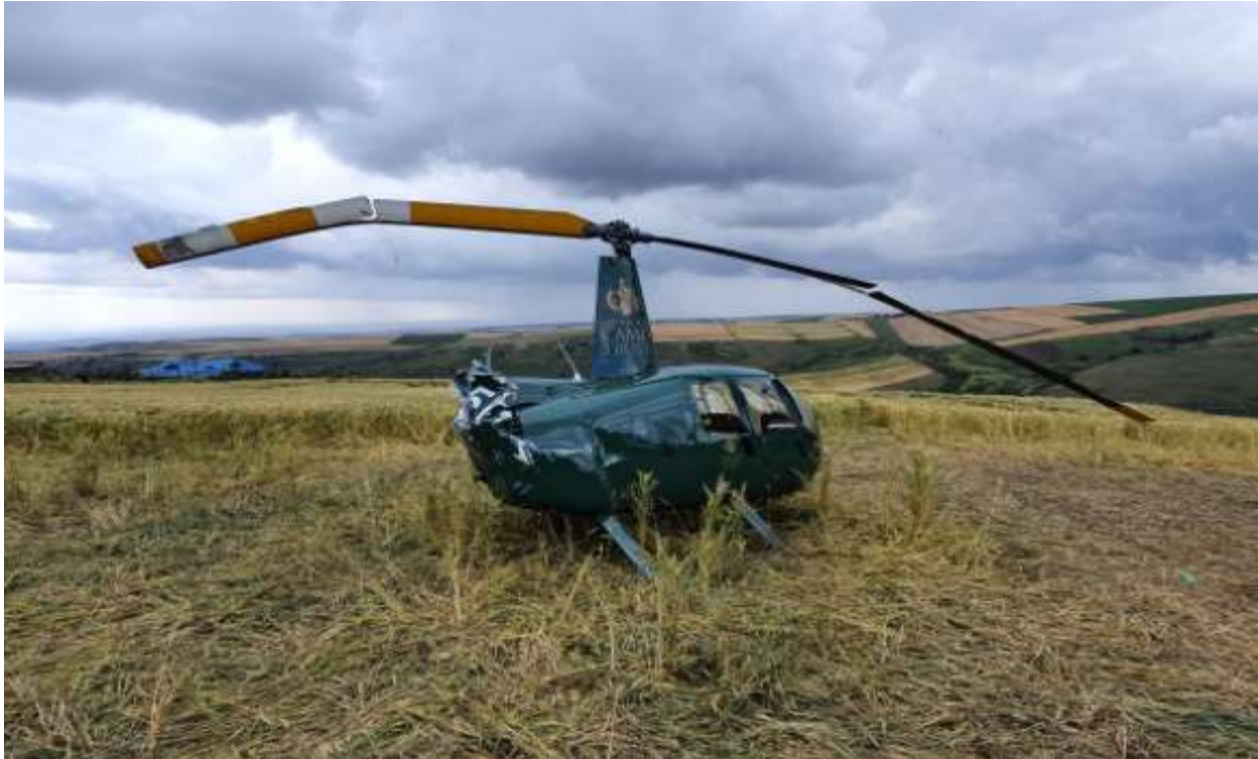
The helicopter was substantially damaged.

Figure 2: The wreckage of the helicopter

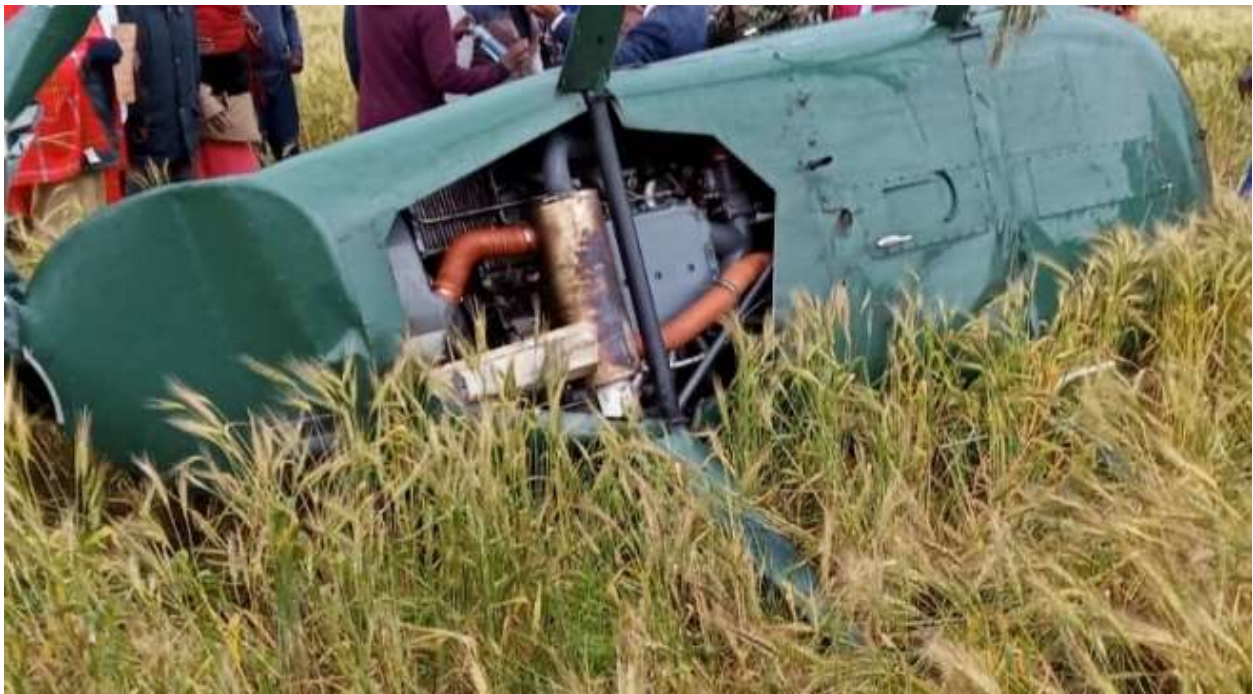
The impact point was approximately 100m to the south of the lift-off position. The wreckage rested on a slightly sloping Wheatfield surface with the fuselage toppled to the left. The engine remained attached to the airframe with no deformation. The fuel tanks were intact.

- (a) The left skid was substantially damaged.
- (b) The main rotor blades remained attached to the helicopter but were significantly bent and twisted.
- (c) Both blades of the tail rotor were intact although detached from the tail boom.
- (d) The tail boom was severely fractured and detached from the main wreckage.

Figure 6: Helicopter Wreckage

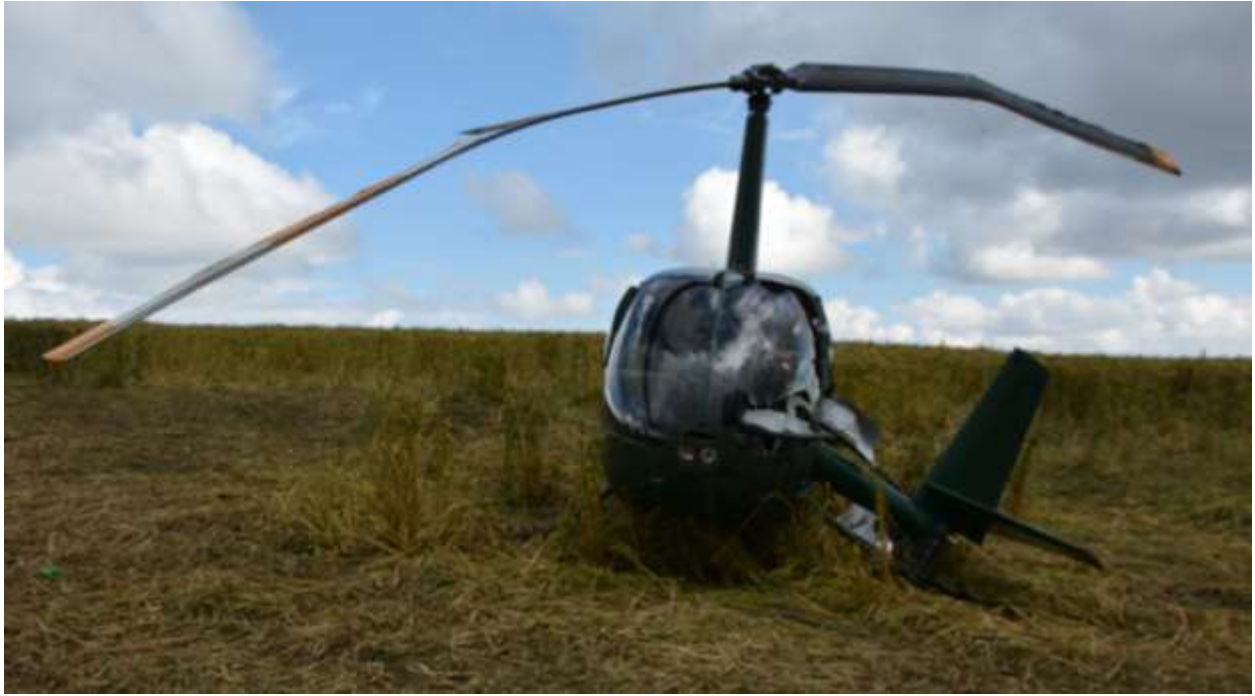
Figure 7: Helicopter Wreckage after it was tilted with the detached tail rotor on the side.

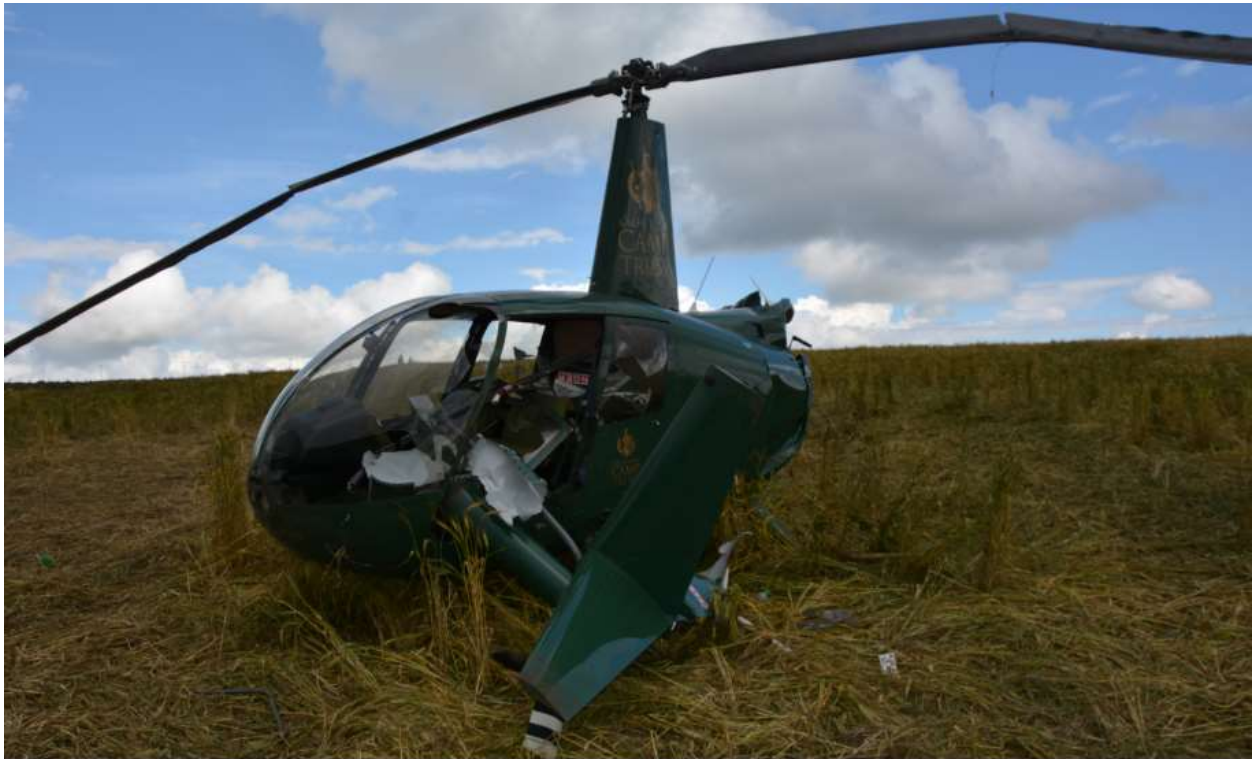
Figure 8: The wreckage after it was tilted.

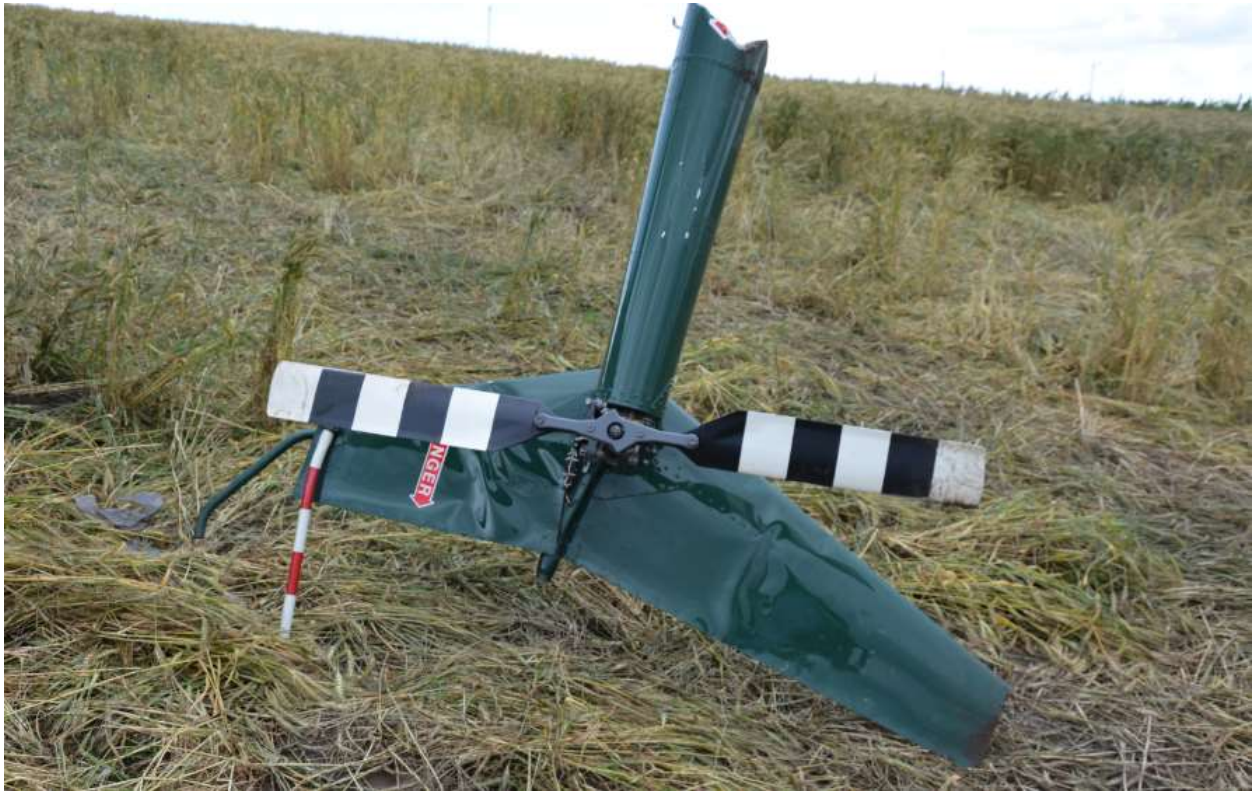
The helicopter eventually came to rest on its left side after the nose tipped over with the tail boom section detached from the main body. The tail boom severely fractured, locally twisted, and bent to the starboard near the damper bearing of the tail rotor drive shaft. The left skid was substantially damaged. The main rotor blades remained attached to the helicopter but were significantly bent and twisted. Both blades of the tail rotor were severed.

Figure 9: Damaged tail rotor assembly

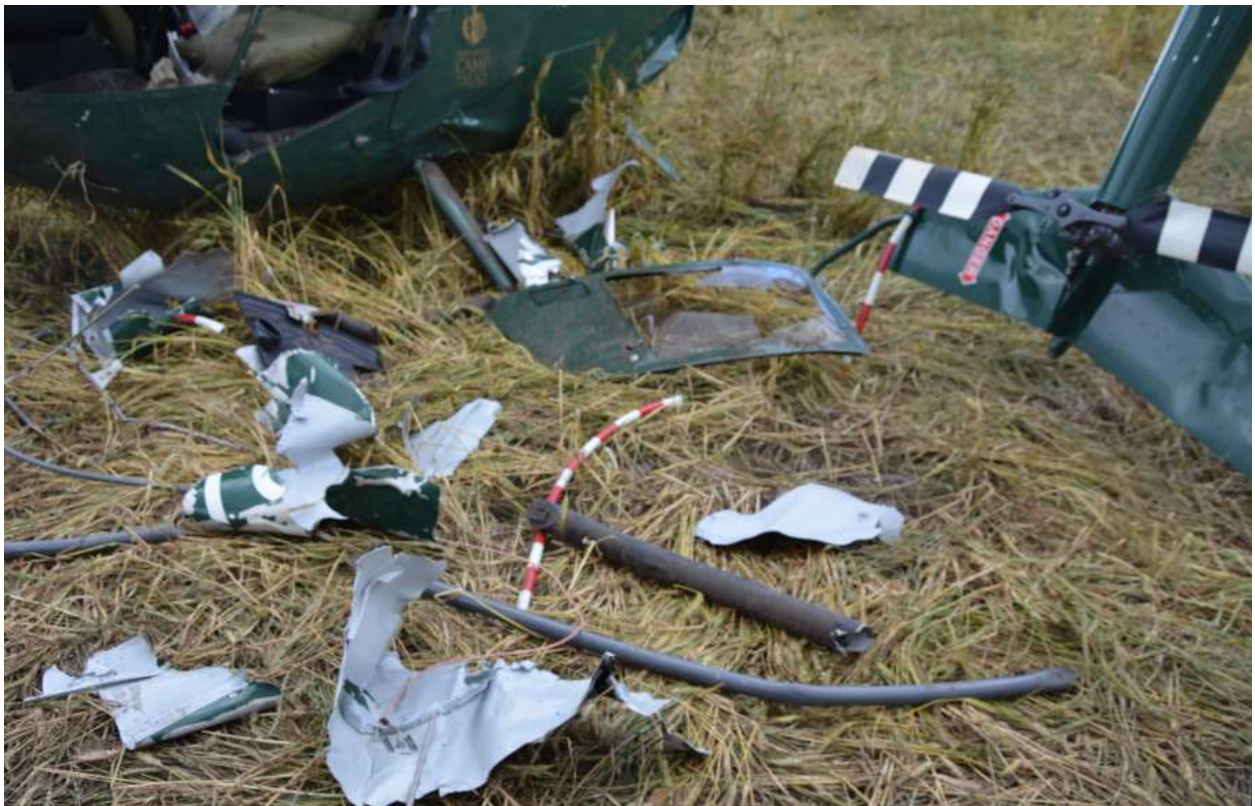
Figure 10: Helicopter damaged components
