**AIRCRAFT ACCIDENT REPORT 06/2020**

**REPORT ON THE ACCIDENT TO AGUSTAWESTLAND  
AW119 MK II REGISTRATION 5Y-NPW OPERATED BY  
NATIONAL POLICE AIR WING  
AT MERU, KENYA ON 13 JUNE 2020**

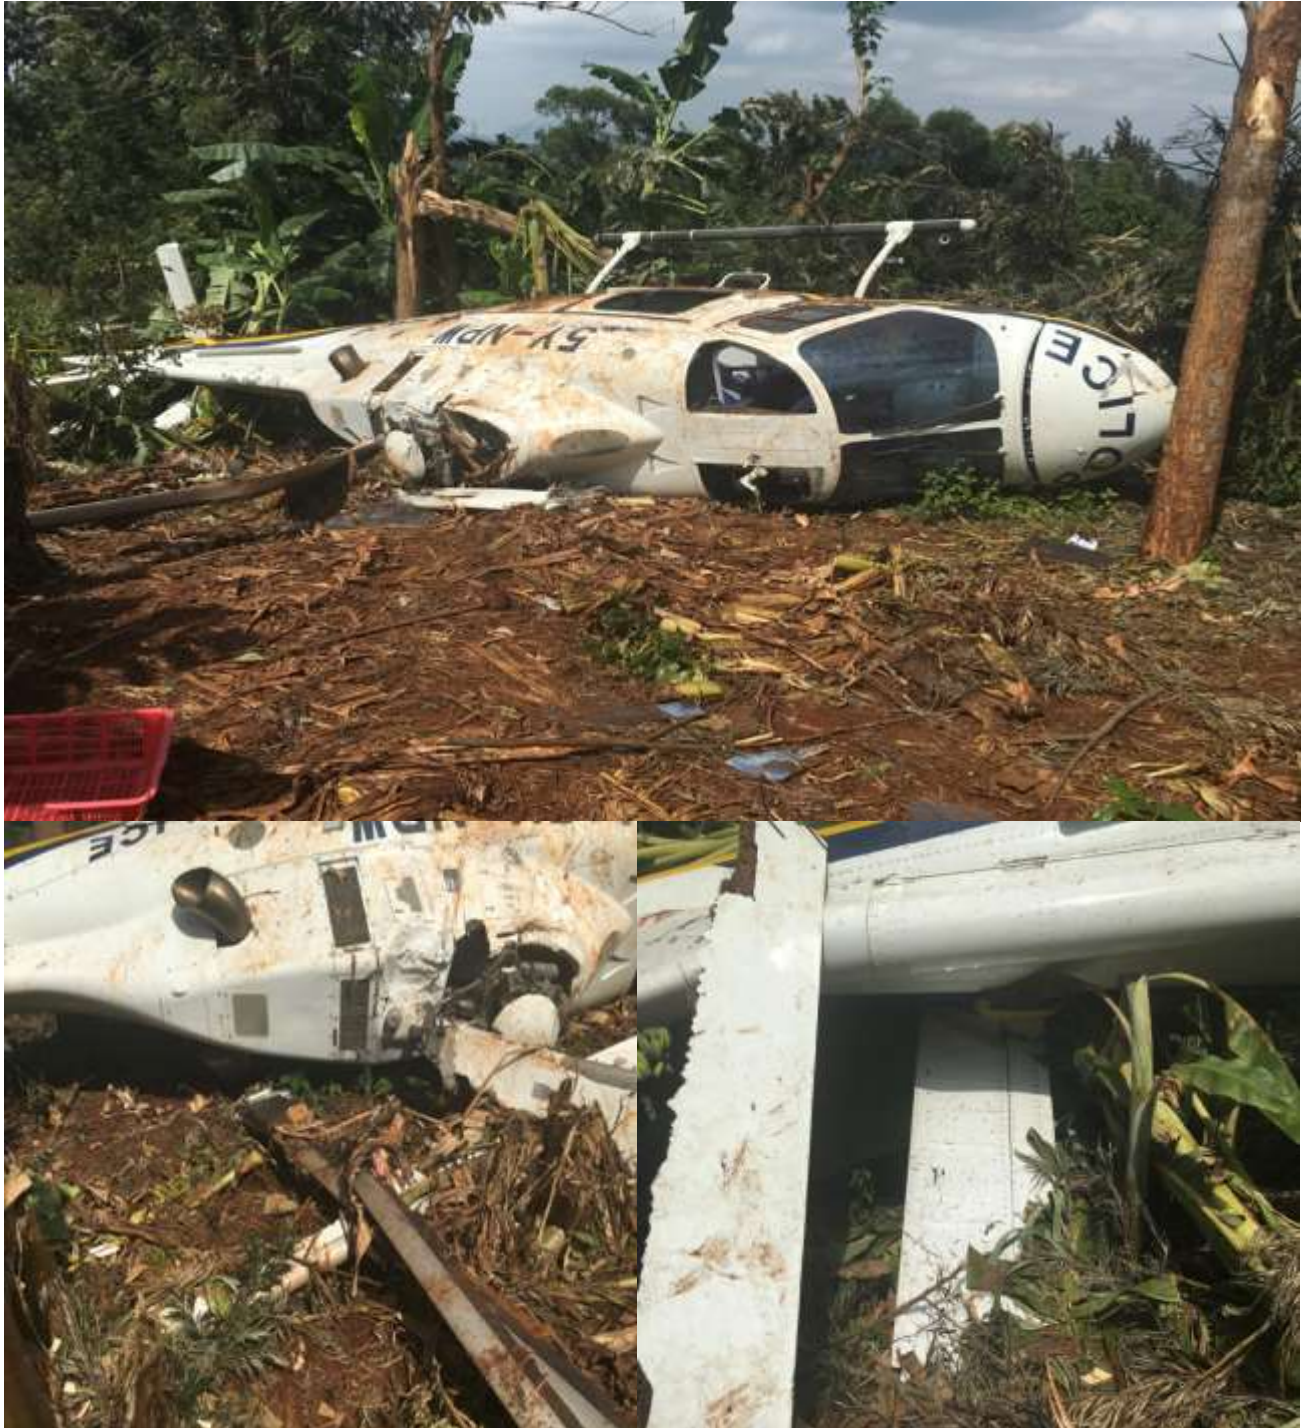
The cabin of the helicopter was intact after the accident. All occupant seats were neither damaged nor distorted. The cockpit doors and cabin doors were intact without deformation and their function was normal. The Nose sections showed significant structural damages. All components were recovered and accounted for at the accident site.

Figure 1: The wreckage of the damaged aircraft

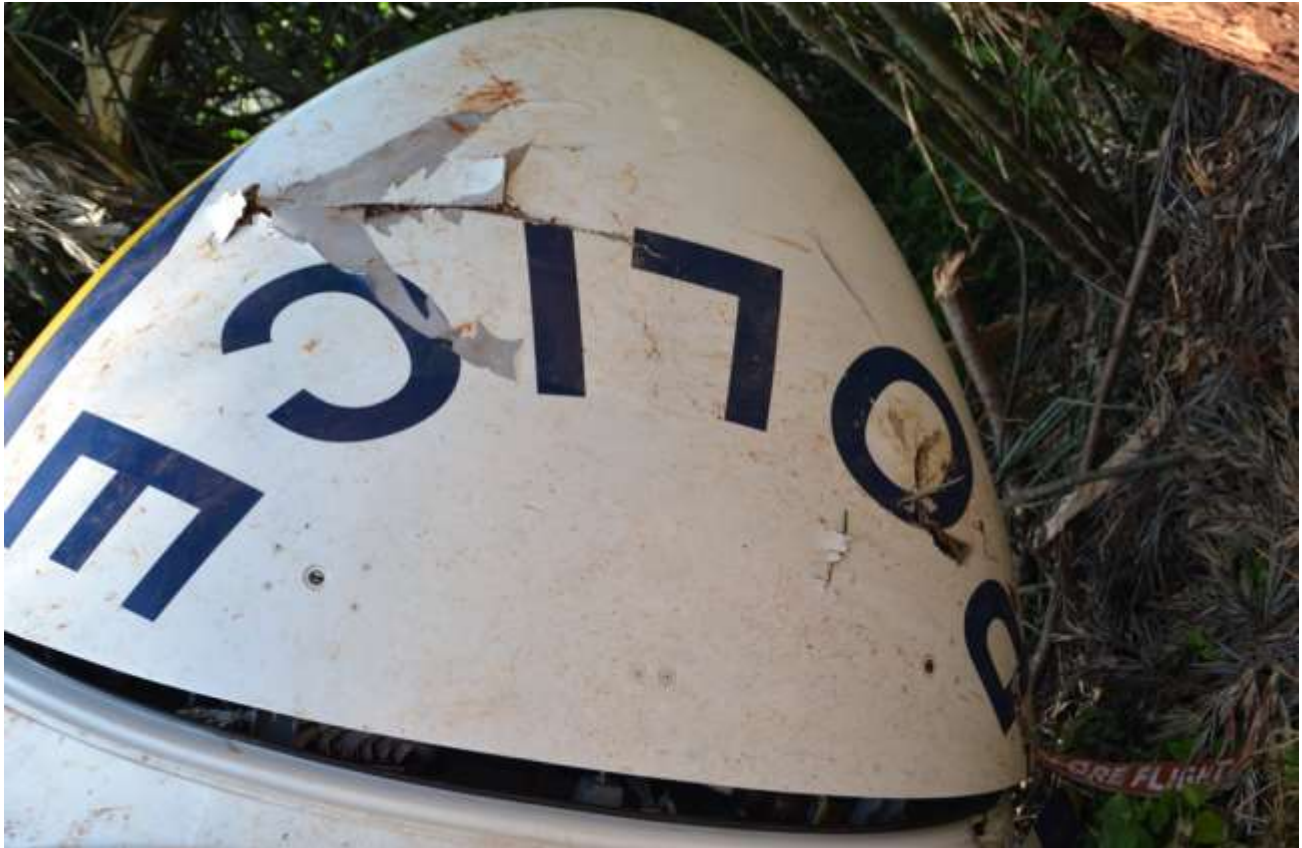
The four glass-fibre composite blades, severed from the main hub at the root. Pitch links and the damper disconnected from the main hub. The Right horizontal stabilizer was found damaged.

Figure 2: The damaged section of the fuselage

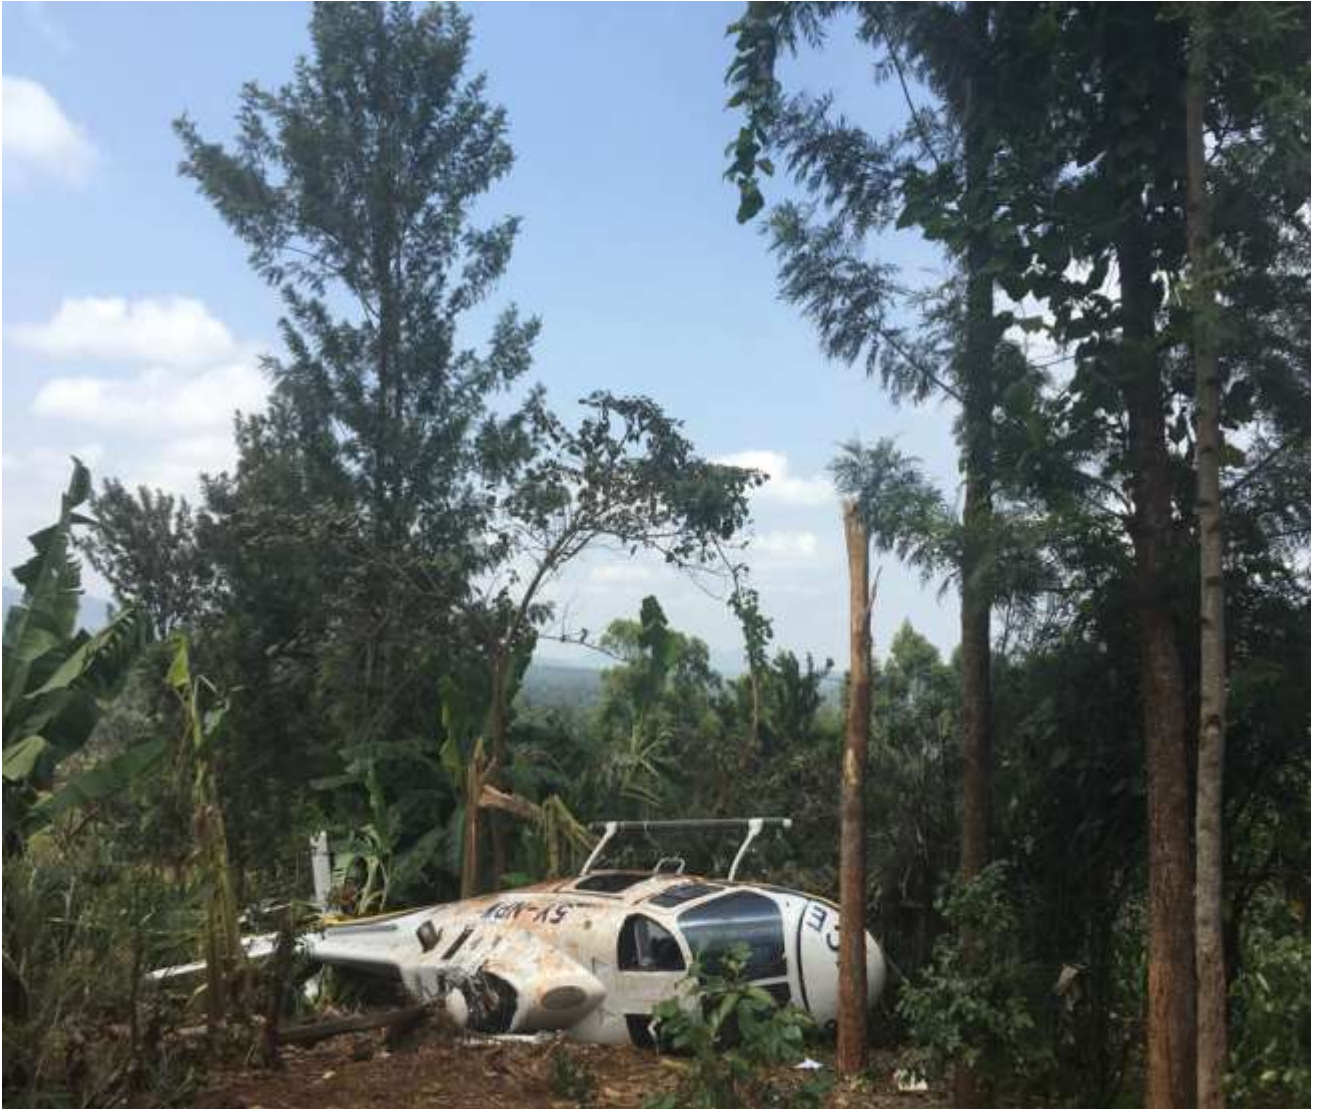
Trees around the accident site and in the path of the flight were found cut from the top by the main rotor blades of the helicopter. Both the surrounding trees and part of the ground suffered lesions after contacting the propellers.

Figure 3: The wreckage at the accident site

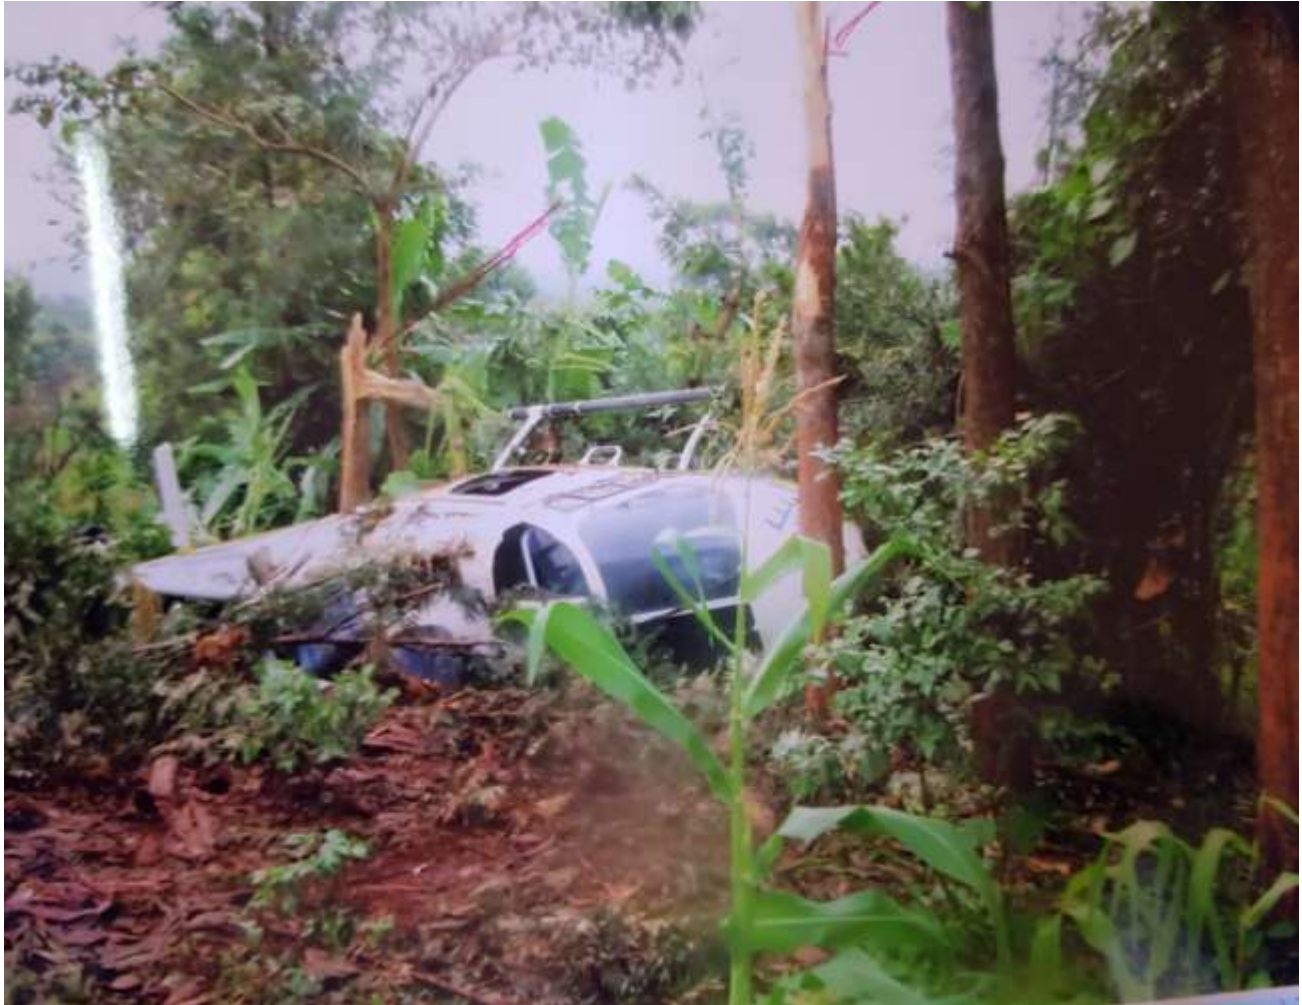
The reported weather by the Kenya Meteorological Department indicated that the weather conditions at the location of the accident at the time of the accident were: generally calm winds, the total cloud cover was overcast OVC (8/8 Oktas) at a height of 1000 feet from the surface in fog.

Figure 8: A picture taken just after the accident depicting fog

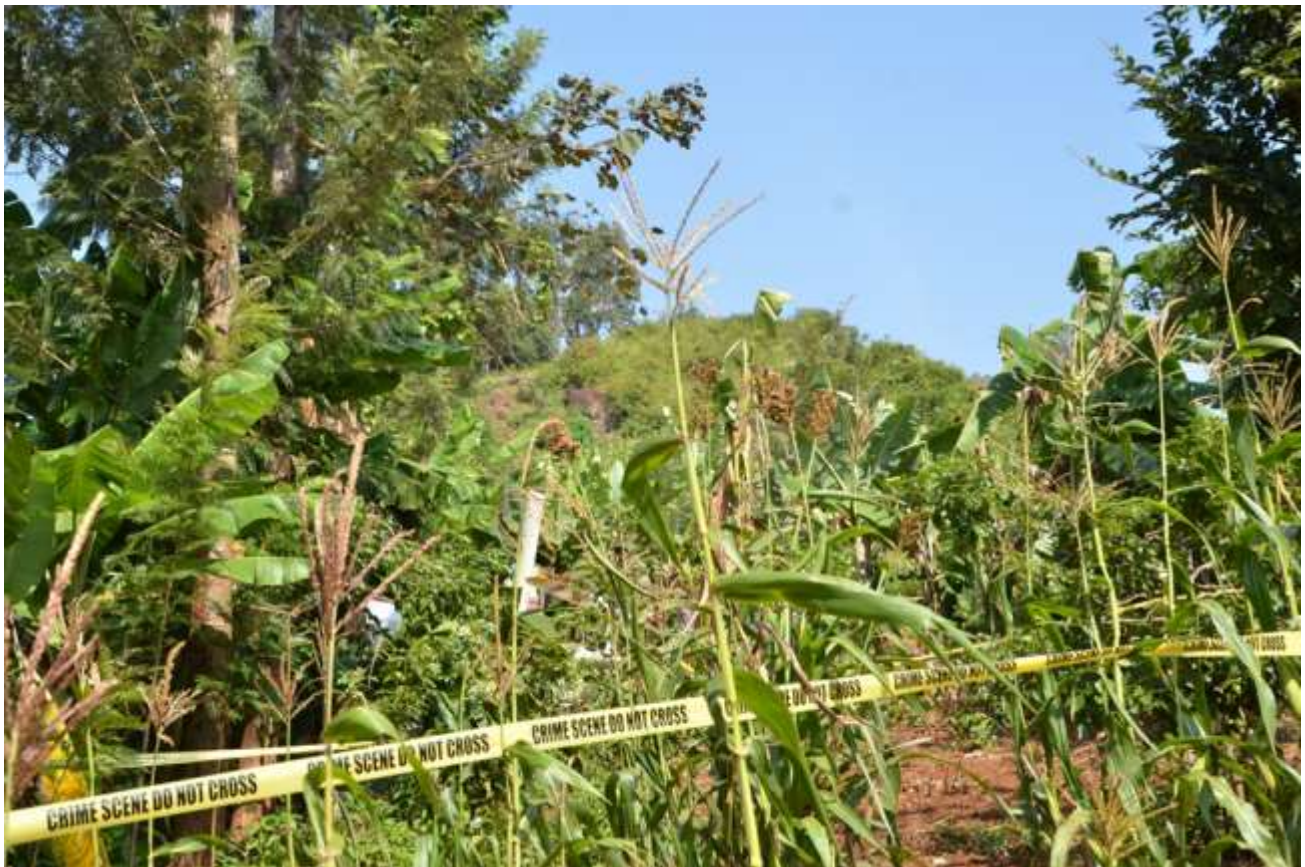
Figure 9: The helicopter collided with terrain at Kaithe location 5 nm South East of Meru town close to Cyompiou hill.

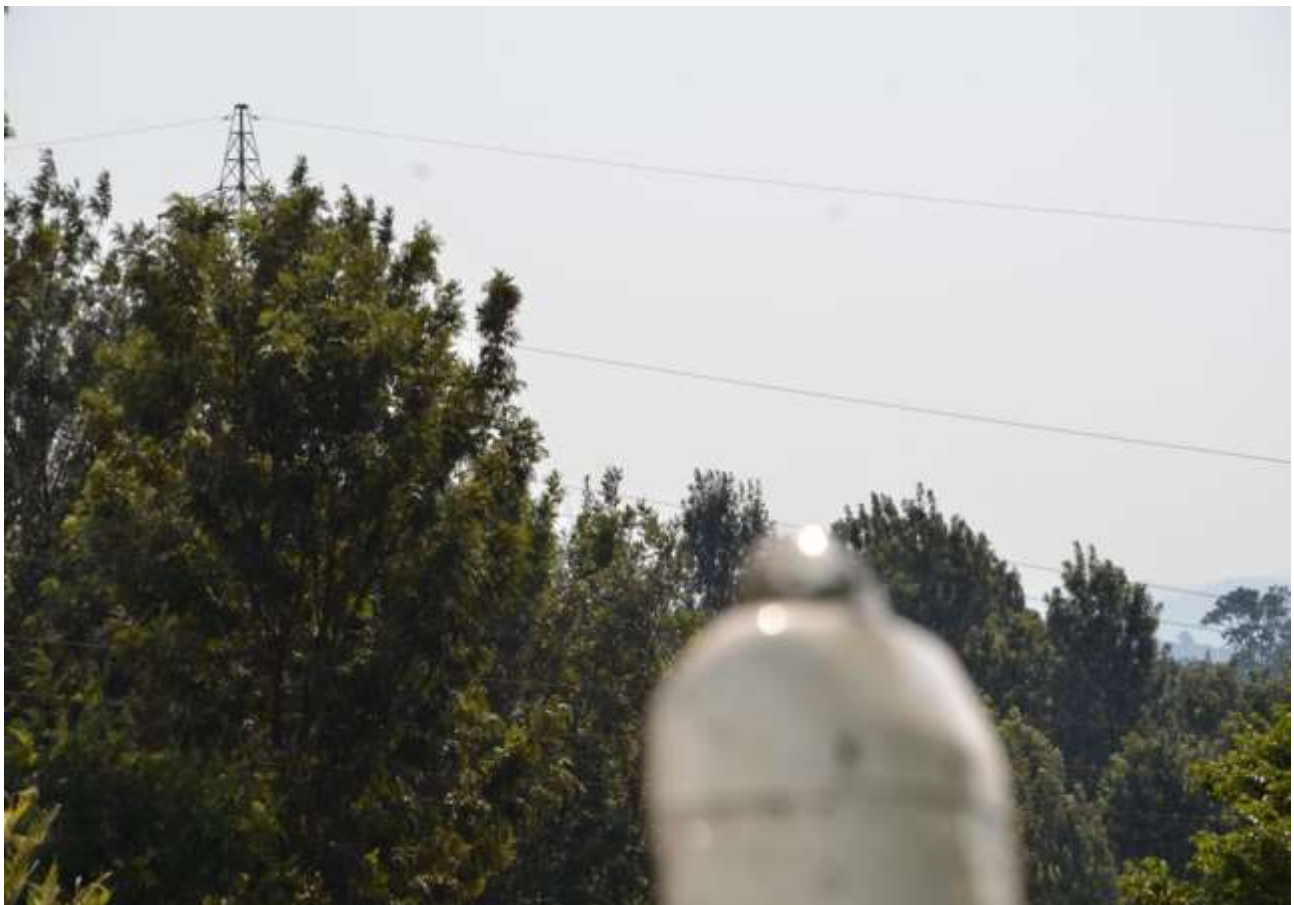
Figure 10: The aircraft evaded the mast shown in the picture

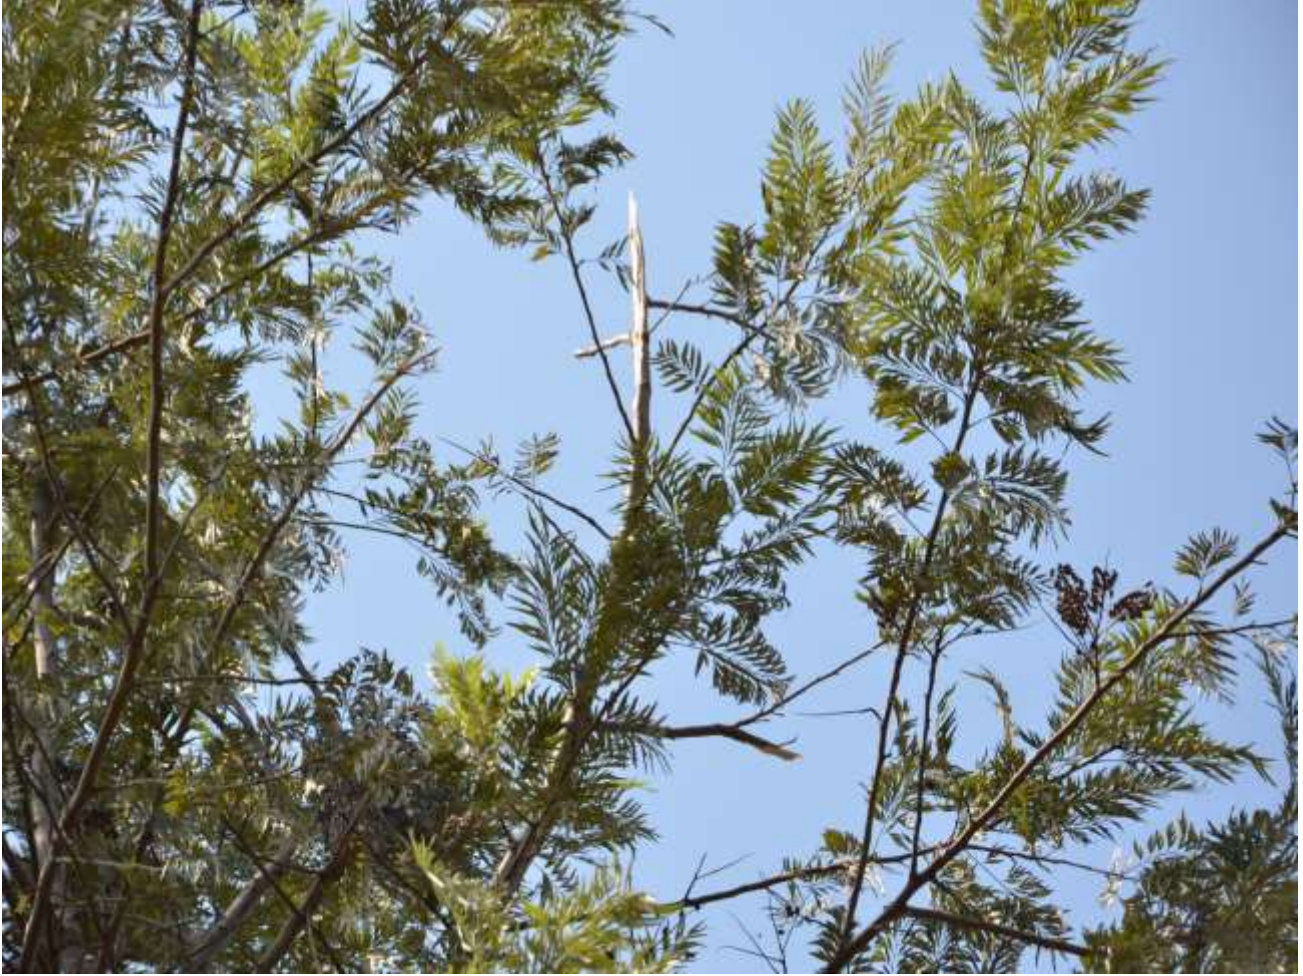
Figure 11: The tree branch that first came in contact with the main helicopter rotors

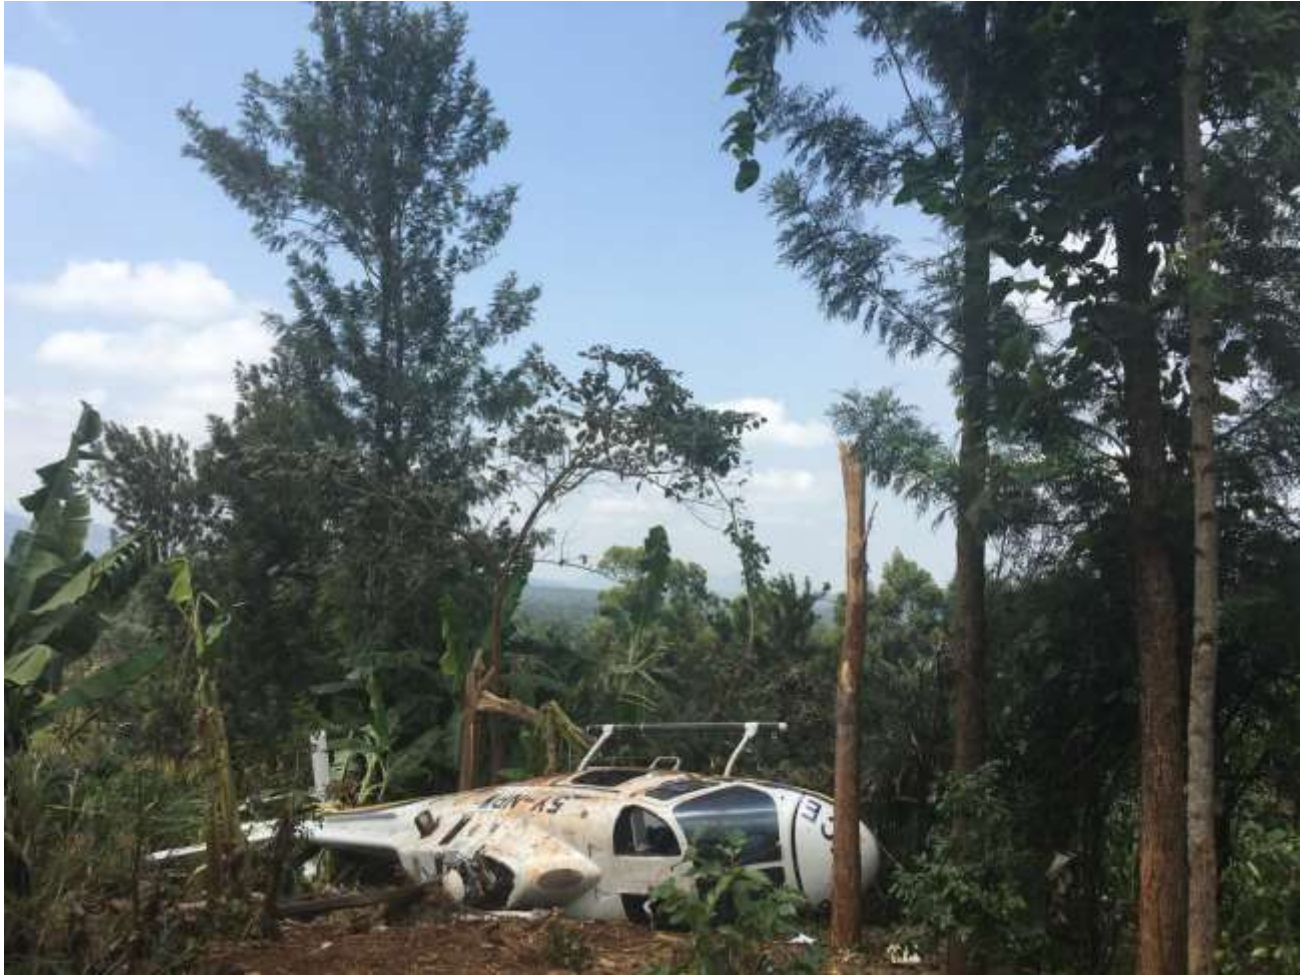
Figure 12: The wreckage and the trees that were involved in the occurrence

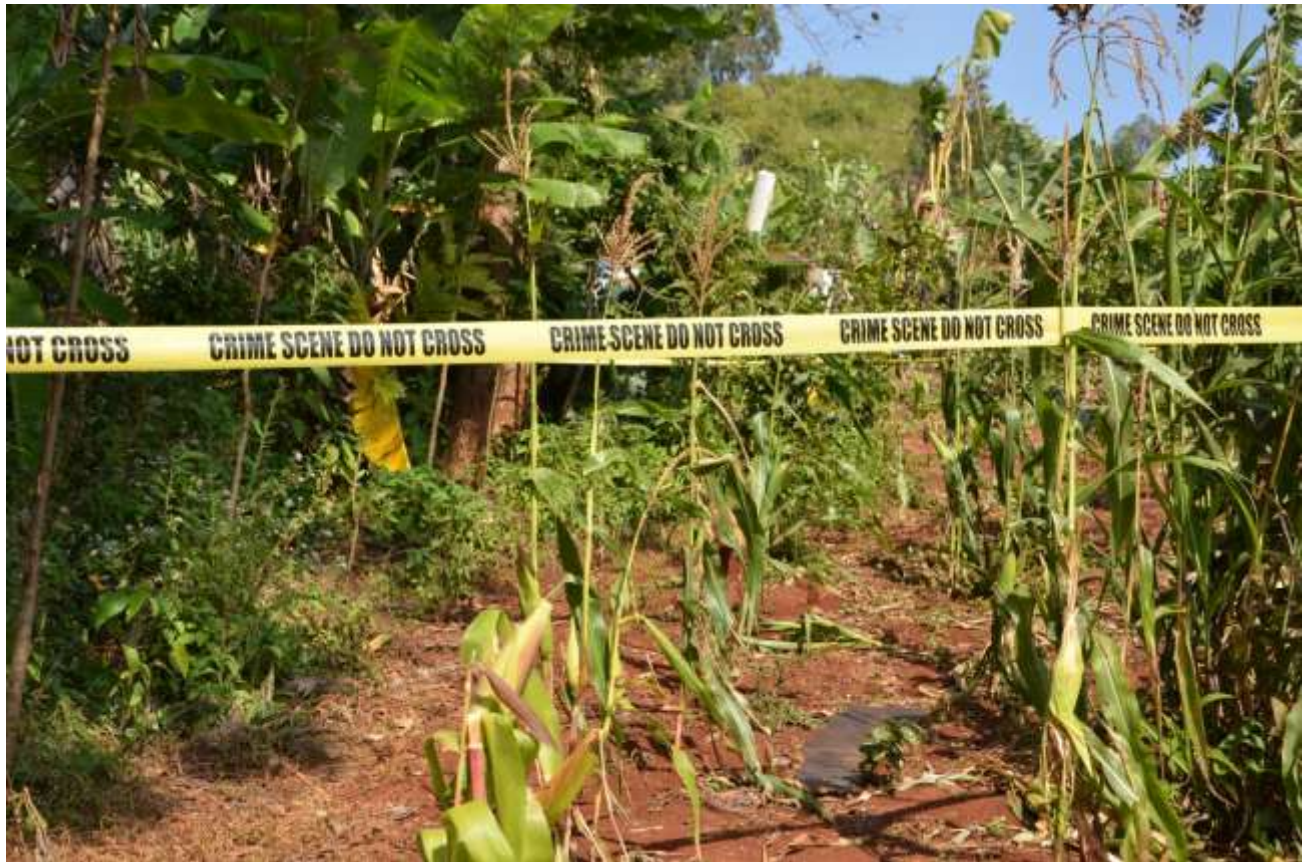
The helicopter was basically intact, except a portion of the main rotor blade which was strewn 15 metres along the flight path from the main wreckage. All the helicopter parts were accounted for at the accident location. There was no evidence of inflight break up.

Figure 13: Part of the main helicopter rotor

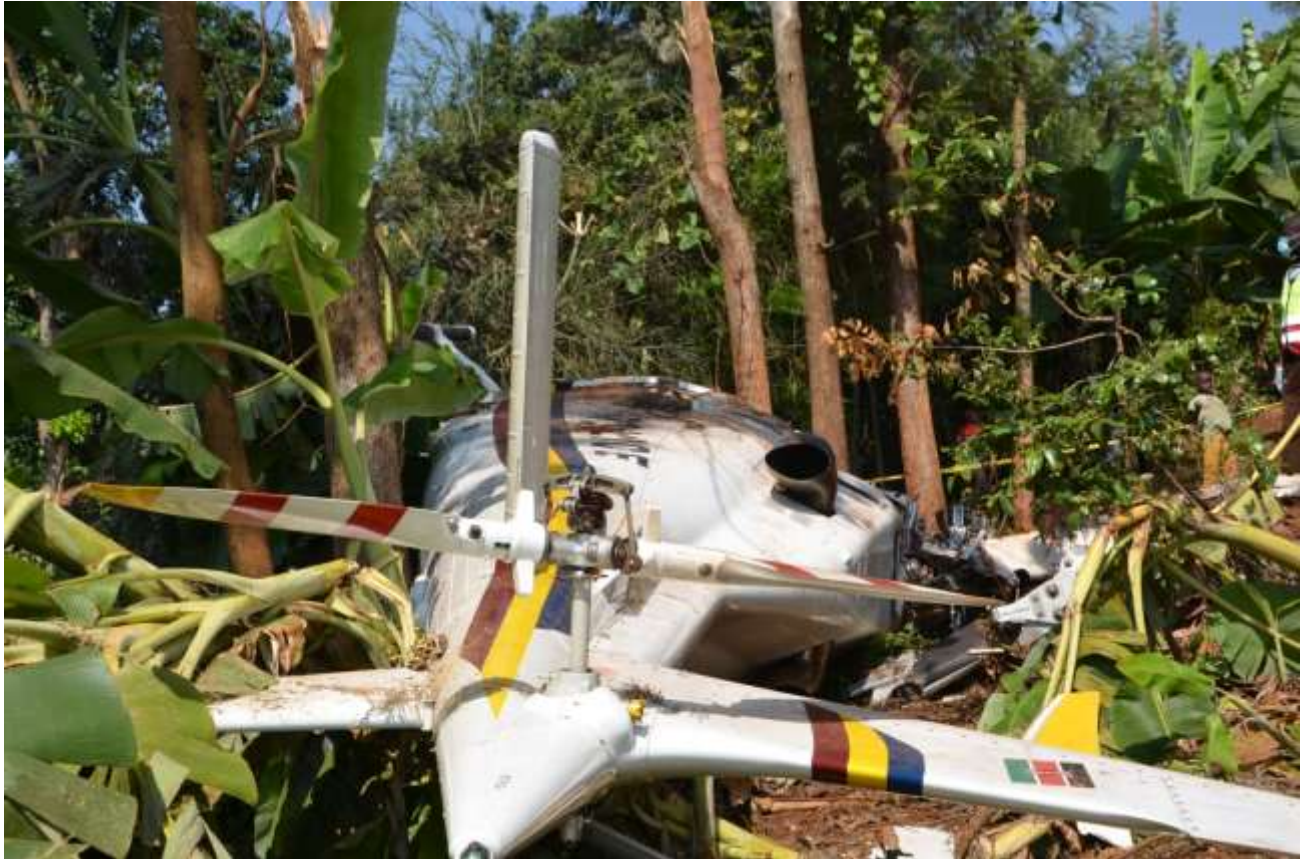
Figure 14: The helicopter tail rotor still intact

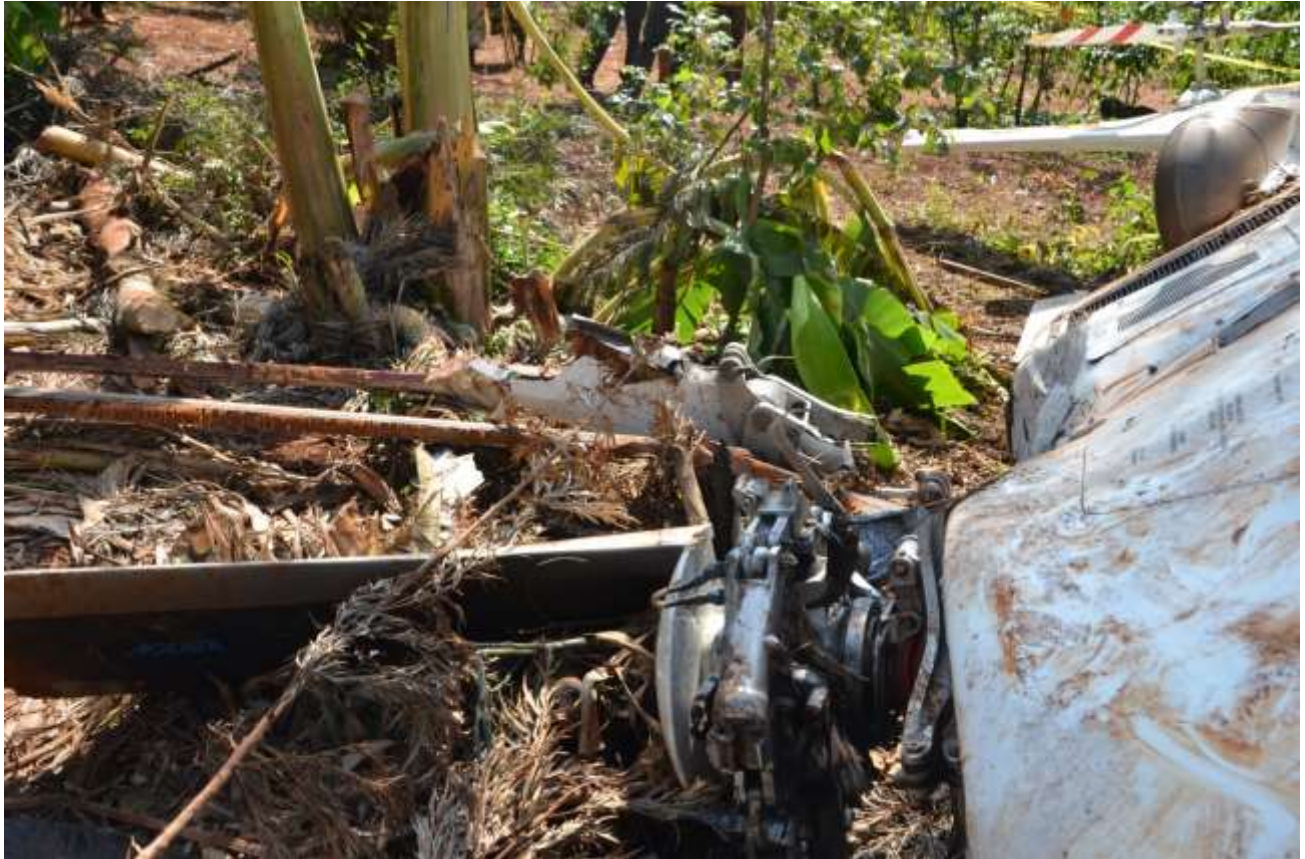
The exam of the damage sustained by the main rotor blades showed that, at the moment of the collision with the ground, the 5Y-NPW rotors were turning at high speed, just on account of aerodynamic and inertial forces indicated by the shearing off of the blades.

Figure 15: The sheared off main rotors

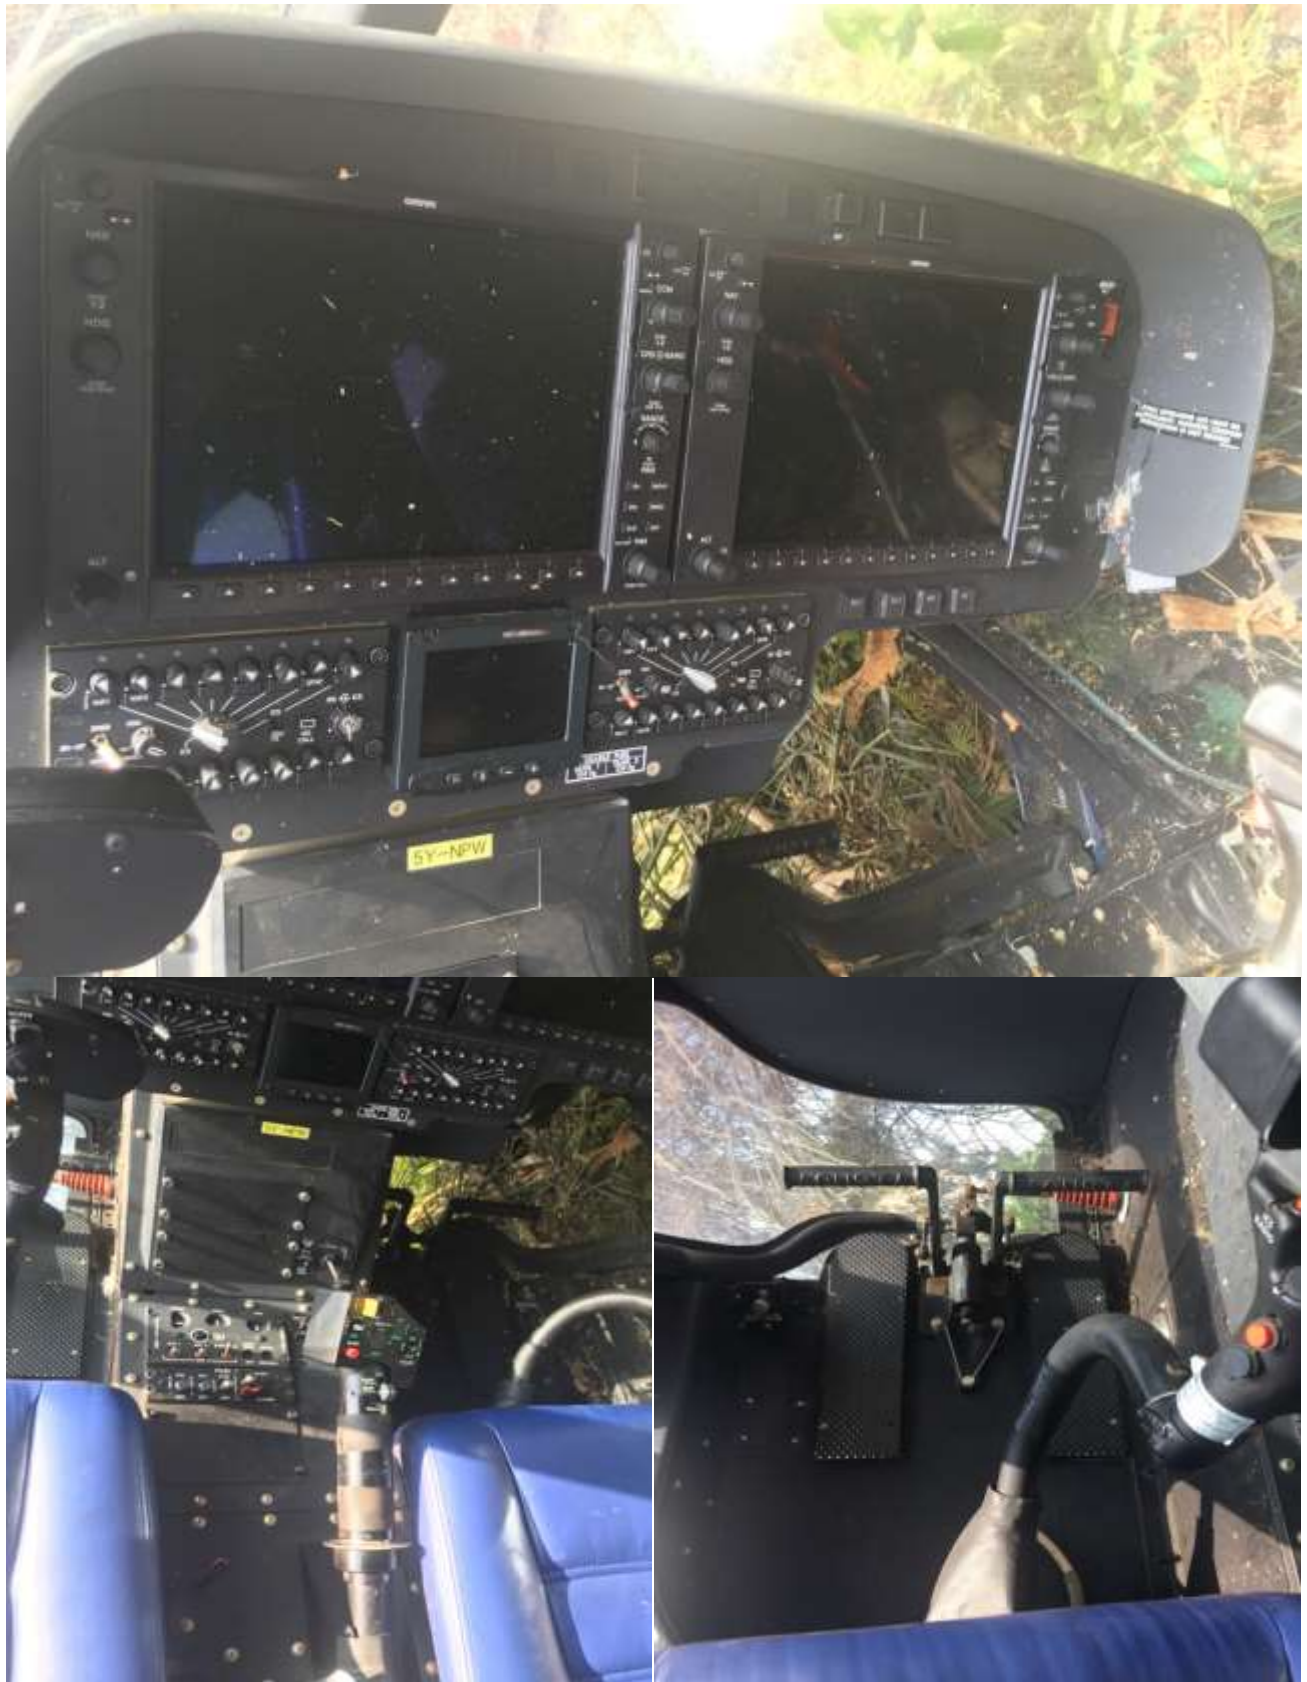
The cabin was intact. The cyclic, collective, throttle and the pedals appeared normal with no visible deformations. The cockpit and the instrument panel were generally intact. Both the EDUs 1 and 2 (primary and secondary) were still in place.

Figure 16: The cabin, cyclic, collective, throttle and the pedals
