AIRCRAFT ACCIDENT INVESTIGATION

PRELIMINARY REPORT TO
SILVERSTONE AIR SERVICES LIMITED
FOKKER 27 MK 050,
5Y-IZO
WILSON AIRPORT, KENYA
ON 11 OCTOBER, 2019

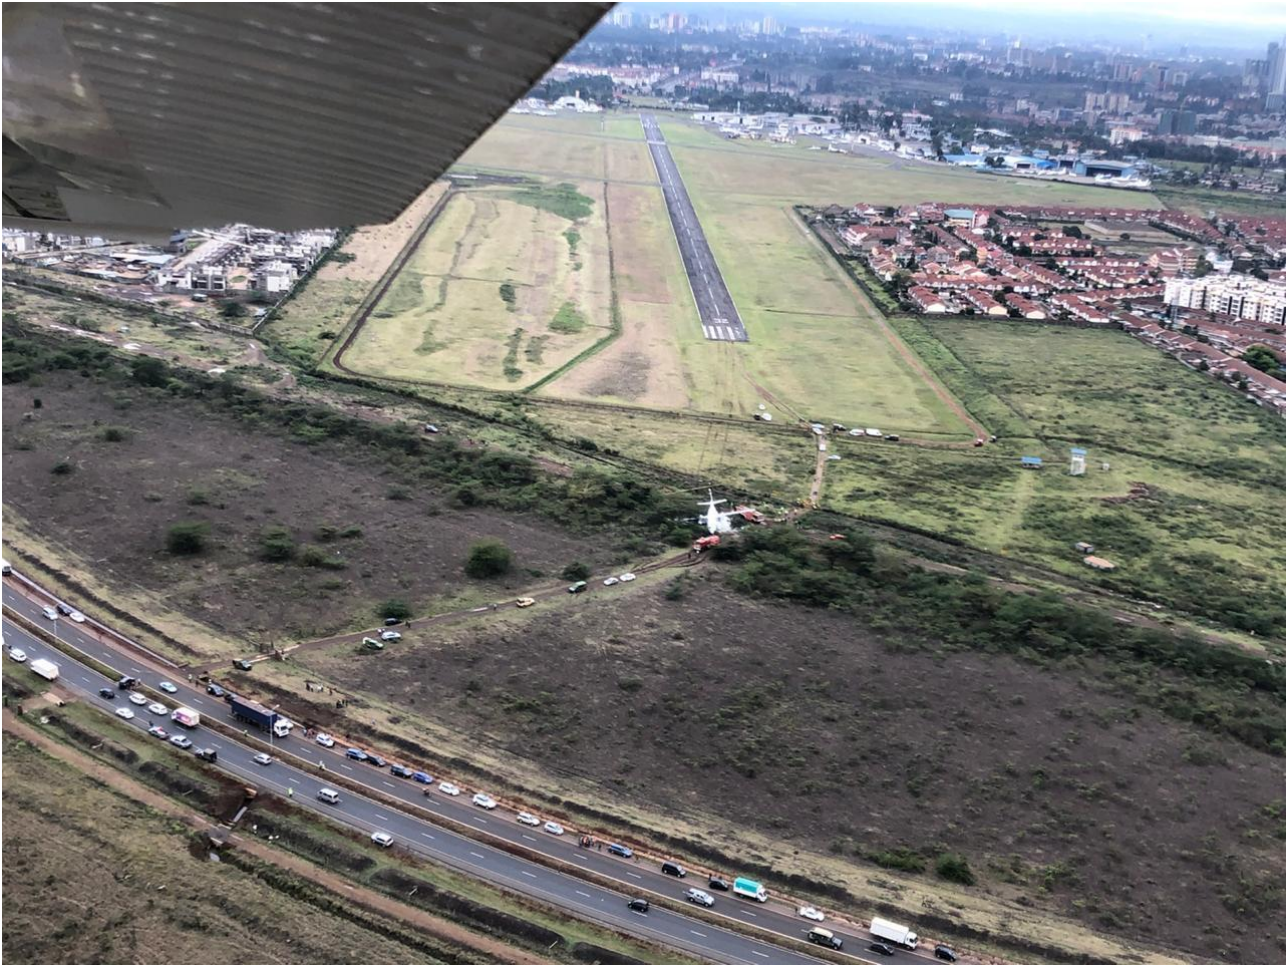
Figure 1: 5Y-IZO at the accident location Wilson airport

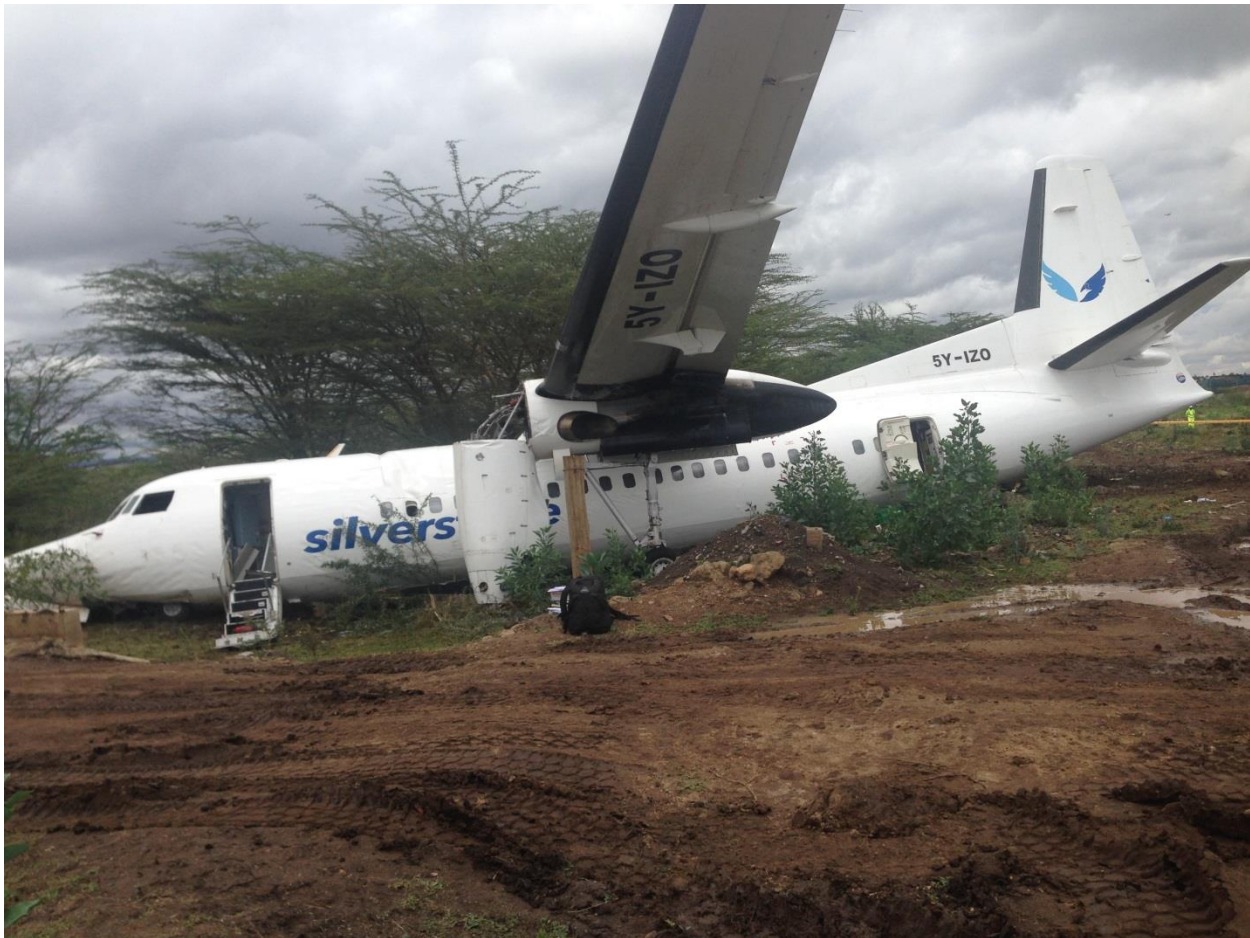
Figure 2: The detached and loosely hanging LH engine

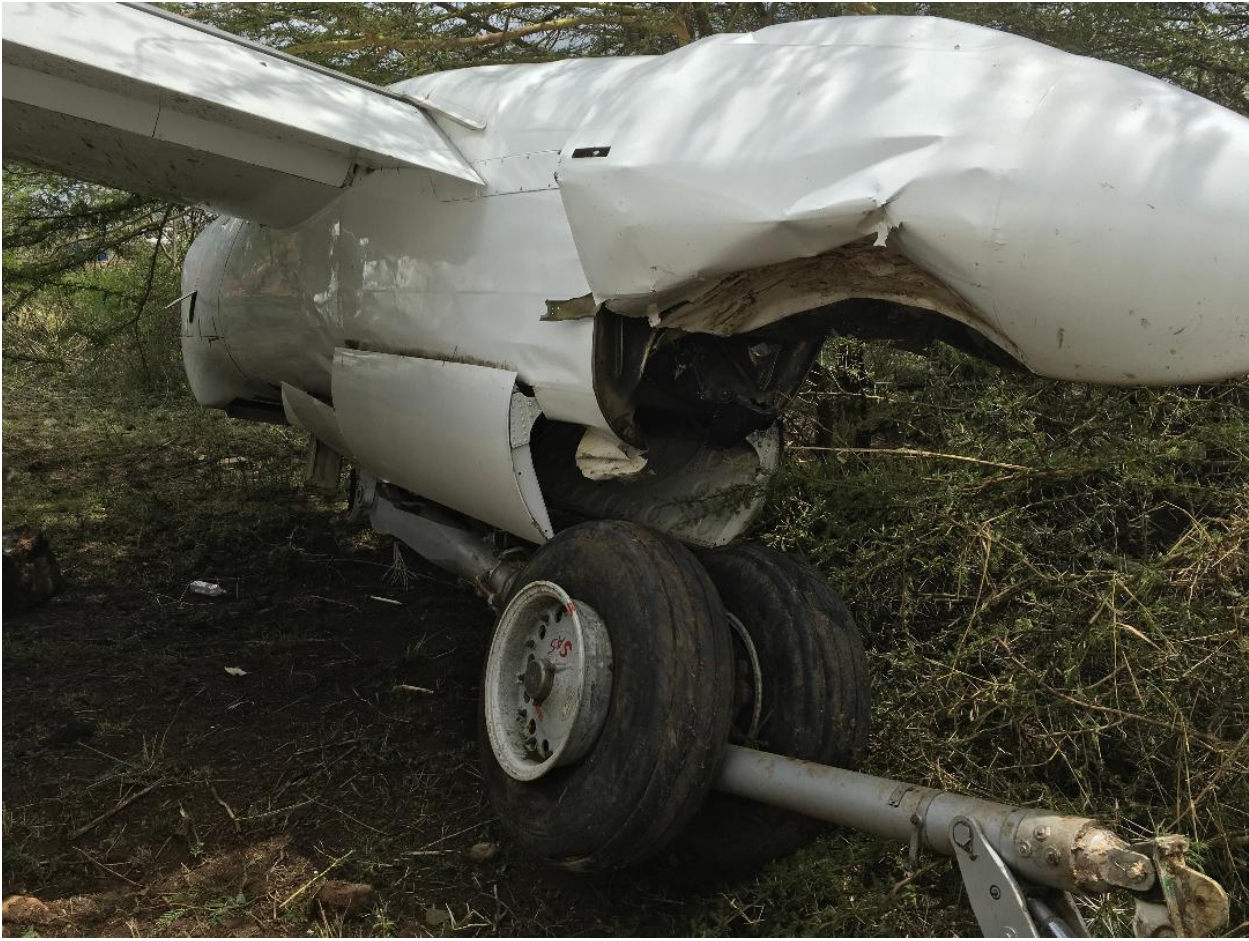
Figure 3: The RH MLG

The aircraft came to a stop after it impacted the perimeter fence of the airport and an embankment 315 metres beyond the paved runway. The NLG was broken, bent rearwards, and the tires still inflated. The LH MLG leg was extended and locked down. Both tires still inflated, with no appreciable damage. The RH MLG severed off and tires deflated. The fuselage suffered substantial damage with ruptured belly. The RH engine was still attached to the wing, but all the blades of the propellers detached. The LH engine detached although still hanging precariously on the wing with five propeller blades still attached to it. The RH wing tip hit the ground and bent where contact was made with the tree. Fuel spillage occurred from the LH engine and RH wing. No other liquid spillage marks were noticed. Major damage to the passenger cabin was noticed, especially the front row seat near the exit and the cabin luggage compartment at the overhead bins, which was detached completely. The two doors on the RH could not be opened because they were partly resting against the ground. No fuel was unloaded from the aircraft because of the spillage.

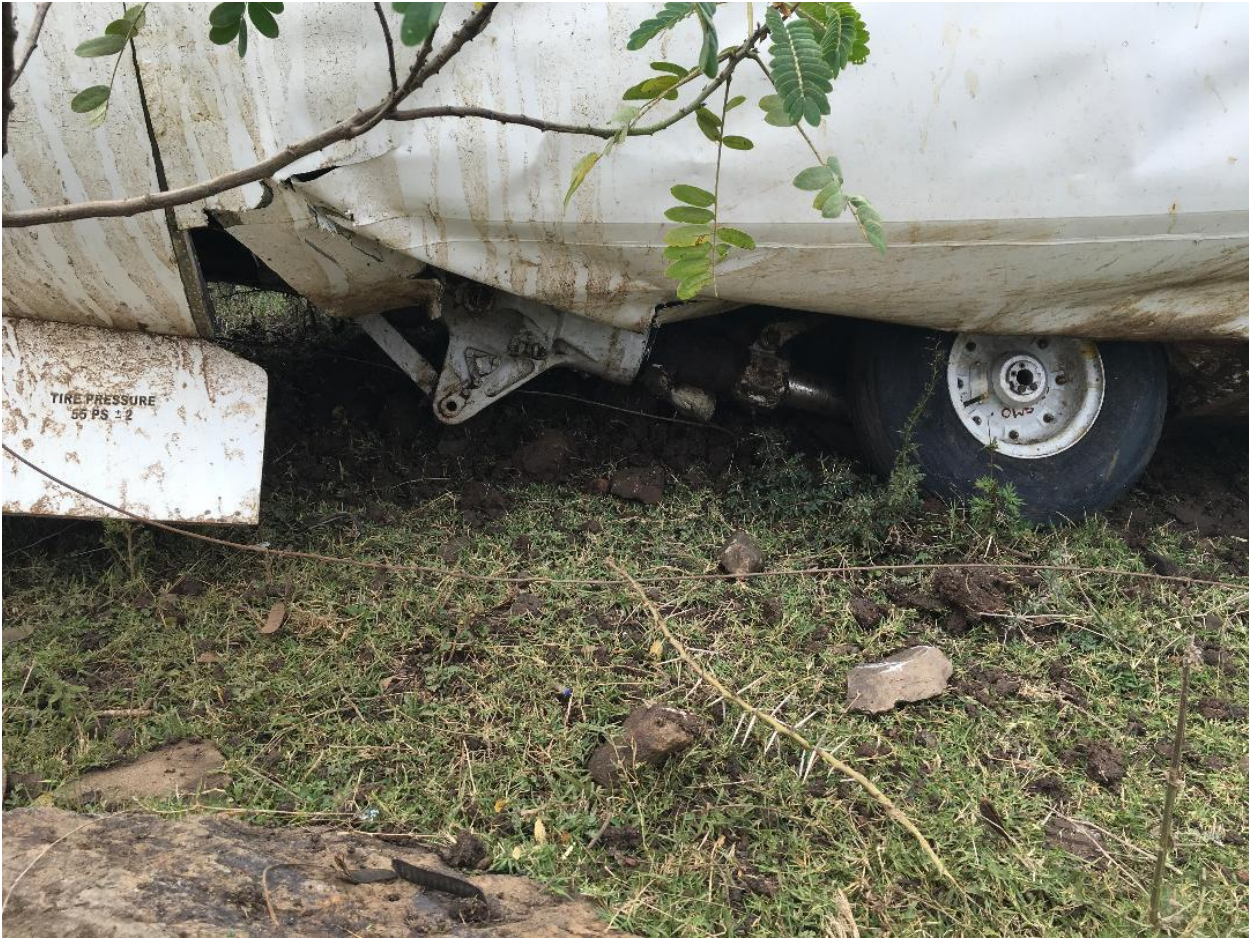
The nose section, including the NLG, its cover and door were damaged and partially buried on ground.

Figure 4: The NLG

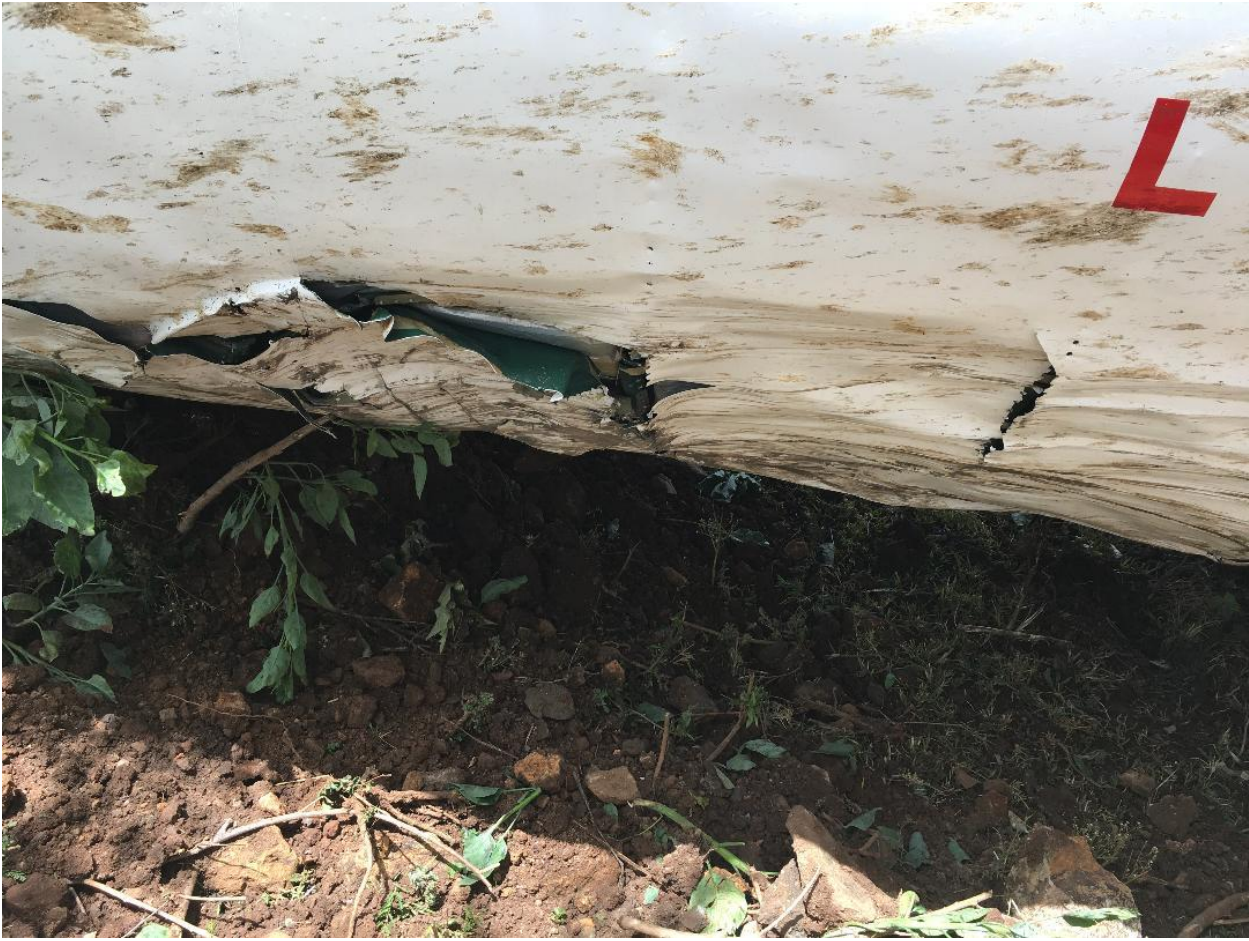
Aircraft damage consisted of severe disruption of the fuselage, damage to the powerplant, landing gears, engine nacelle, propellers, landing gear doors, and starboard wing, NLG and the right Main Landing Gear (MLG) and wheel well. The cockpit and the empennage, did not display visible damage.

Figure 5: The ruptured skin of the Fuselage

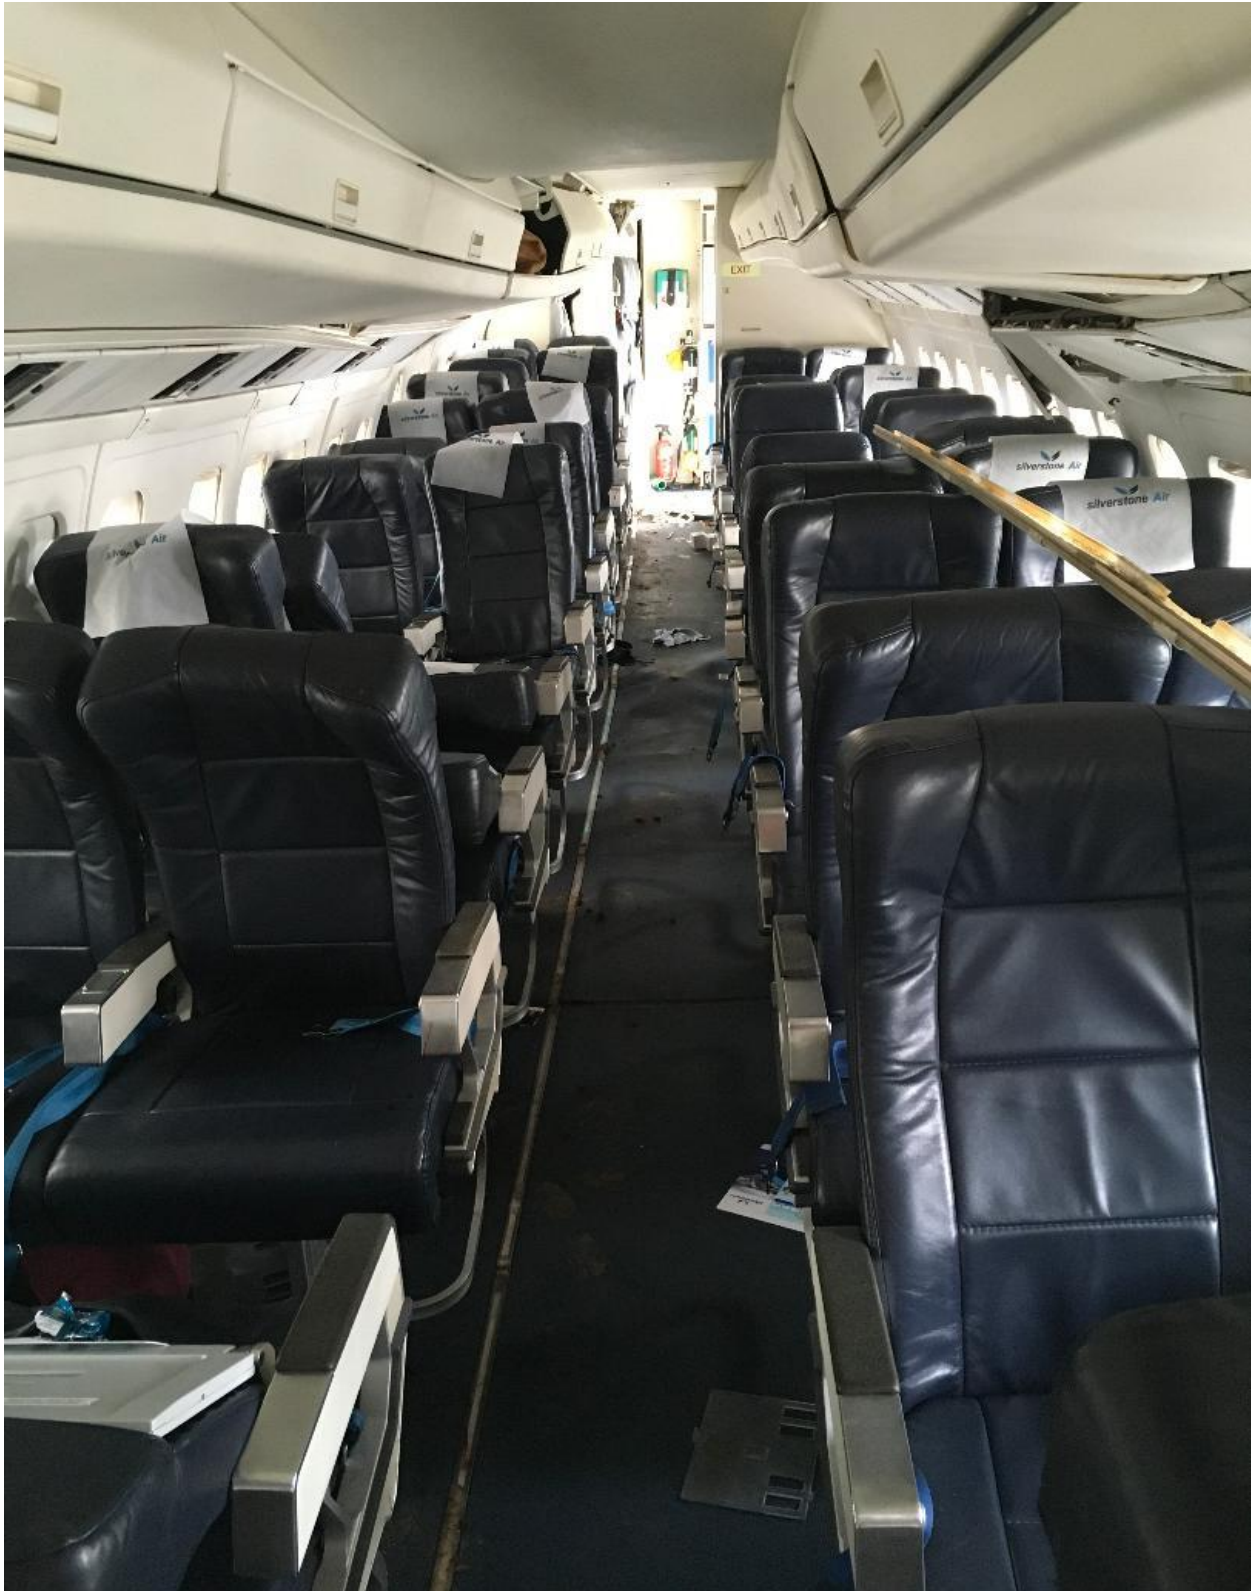
Figure 6: Passenger cabin and the overhead storage

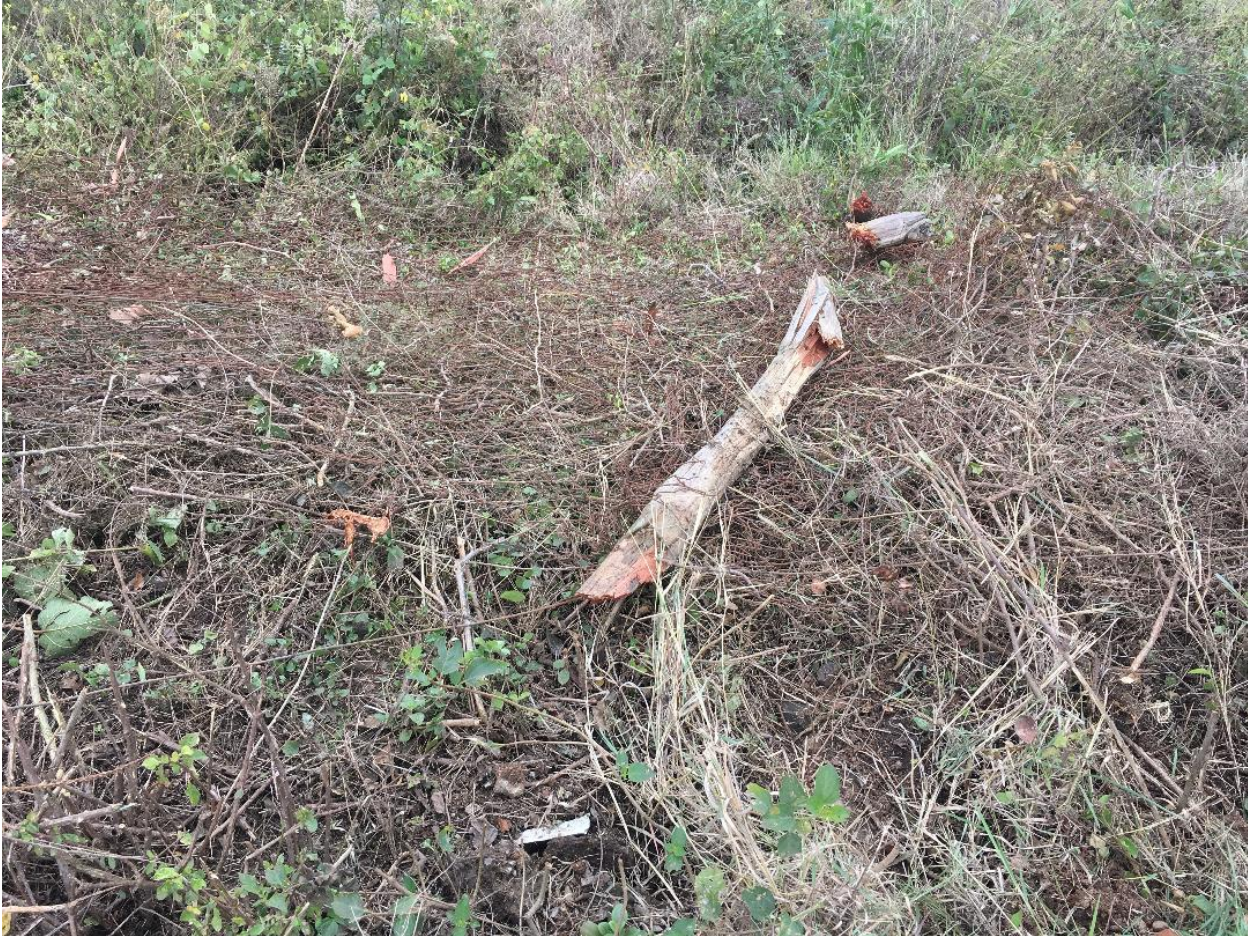
Figure 7: Part of the damaged Perimeter fence

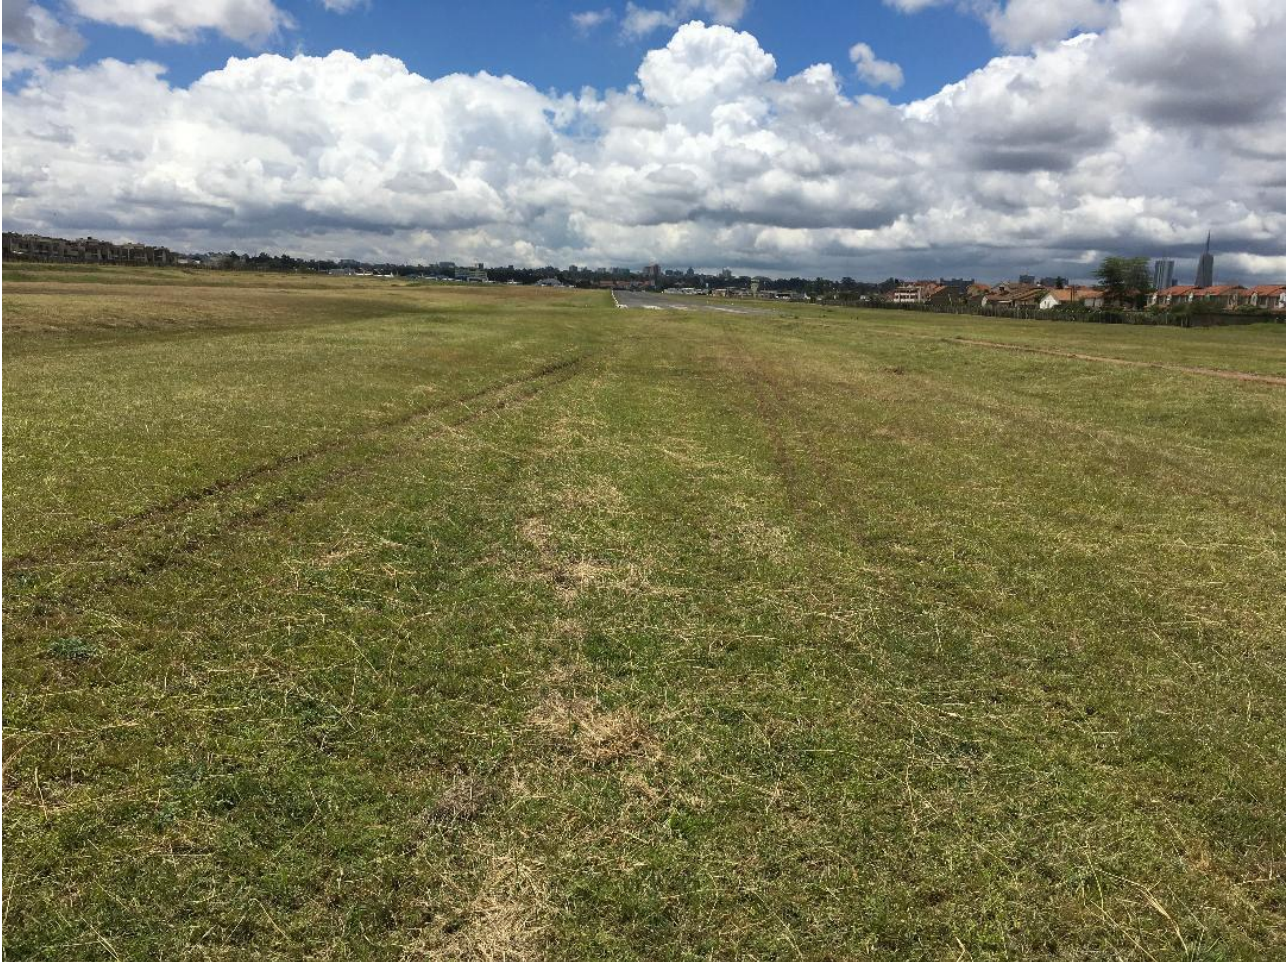
The aircraft ground wheel marks were visible on the runway and grass surface.

Figure 11: Aircraft ground marks

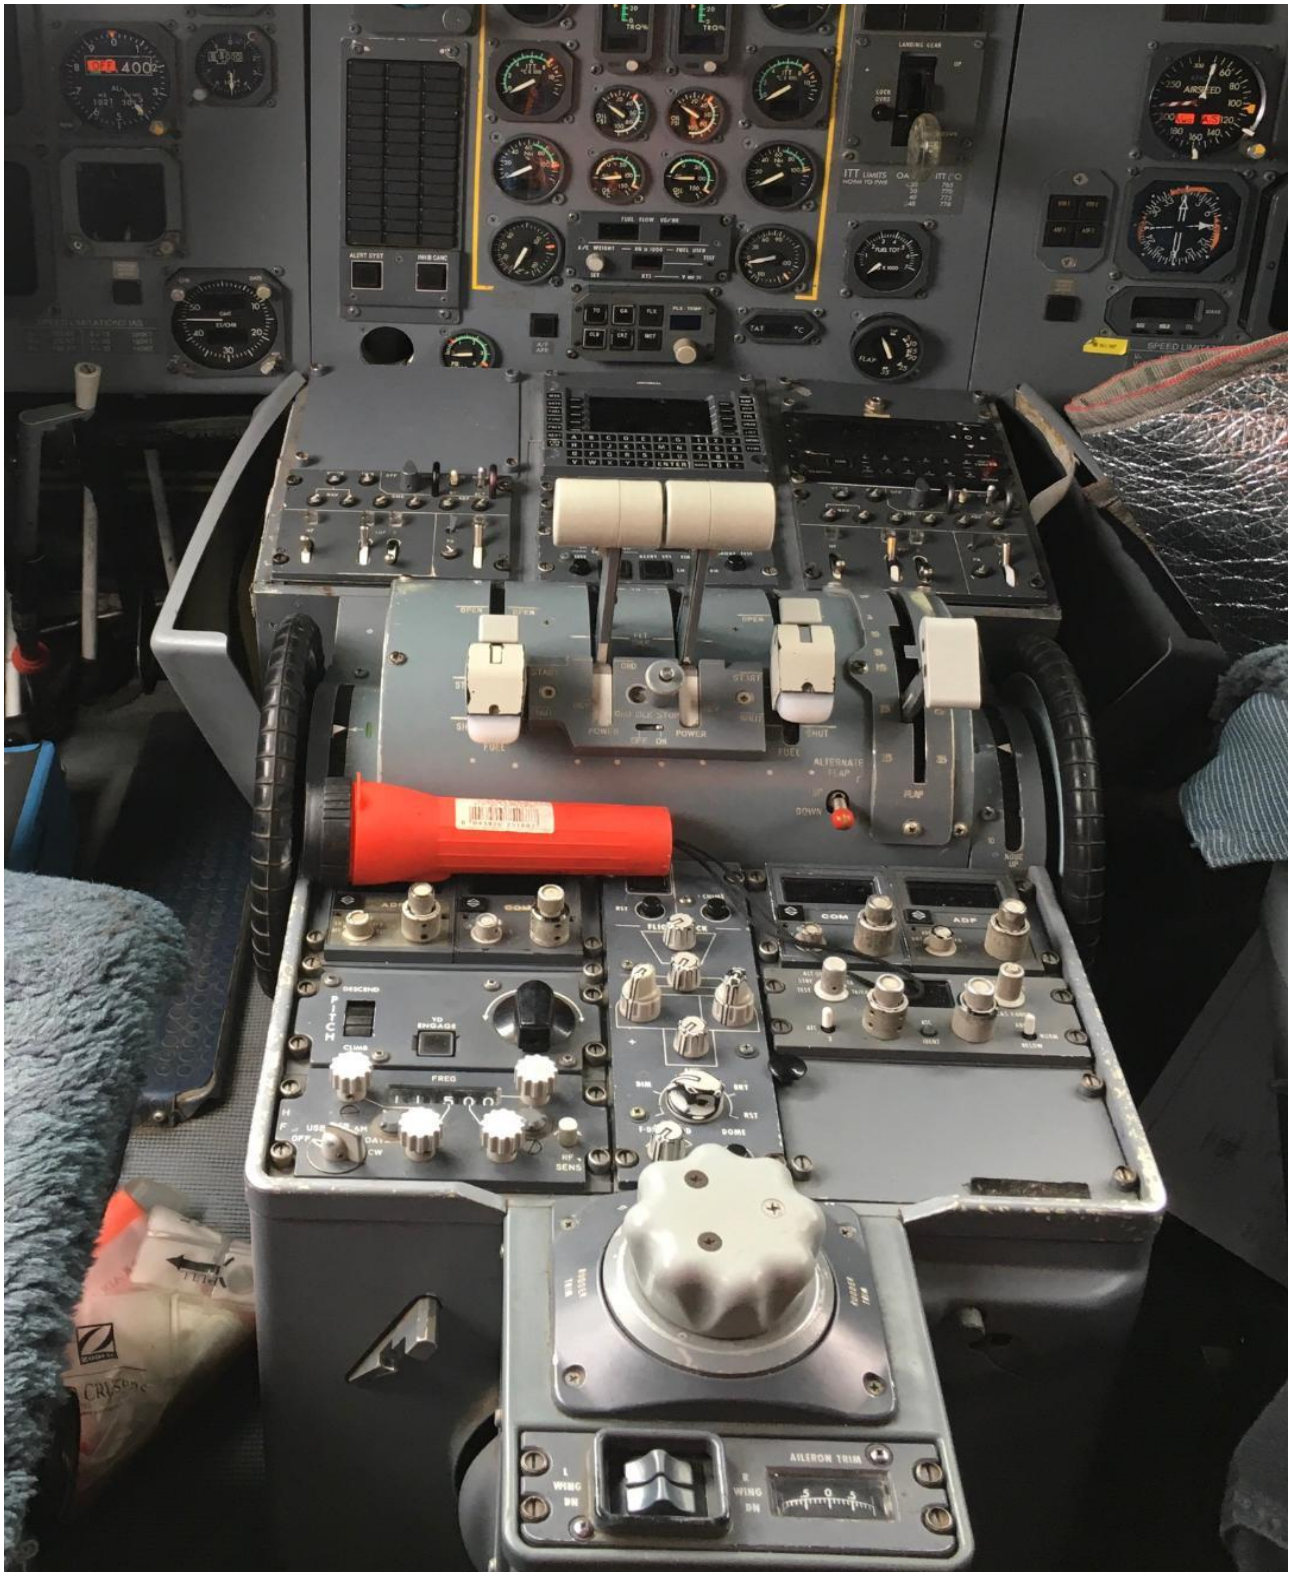
Figure 12: Cockpit instrument panel after the accident

Landing gear selector down

Power selector-idle

Fuel selector-shut

Flap selector-25

Control wheel-neutral

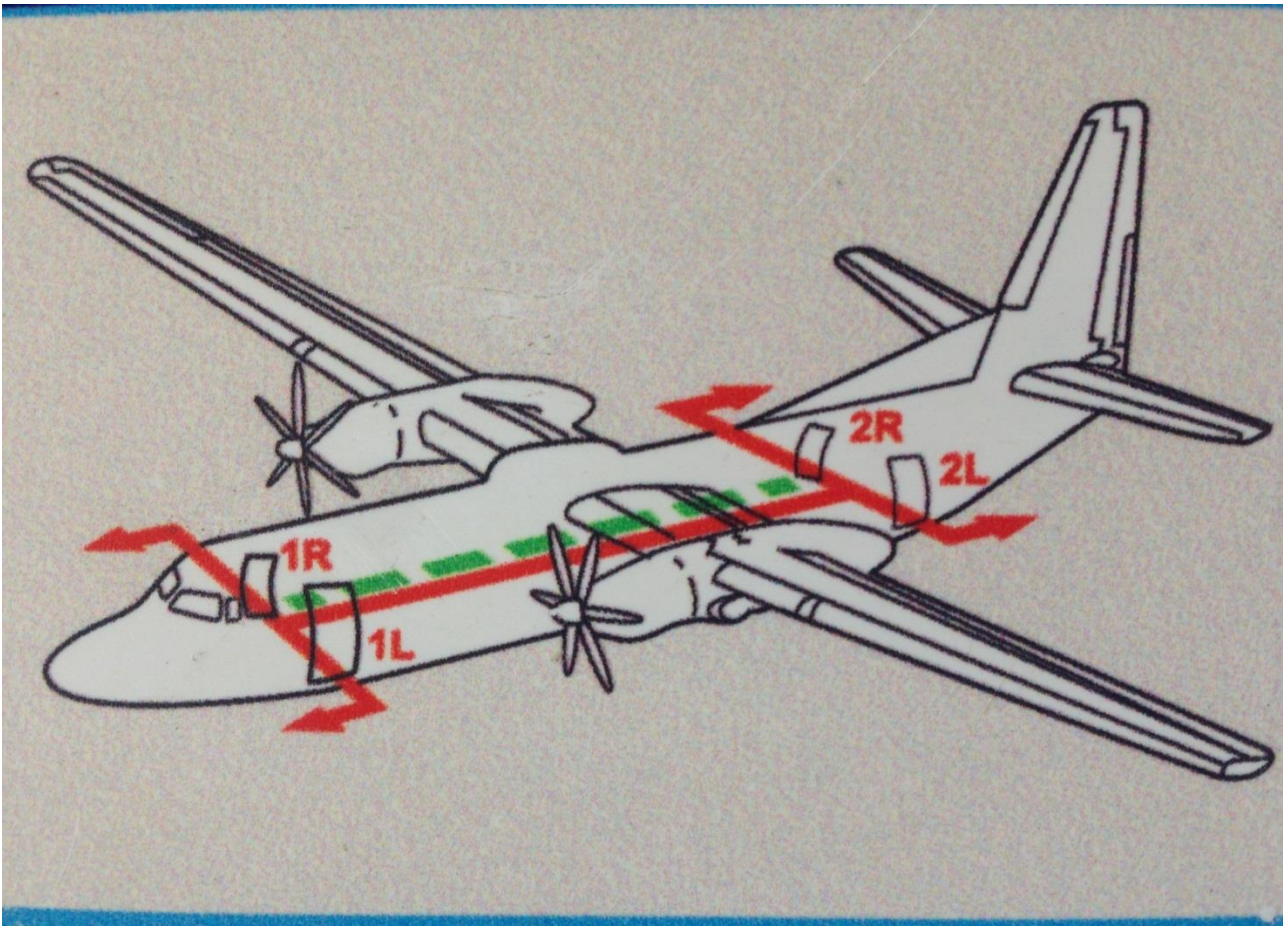
Figure 13: 5Y-IZO Exit doors

Emergency procedures are some of the eventualities that crews are trained for and regularly examined upon. As such they would be expected to carry out the appropriate procedures correctly. This was the case with 5Y-IZO. There was no pre or post impact fire despite the fact that the aircraft had 2100kgs of jet fuel. After impact, the two exit doors, 1R and 2R on the starboard side were inoperative and therefore they were not effective during evacuation. The two port exit doors, 1L and 2L were opened and used to evacuate the passengers.
