**AIRCRAFT INCIDENT INVESTIGATION DEPARTMENT**

**INVESTIGATION REPORT**

**INCIDENT TO THE AIRCRAFT 5Y-BRJ, PIPER PA 32R301T ON  
19.03.2022 AT WILSON AIRPORT, NAIROBI COUNTY**

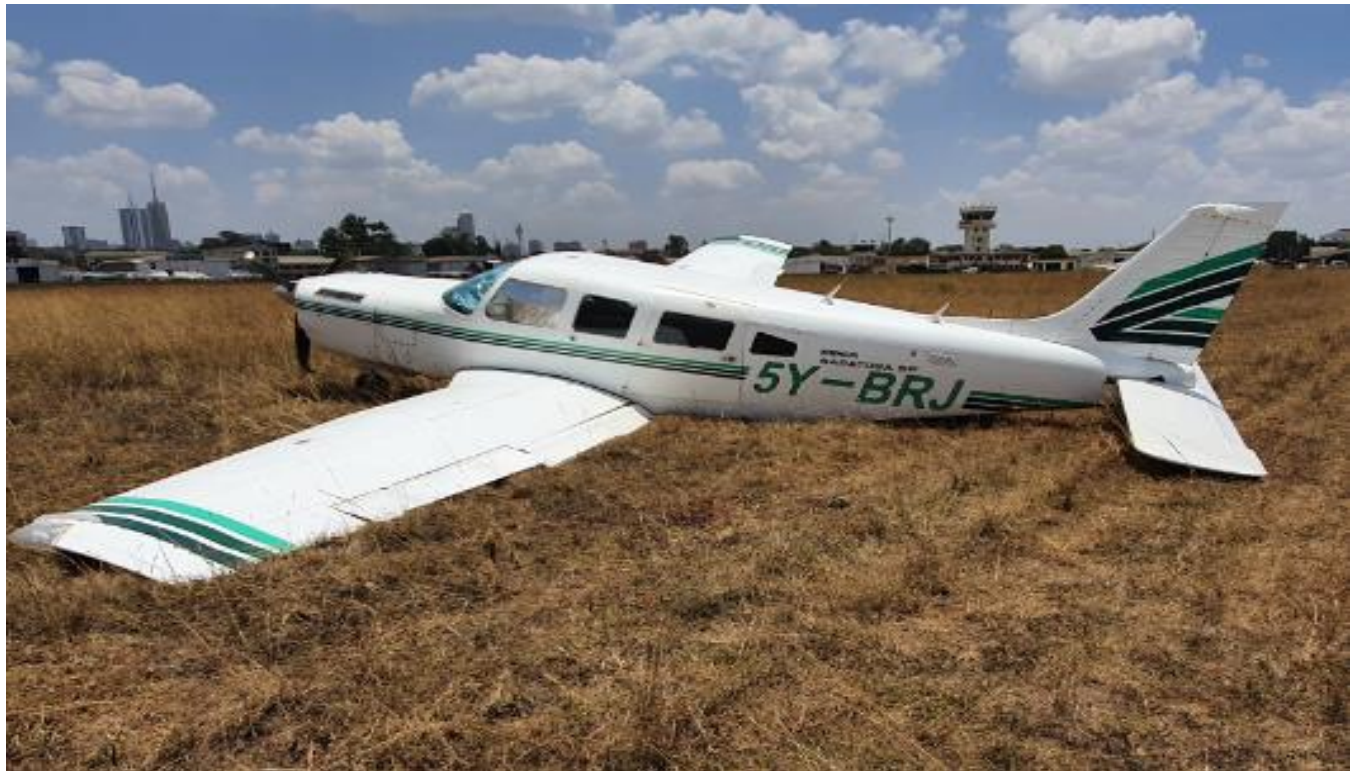
*Figure 1: The aircraft in a grassy area within the confines of the Aerodrome*

The aircraft sustained minor damage on the left wing and both blades were bent at the tip. Bottom of engine cowls had scratches and slightly worn on the sides.

The left landing gear collapsed and the flaps retracted. There was no damage to right and nose landing gear gear strut, gear-strut-to-actuator joint or actuator. Except for the nose portion, the bottom surfaces of the Aircraft were free of scratches and other damage both in the fuselage portion and the doors of the left and right main landing gears.

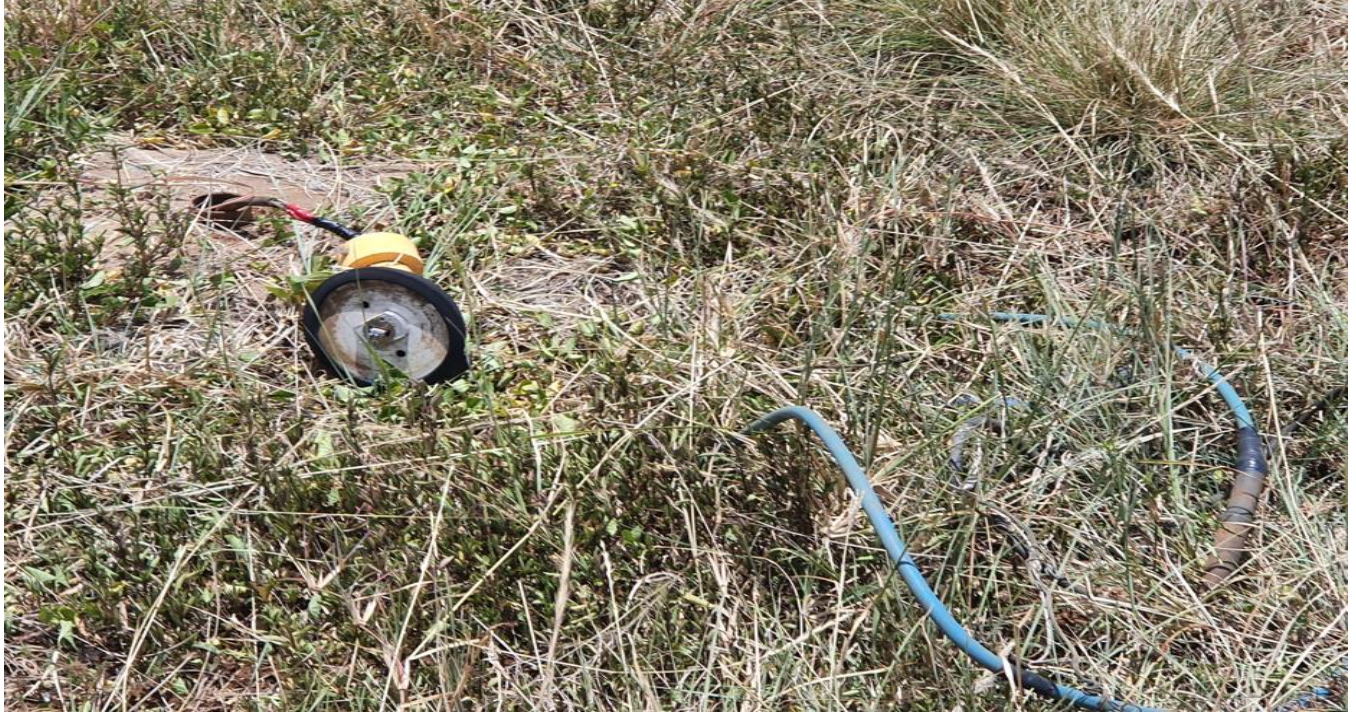
There was damage to the runway edge light.

*Fig 2: Damage on the runway edge light*

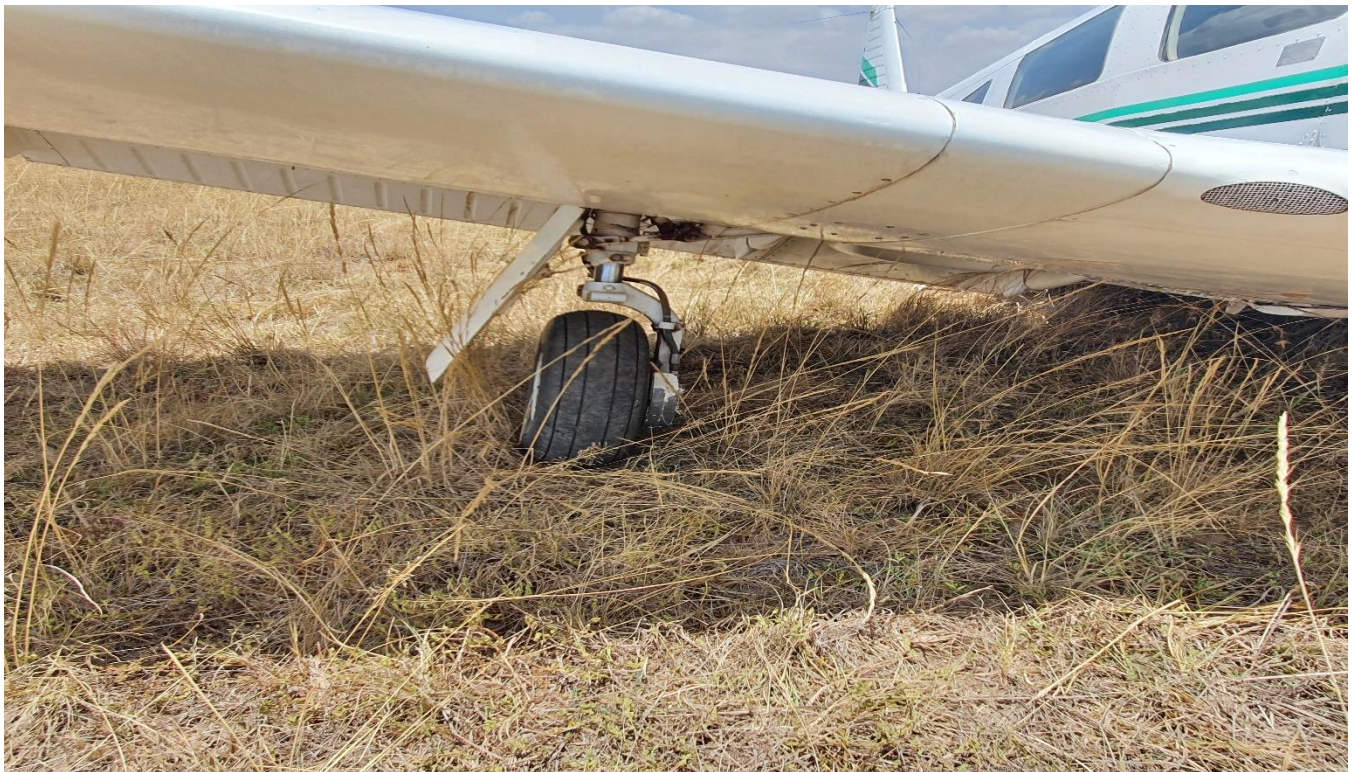
*Figure 5: The R/H landing gear.*

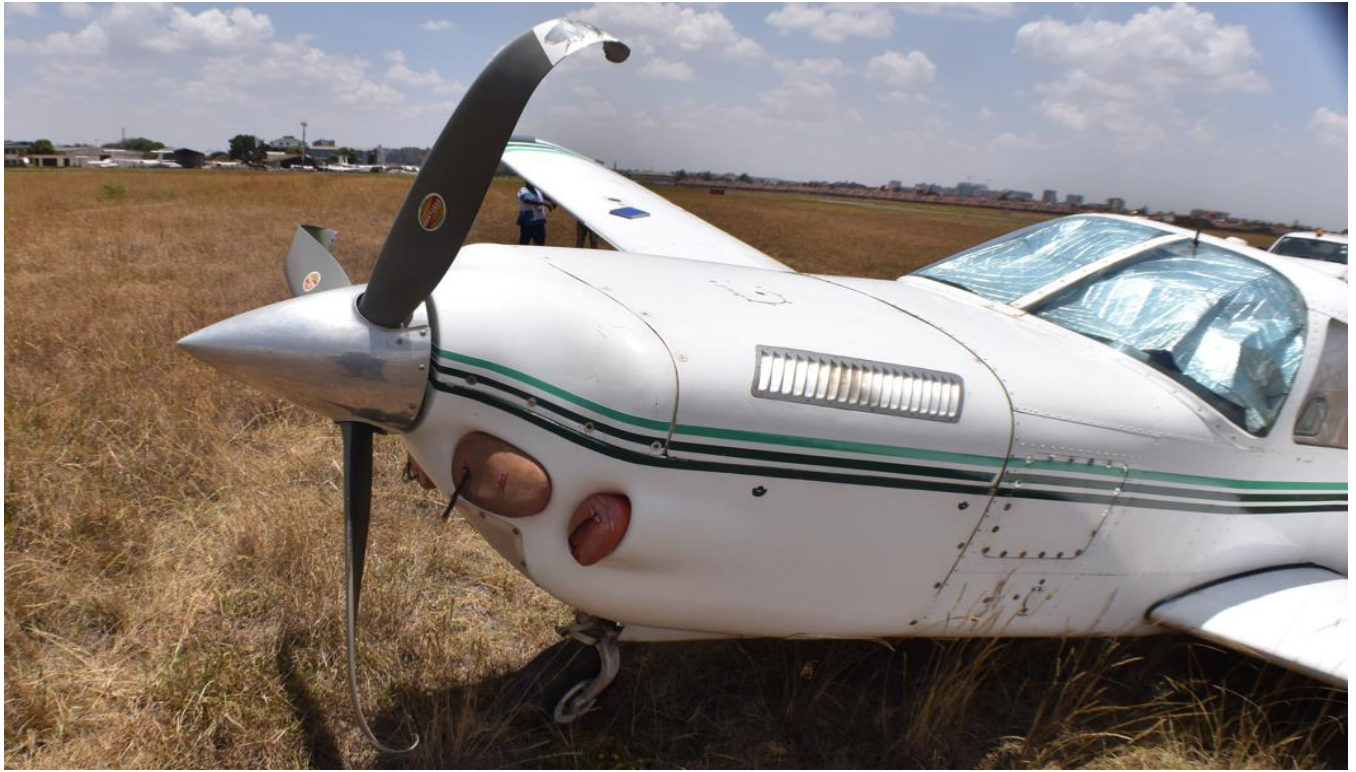
*Figure 6: Damage to the propellers blades.*

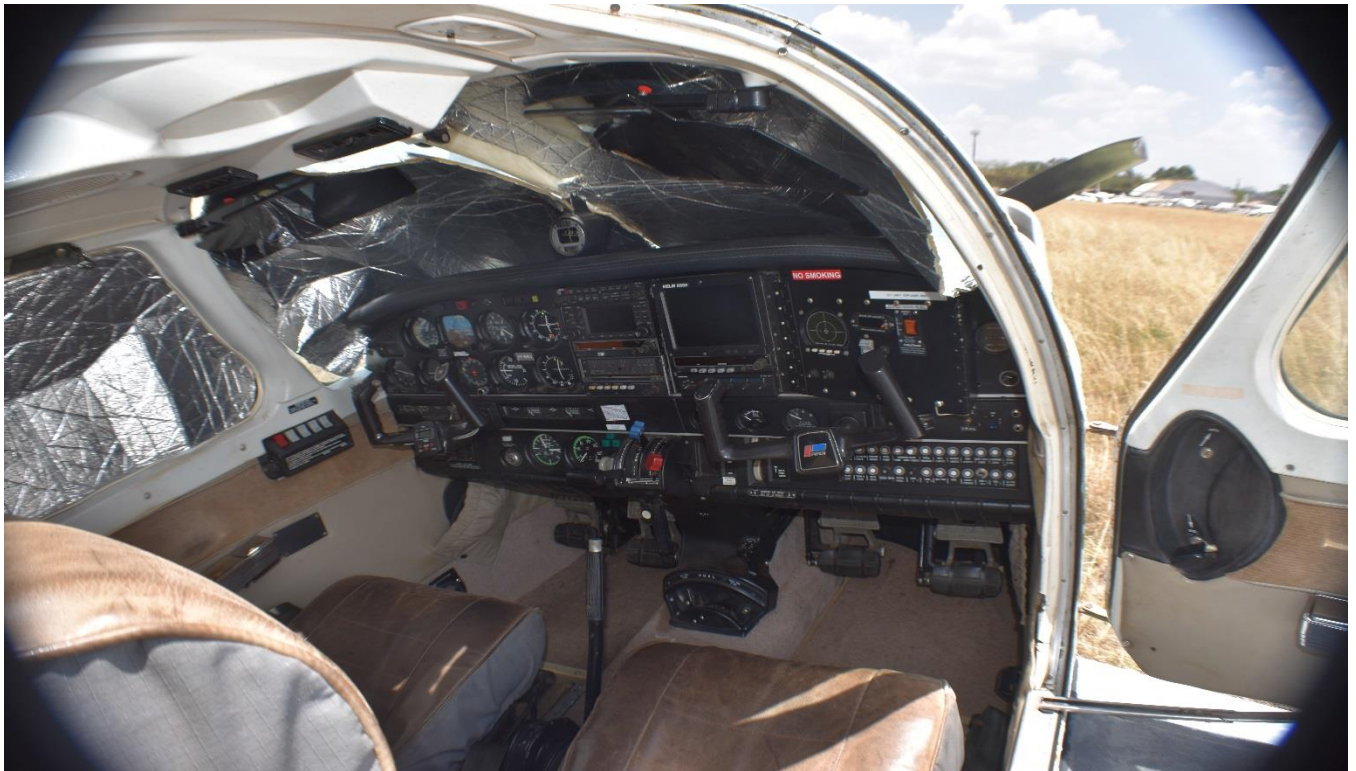
*Fig 7: The Section of the Cockpit Instruments*
